Aviation Investigation Preliminary Report

Location:	Galliano, LA	Accident Number:	CEN23FA071
Date & Time:	December 29, 2022, Local	Registration:	N595RL
Aircraft:	Bell 407	Injuries:	4 Fatal
Flight Conducted Under:	Part 135: Air taxi & commuter - Non-scheduled

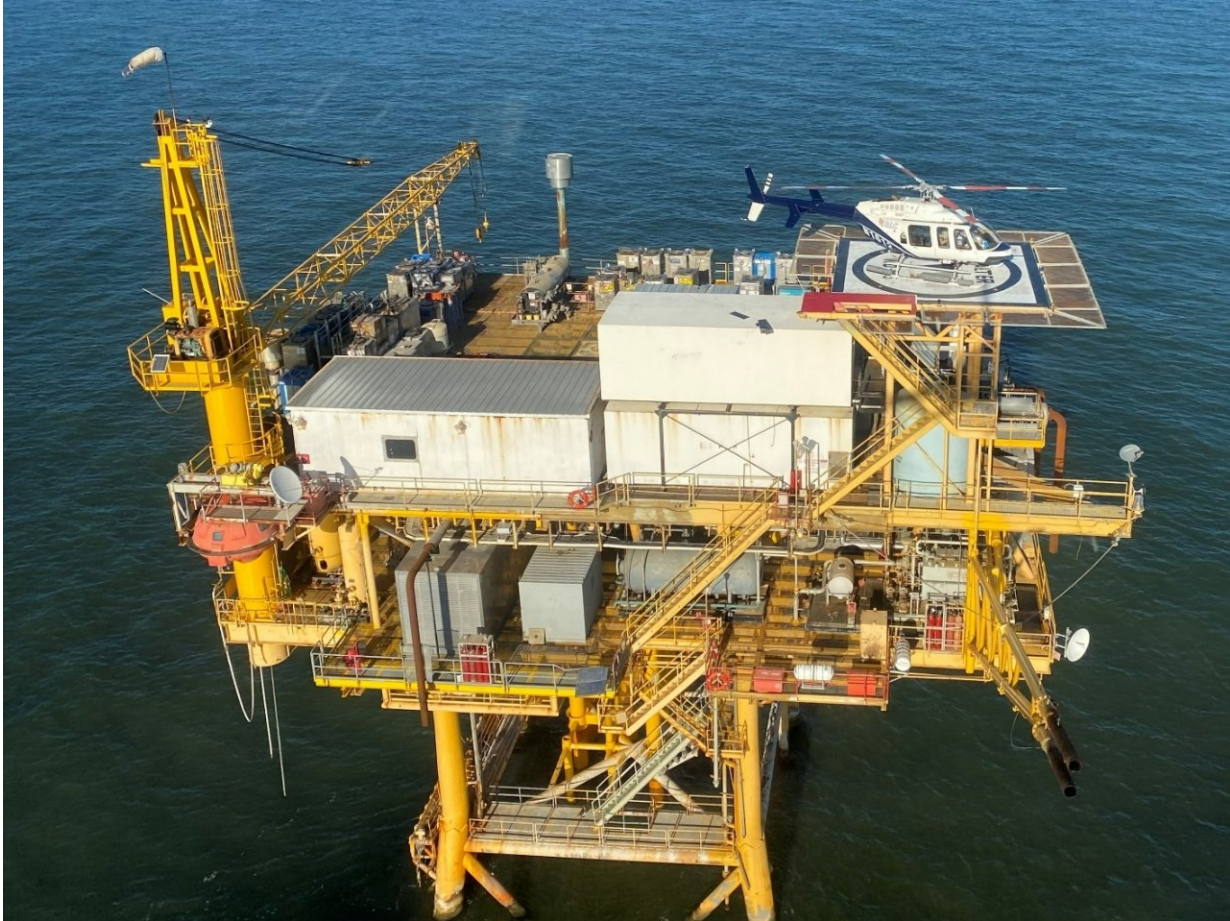
The WD106 platform is equipped with a 24 ft by 24 ft helipad, as shown in Image 1. The helipad was constructed of recently repainted metal and was surrounded with a chain link

perimeter skirt. Eight lights outlined the perimeter of the landing pad. The stairwell leading down from the helipad was recently painted red. The helipad was located on the southeast corner of the platform and about 100 ft above the water.

Image 1 – Overview photo of West Delta 106 platform with exemplar Bell 407 helicopter on the helipad. The helicopter is facing southeast on the helipad. The damaged chain link perimeter skirt on the southwest side of the helipad was removed after the accident.

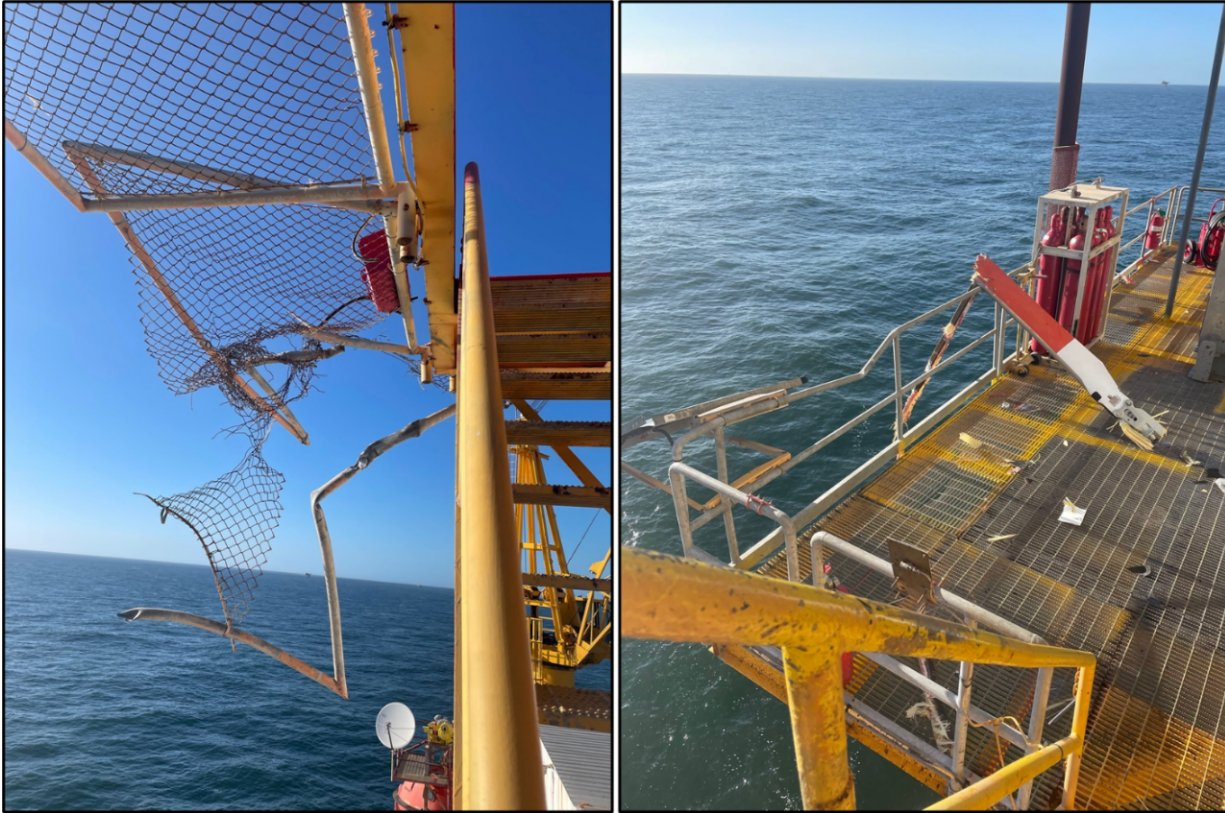
Examination of the helipad revealed the red paint of the stairwell was gouged and scratched near the southwest end, nearest the skirted area. The skirt near the stairwell was damaged with metal posts bent and broken and the skirt wire damaged and torn, as shown in Image 2a. One perimeter light, on the southwest corner separated from the helipad and was not recovered. An adjacent perimeter light, located at the center of the west edge of the helipad, was damaged and separated from the helipad, as shown in Image 3a. The light's blue glass globe was shattered, and shards were found on the deck below the helipad. The remaining perimeter lights appeared undamaged. There were two areas of the landing pad surface with gouges in the paint. One area was located on the western area of the aiming circle and consisted of 3 linear gouges and 2 circular gouges into the paint. The other area consisted of 9 linear gouges in the paint.

Further examination of the platform revealed composite debris scattered throughout multiple decks below the helipad. Most of the scattered debris was consistent with the materials used to construct the main rotor blades. A six-foot-long portion of a main rotor blade came to rest on a metal handrail located on the deck below the helipad, as shown in Image 2b. The handrail exhibited a downward bend near the location of the main rotor blade. Three pieces of lead weight, consistent with blade weights, and multiple pieces of dark tinted acrylic, consistent with the cockpit overhead windows from the helicopter, were found on the same platform deck as the main rotor blade. The acrylic shards exhibited red paint transfer consistent in color with the red paint of the stairwell. The upper hydraulic servo cover, normally located above the cockpit, also exhibited the same red paint transfer, as shown in Image 3b. Fragments of tail rotor blades were found on the deck below the helipad. There was impact damage to the left landing skid-to-aft crosstube interface.

*Image 2a (left) – Damaged chain link perimeter skirt on southwest corner of helipad
Image 2b (right) – Portion of a main rotor blade found on the deck below the helipad*

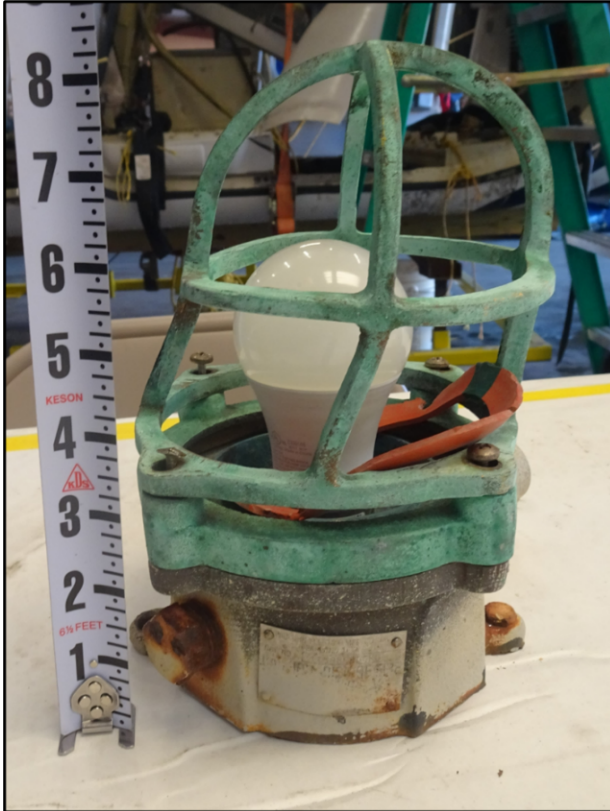
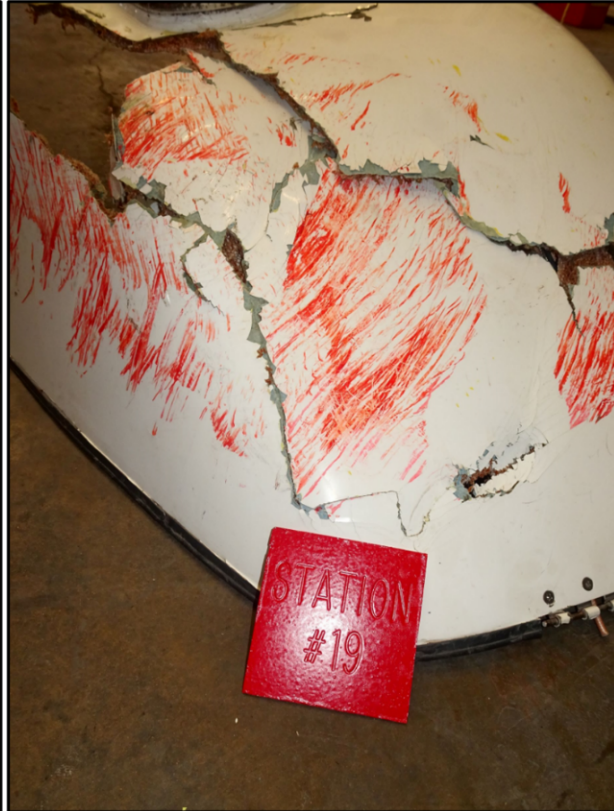
Image 3a (left) – Damaged perimeter light from west edge of helipad
 Image 3b (right) – Upper hydraulic servo cover with red paint transfer and exemplar paint sample from platform.
