# Aviation Investigation Final Report

<b>Location:</b>	Galliano, Louisiana	<b>Accident Number:</b>	CEN23FA071
<b>Date &amp; Time:</b>	December 29, 2022, Local	<b>Registration:</b>	N595RL
<b>Aircraft:</b>	Bell 407	<b>Aircraft Damage:</b>	Substantial
<b>Defining Event:</b>	Dynamic rollover	<b>Injuries:</b>	4 Fatal
<b>Flight Conducted Under:</b>	Part 135: Air taxi & commuter - Non-scheduled

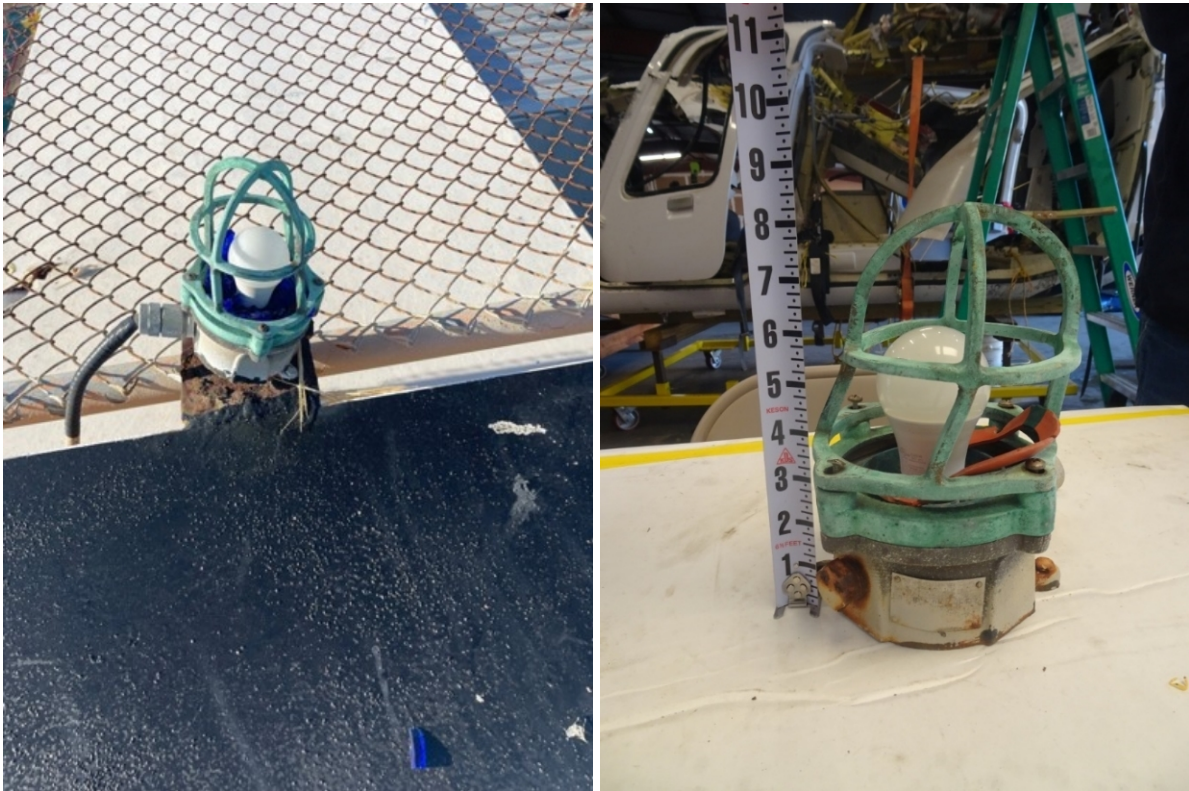
Further examination of the helideck revealed that the center blue light assembly on the northwest elevation of the helideck was damaged but still attached to its 6 inch by 6 inch light mount. Although the light remained installed on the mount, its blue glass globe was fragmented and the metal protective guard for the globe was significantly deformed and bent toward the stairwell, as shown in Figure 2. After the accident, a platform employee removed the damaged light assembly from the mount out of concern for safety during future use of the helideck. The amber light, located on the west corner of the helideck, near the stairwell, separated from its mount and was not recovered. The remaining perimeter lights appeared undamaged.

**Figure 2.** Photo (left) of the damaged center perimeter light shortly after the accident (Source: Walter Oil and Gas). Photo (right) of the same light assembly after it was removed from the helideck (Source: NTSB).

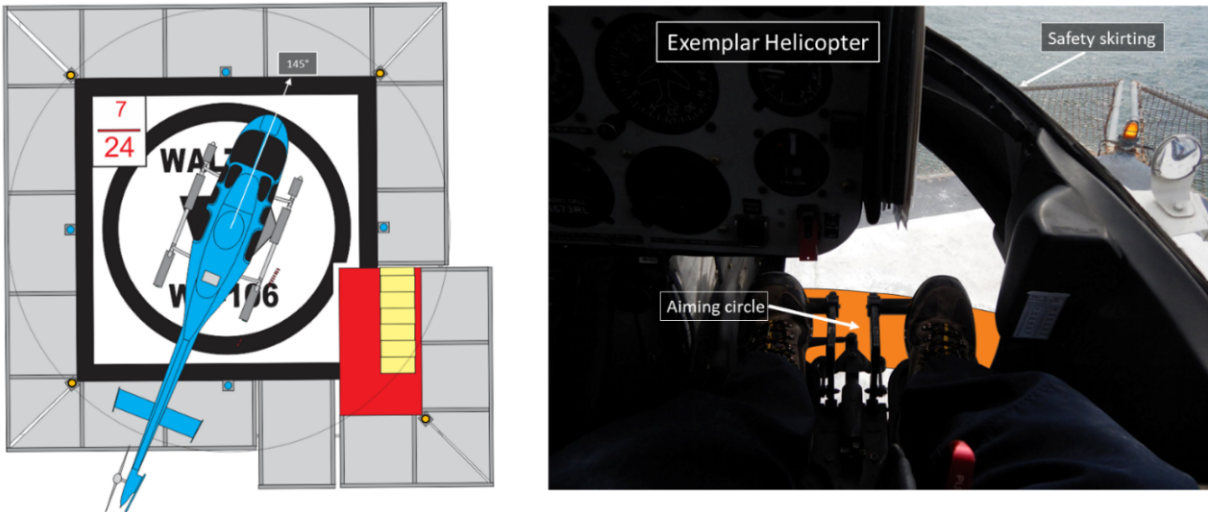
helicopter's Appareo FOV. The exemplar helicopter was flown to WD-106 and parked in the center of the 10-ft-diameter aiming circle on a magnetic heading of 145°. With a camera placed alongside the Appareo recorder, a photo was captured to show the view of the aiming circle from the right-side pilot's chin bubble. The aiming circle was positioned under the anti-torque pedals, as shown in Figure 5.

**Figure 5.** Photo (right) captured while the exemplar helicopter was in the center of the aiming circle and showing the right-side chin bubble and the location of the aiming circle, highlighted in orange, under the anti-torque pedals. The illustration (left) depicts the exemplar helicopter's position and orientation on the helideck.

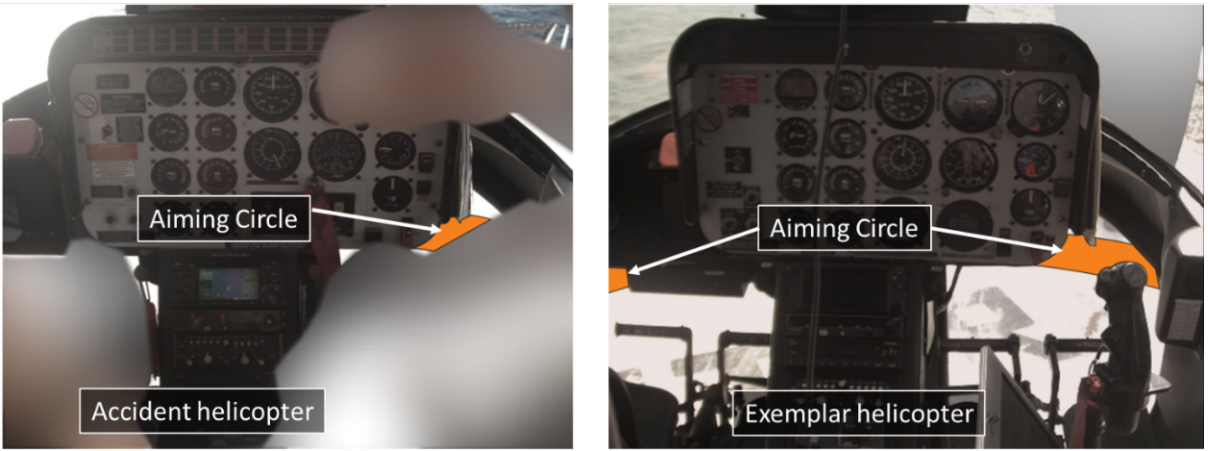
The exemplar helicopter was then repositioned straight aft on the helideck to match the accident recorder's FOV before the takeoff, as shown in Figure 6.

**Figure 6.** Side-by-side comparison of the accident helicopter's Appareo FOV (left) and the exemplar helicopter's Appareo FOV (right). Aiming circles are highlighted in orange.

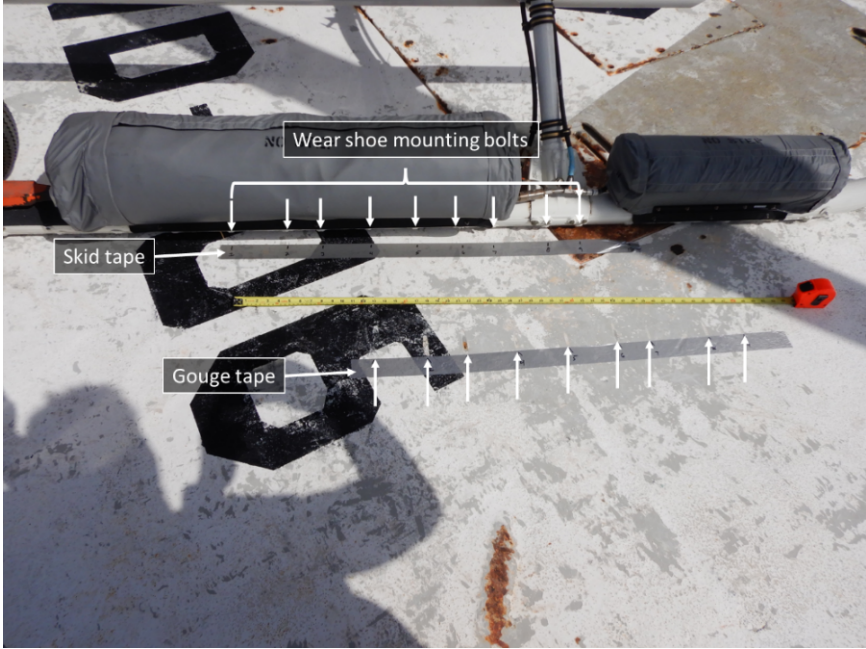
With the exemplar helicopter still in the position that matched the accident helicopter's FOV, the middle section of the right skid was compared to the row of nine irregularly spaced but inline gouges to the helideck paint. A section of nine wear shoe mounting bolts were near the gouges and matched the spacing of the gouges, as shown in Figure 9.

**Figure 9.** Photo showing the row of nine irregularly spaced but inline gouges in the paint alongside the matching wear shoe mounting hardware.
