Aviation Investigation Final Report

Location:	Montgomery, Alabama	Accident Number:	DCA23LA109
Date & Time:	December 31, 2022, 15:39 Local	Registration:	N264NN
Aircraft:	EMBRAER S A ERJ 170-200 LR	Aircraft Damage:	Minor
Defining Event:	Prop/jet/rotor blast/suction	Injuries:	1 Fatal, 63 None
Flight Conducted Under:	Part 121: Air carrier - Scheduled

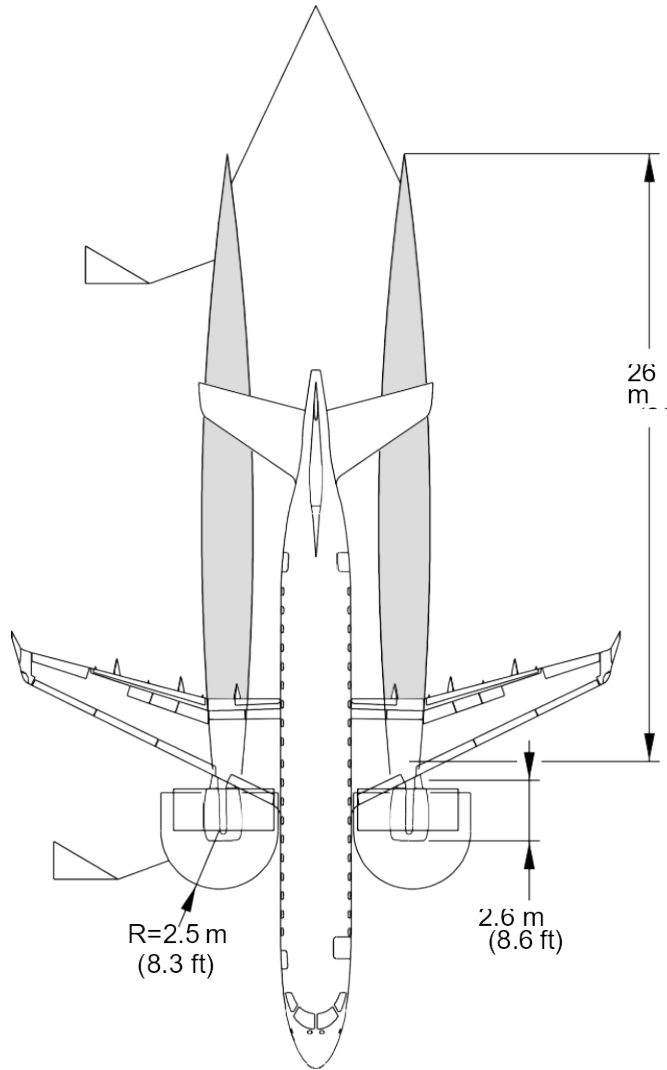
Figure 1. Inlet and exhaust hazard area (Source: *Embraer 175 Airport Planning Manual*).

According to the lead ramp agent on the day of the accident, ramp personnel were required to stay 15 ft away from an engine, consistent with guidance in the *American Eagle Ground Operations Manual*. The accident ramp agent should have been familiar with the company's ramp safety policy because her position required her to continuously work around jet-powered airplanes. The 15-ft guidance provided a buffer that was almost two times the airplane manufacturer's boundary for the inlet hazard area (8.3 ft).

The *Embraer 175 Airport Planning Manual* depicted the inlet and exhaust hazard areas, as shown in figure 1. The inlet hazard area comprised a 2.5-meter (8.3-ft) radius around each engine inlet. The exhaust hazard area extended about 26 meters (85 ft) behind the engines and generated wind velocities of at least 65 miles per hour.

2 INLET HAZARD AREA - CONDITION: 20 kn HEADWIND/CROSSWIND/TAILWIND BASED ON 12.2 m/s (40 ft/s) CRITICAL VELOCITY WITH 0.9 m (3 ft) CONTINGENCY FACTOR.

1 EXHAUST HAZARD AREA - CONDITION: 20 kn HEADWIND WITH GROUND EFFECTS
