# Aviation Investigation Preliminary Report

| <b>Location:</b> | Provo, UT | <b>Accident Number:</b> | WPR23FA080 |
| <b>Date &amp; Time:</b> | January 2, 2023, Local | <b>Registration:</b> | N555NR |
| <b>Aircraft:</b> | EMBRAER EXECUTIVE AIRCRAFT<br>INC EMB-505 | <b>Injuries:</b> | 1 Fatal, 2 Serious, 1<br>Minor |

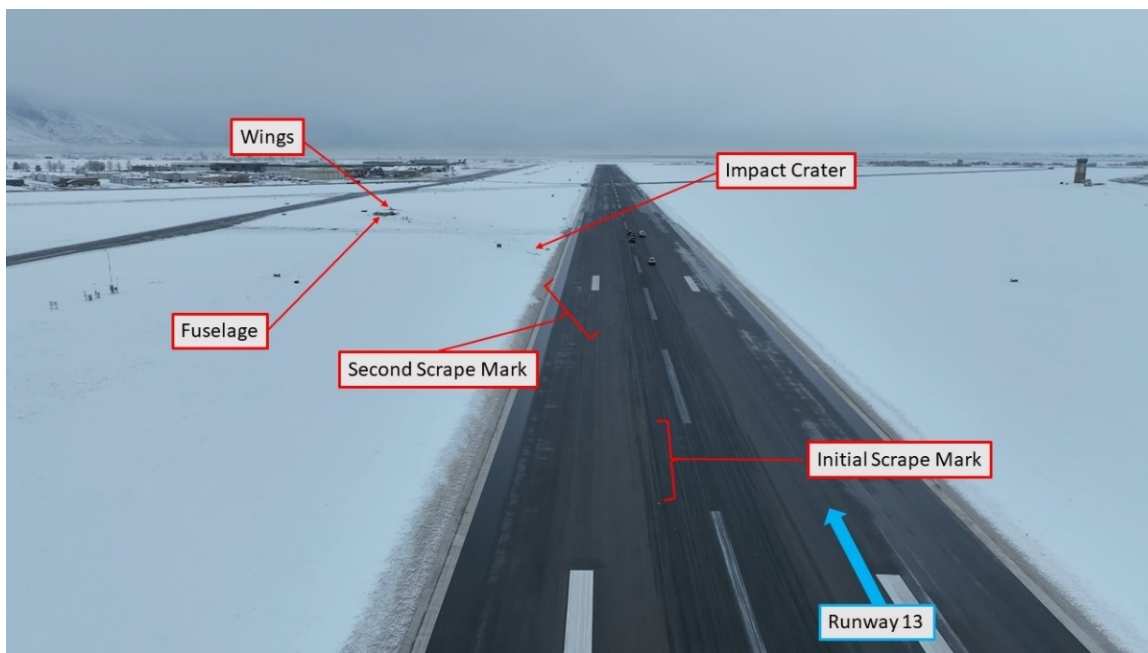
Investigators arrived onsite about 23 hours after the accident, and about 4 to 6 inches of fresh snow had fallen, masking impact marks, ground scars, and debris. Examination of the accident site revealed that the airplane impacted the runway surface about 2,626 ft from the approach end of runway 13 and about 20 ft left of the runway centerline. The scrape mark extended about 91 ft and was parallel to the runway centerline.

A second scrape mark was observed about 2,903 ft from the approach end of runway 13, and arced left to the left edge of the runway surface about 3,126 ft from the approach end of the runway. A swath of displaced snow and dirt extended from the runway's left edge about 100 ft to a large impact crater. The crater contained portions of airframe debris and various airframe components. Wreckage debris extended from the crater about 597 ft to the fuselage. The wings were separated from the airframe and were located about 106 ft beyond the fuselage. Both engines were separated and located adjacent to the fuselage.

Figure 1: Aerial overview of the accident site. Image courtesy of Provo Police Department with NTSB annotations.
