# Aviation Investigation Preliminary Report

<b>Location:</b>	Provo, UT	<b>Accident Number:</b>	WPR23FA080
<b>Date &amp; Time:</b>	January 2, 2023, Local	<b>Registration:</b>	N555NR
<b>Aircraft:</b>	EMBRAER EXECUTIVE AIRCRAFT INC EMB-505	<b>Injuries:</b>	1 Fatal, 2 Serious, 1 Minor
<b>Flight Conducted Under:</b>	Part 91: General aviation - Personal

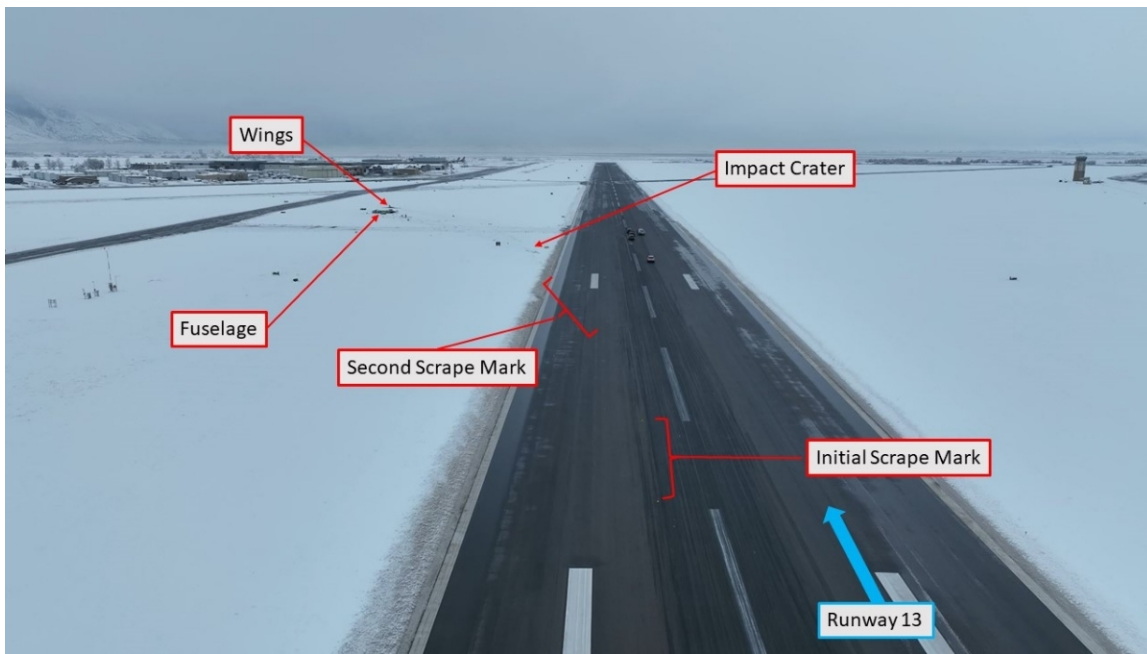
Investigators arrived onsite about 23 hours after the accident, and about 4 to 6 inches of fresh snow had fallen, masking impact marks, ground scars, and debris. Examination of the accident site revealed that the airplane impacted the runway surface about 2,626 ft from the approach end of runway 13 and about 20 ft left of the runway centerline. The scrape mark extended about 91 ft and was parallel to the runway centerline.

A second scrape mark was observed about 2,903 ft from the approach end of runway 13, and arced left to the left edge of the runway surface about 3,126 ft from the approach end of the runway. A swath of displaced snow and dirt extended from the runway's left edge about 100 ft to a large impact crater. The crater contained portions of airframe debris and various airframe components. Wreckage debris extended from the crater about 597 ft to the fuselage. The wings were separated from the airframe and were located about 106 ft beyond the fuselage. Both engines were separated and located adjacent to the fuselage.

Figure 1: Aerial overview of the accident site. Image courtesy of Provo Police Department with NTSB annotations.
