Aviation Investigation Final Report

Location:	Auburn, Nebraska	Accident Number:	CEN23FA077
Date & Time:	January 11, 2023, 19:24 Local	Registration:	N22859
Aircraft:	Cessna 150H	Aircraft Damage:	Substantial
Defining Event:	Loss of control in flight	Injuries:	2 Fatal
Flight Conducted Under:	Part 91: General aviation - Instructional

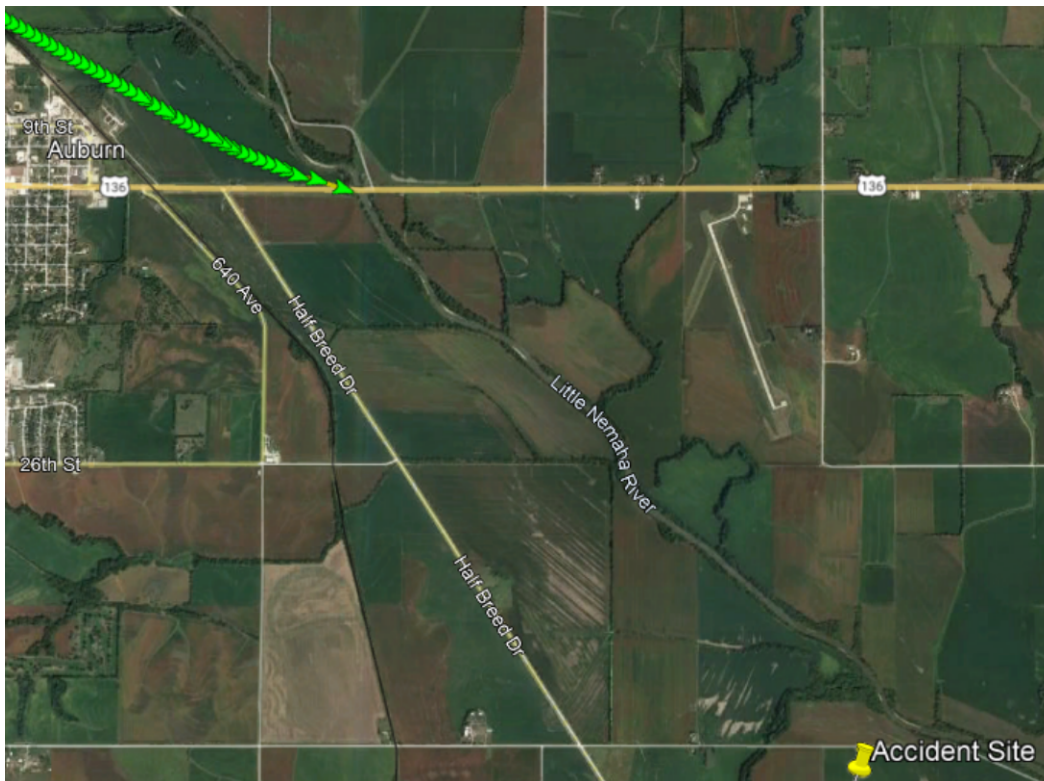
According to automatic dependent surveillance-broadcast (ADS-B) information, the airplane departed Lincoln Airport (LNK), Lincoln, Nebraska, about 1845 and climbed to 3,500 ft mean sea level (msl). About 6 miles northwest of K01, the airplane began a descent and the last ADS-B information captured at 19:22:26 showed the airplane about 1.1 miles west of K01 at 105 knots groundspeed and about 1,900 ft msl (see Figure 1).

Figure 1. Airplane's Flight Track, K01 Airport, and Accident Site

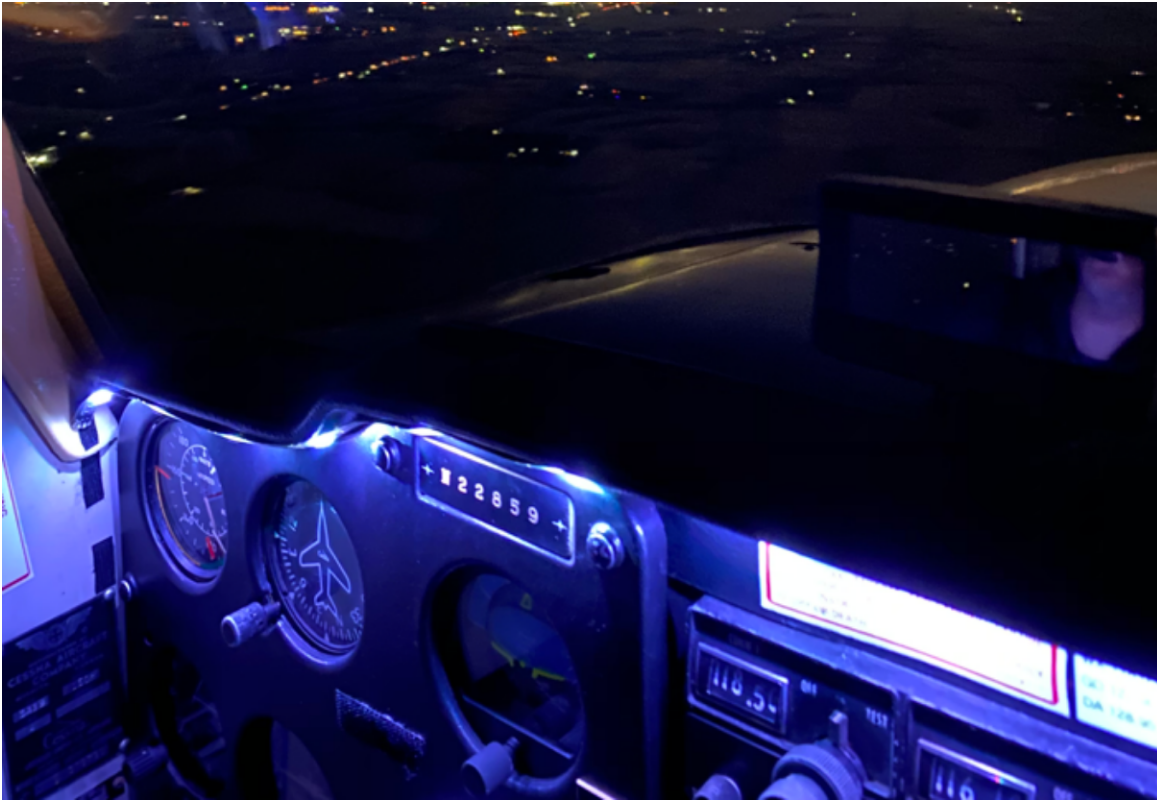
The cockpit was equipped with flood 'strip' lights, which the flight instructor had previously reported could make viewing the in-set instruments in the cockpit more difficult at night (see Figure 2).

Figure 2. Accident Airplane Cockpit Illuminated by Flood Lights
