Aviation Investigation Final Report

Location:	Dawsonville, Georgia	Accident Number:	ERA23FA109
Date & Time:	January 12, 2023, 20:17 Local	Registration:	N4254T
Aircraft:	Piper PA-28-180	Aircraft Damage:	Destroyed
Defining Event:	VFR encounter with IMC	Injuries:	1 Fatal
Flight Conducted Under:	Part 91: General aviation - Personal

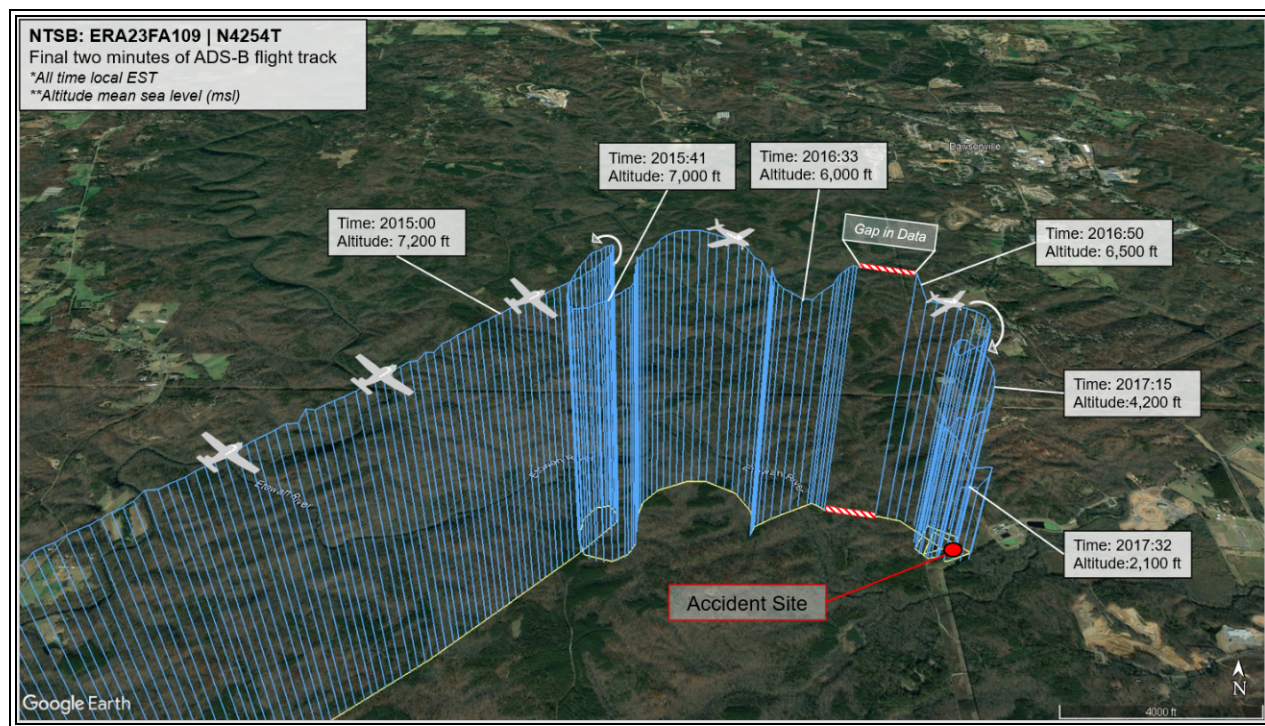
Review of automatic dependent surveillance - broadcast (ADS-B) data found that about ten minutes into the flight the flight track began turning left and right and climbing and descending. In the final two minutes of the flight, the airplane entered a series of tight turns and then a rapidly descending spiral turn. The wreckage was located near the final reported ADS-B position.

According to Federal Aviation Administration (FAA) ADS-B flight track data, at 2005 the airplane departed runway 23 at CNI. The airplane flew on varying headings towards the east-northeast and continued to climb for about 10 minutes, reaching a peak altitude of about 7,200 ft mean sea level (msl). In the final two minutes of the flight, the airplane began to descend followed by a series of tight turns before the airplane entered a rapidly descending spiral turn. The airplane’s final position was recorded at 2017:32, about 0.15-mile south of the accident site at an altitude of about 2,000 ft msl. Figure 1 shows the final 2 minutes of the ADS-B flight track and the location of the accident site.

Figure 1 - Overview of the final minutes of the ADS-B flight track.

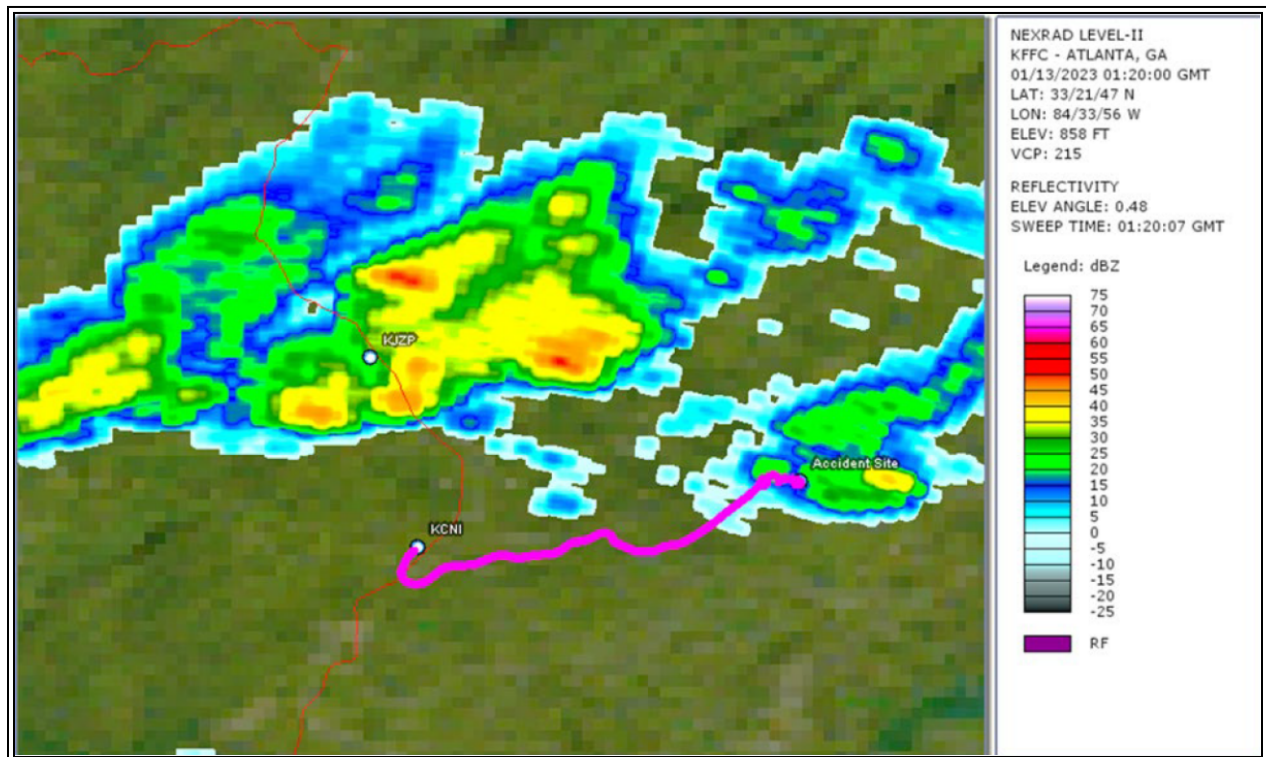
According to a review of weather radar and the base reflectivity imagery, during the final portion of the flight the airplane entered areas of light intensity echoes. Figures 2 and 3 provide an overview of the echoes near the time of the accident with the airplane's ADS-B flight track overlaid into the images.

Figure 2 - Base reflectivity image for 2020 with flight track overlaid in magenta.

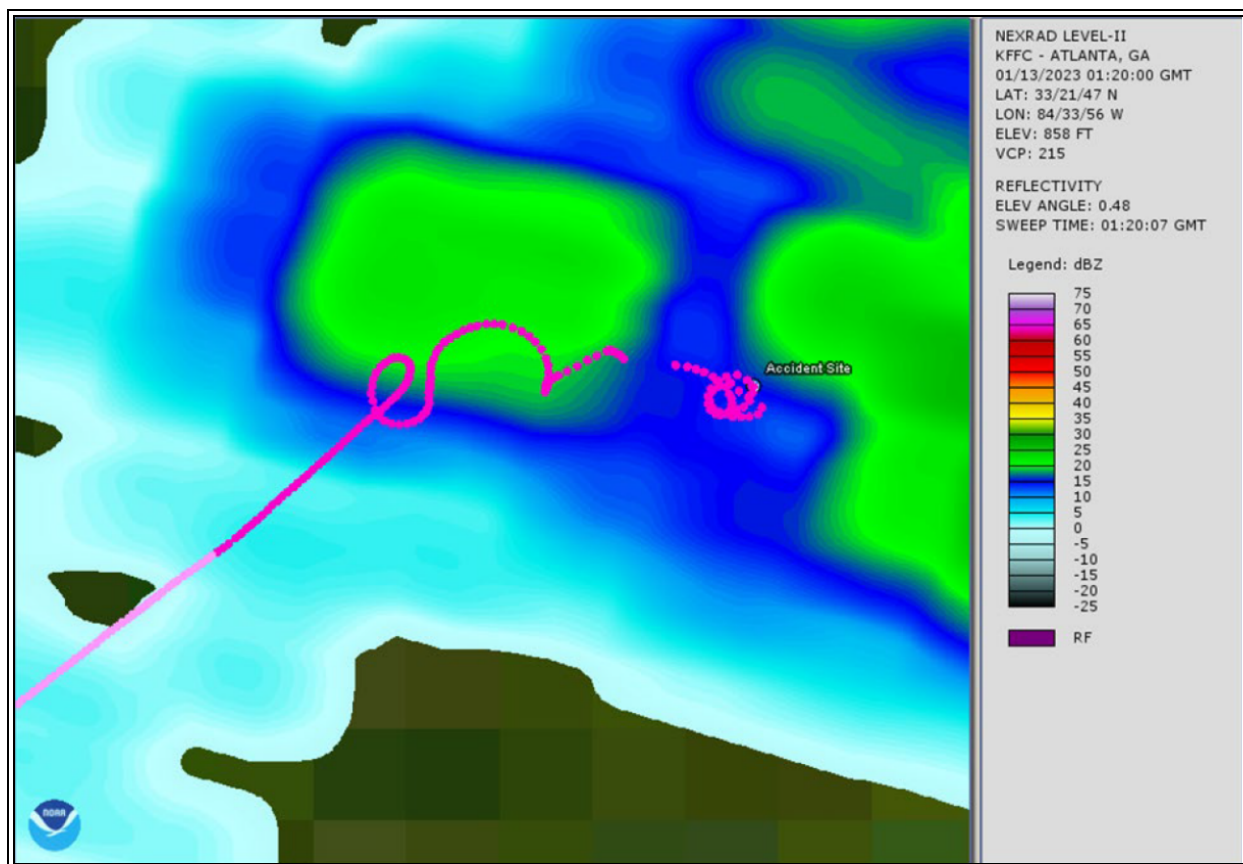
Figure 3 - Closer view of the base reflectivity image for 2020 with the flight track overlaid.
