Aviation Investigation Final Report

Location:	Kingfisher, Oklahoma	Accident Number:	CEN23FA079
Date & Time:	January 16, 2023, 12:42 Local	Registration:	N8266D
Aircraft:	Piper PA-32-301T	Aircraft Damage:	Destroyed
Defining Event:	Fire/smoke (non-impact)	Injuries:	2 Fatal
Flight Conducted Under:	Part 91: General aviation - Instructional

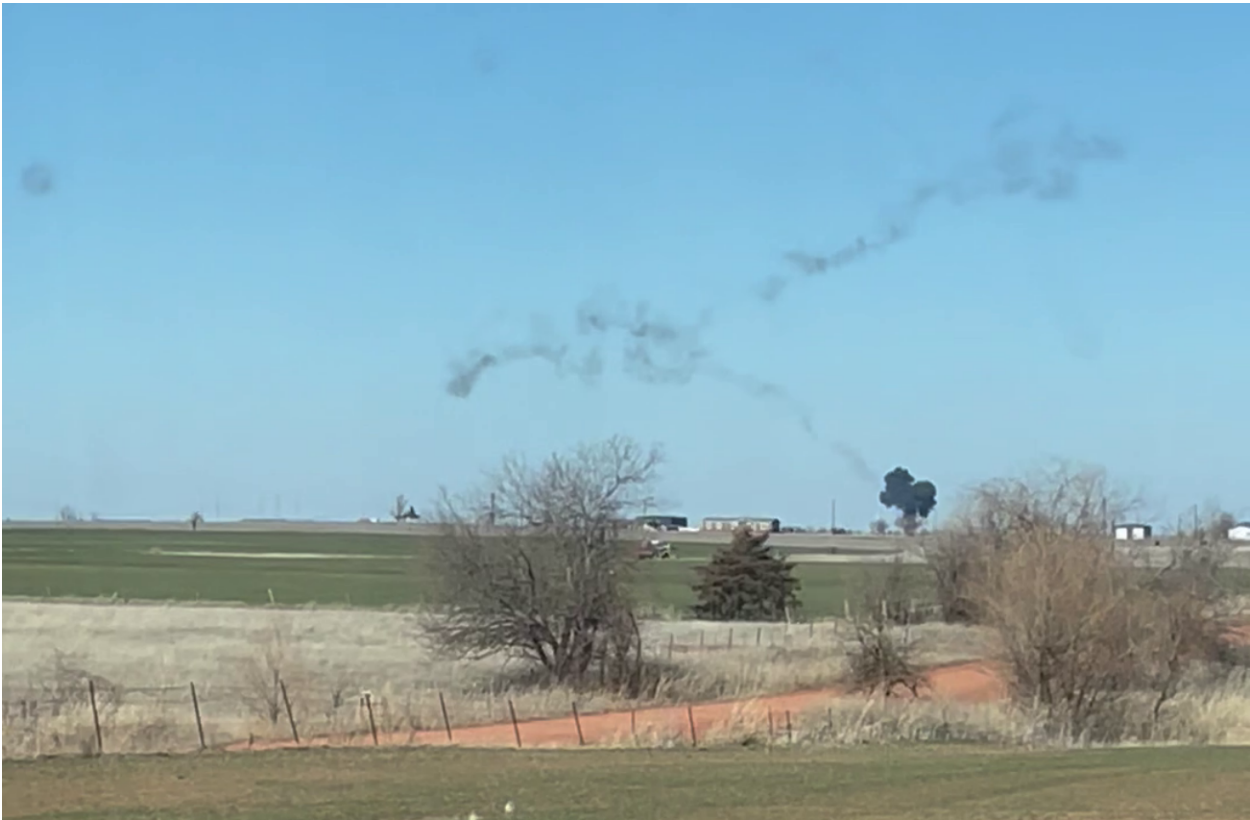
According to witnesses, the airplane was seen trailing black smoke before it rolled over and dove into the ground. A witness-provided cell phone video confirmed the presence of the black smoke and an explosion after impact (Figure 1).

Figure 1. Still frame image from witness-provided cell phone video.

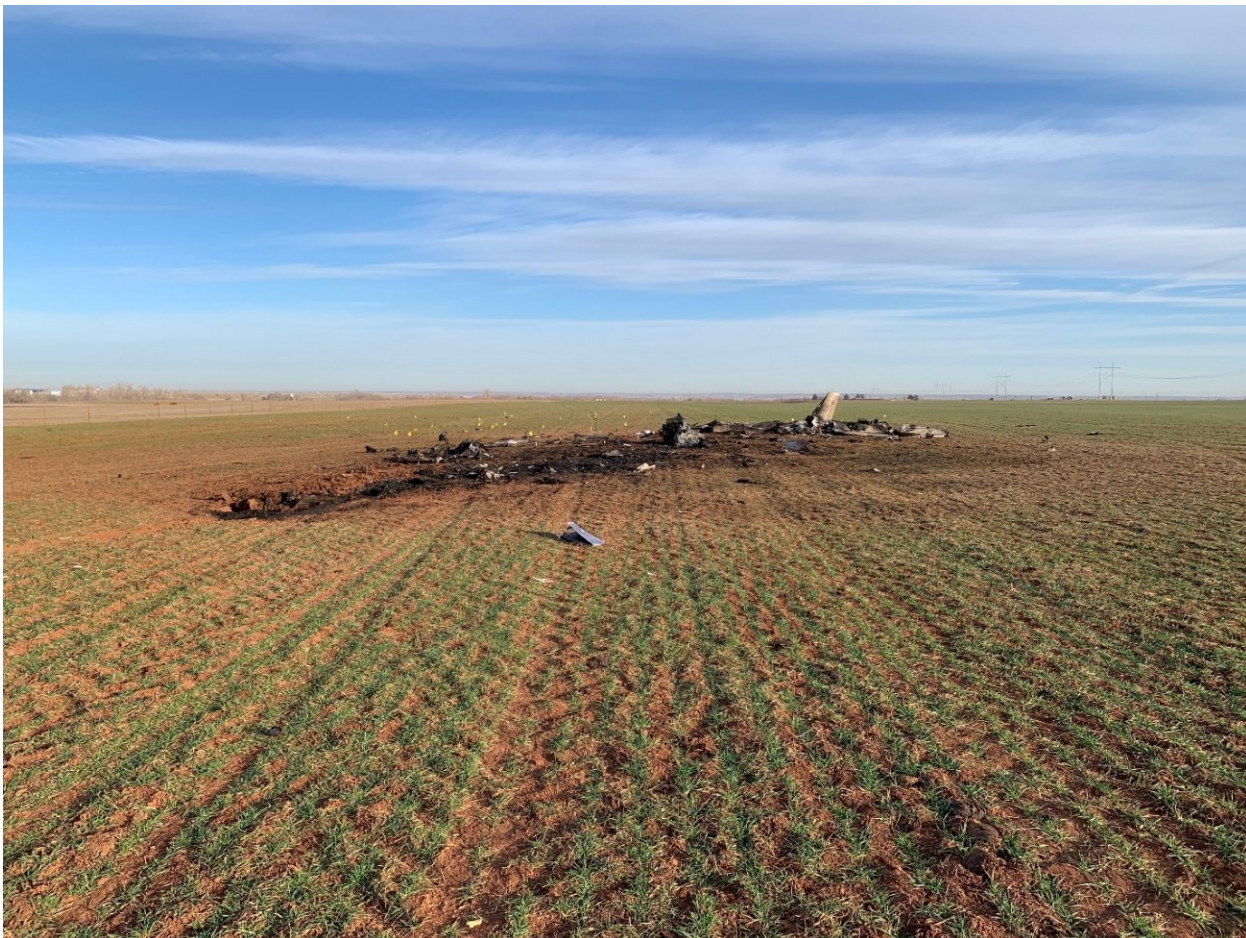
The airplane impacted a firm, level field with little vegetation. The initial impact location was a crater that contained the airplane's propeller. The rotation axis of the propeller was near vertical, consistent with the airplane impacting the ground in a near-vertical attitude. All components of the airplane were in the immediate vicinity of the accident site (Figure 2).

Figure 2. Overall view of the accident scene (NTSB Photo).

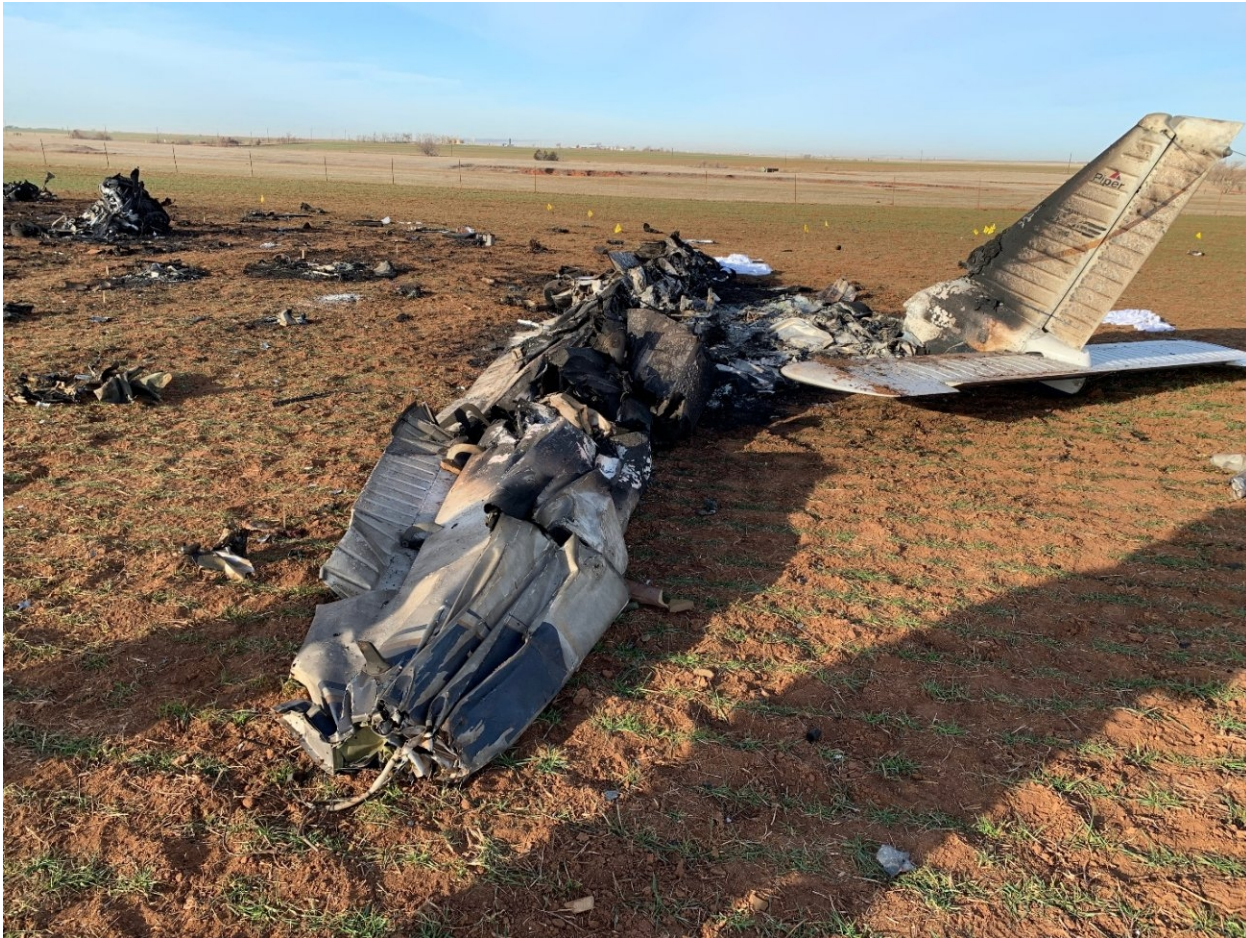
The main portion of the fuselage, wings, and tail surfaces came to rest about 100 ft north of the initial impact point. The wings were damaged from impact but continuous from tip to tip except for the center spar section, which was melted and consumed by fire. The ailerons and

flaps remained attached to the wing. The wing's leading edge was crushed aft, and all four fuel tanks were ruptured. The fuselage forward of the tail surfaces was almost completely consumed by fire. The aft fuselage from the leading edge of the vertical stabilizer and aft was intact with the tail surfaces still attached. The vertical tail surfaces were intact and the horizontal tail surfaces were intact but with impact damage to the right tip. Control continuity was confirmed from all surfaces to the cockpit with all breaks in the control system consistent with impact damage.

Figure 3. Main wreckage at the accident site (NTSB Photo).

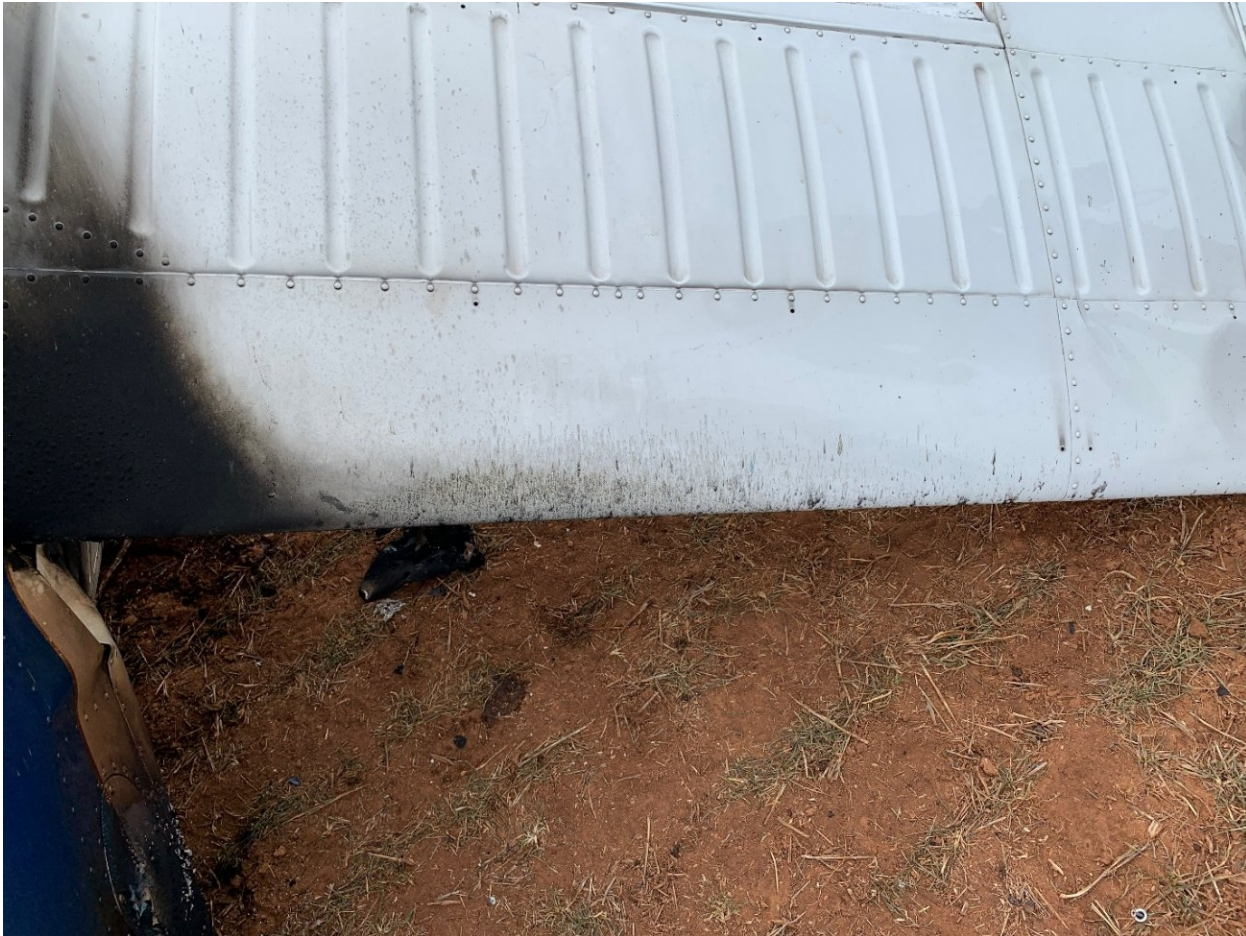
Oil streaking opposite the direction of flight on the airplane's horizontal stabilator was consistent with a significant oil leak. No other anomalies with respect to the airplane were discovered; however, the amount of impact and fire damage to the airplane impeded comprehensive examination. The witness video, oil streaking, and engine monitor data were all consistent with an engine compartment fire due to an oil leak. The extent of the impact and fire damage precluded determination of the exact source of the oil leak.

An oil leak of undetermined origin that resulted in an in-flight engine compartment fire and subsequent loss of airplane control.

The horizontal tail surfaces had oil streaking from the leading edge toward the trailing edge in the longitudinal direction, consistent with an in-flight oil leak (Figure 4).

Figure 4. Oil streaking on the underside of the left horizontal stabilator.
