Aviation Investigation Preliminary Report

Location:	Kingfisher, OK	Accident Number:	CEN23FA079
Date & Time:	January 16, 2023, Local	Registration:	N8266D
Aircraft:	Piper PA-32-301T	Injuries:	2 Fatal
Flight Conducted Under:	Part 91: General aviation - Instructional

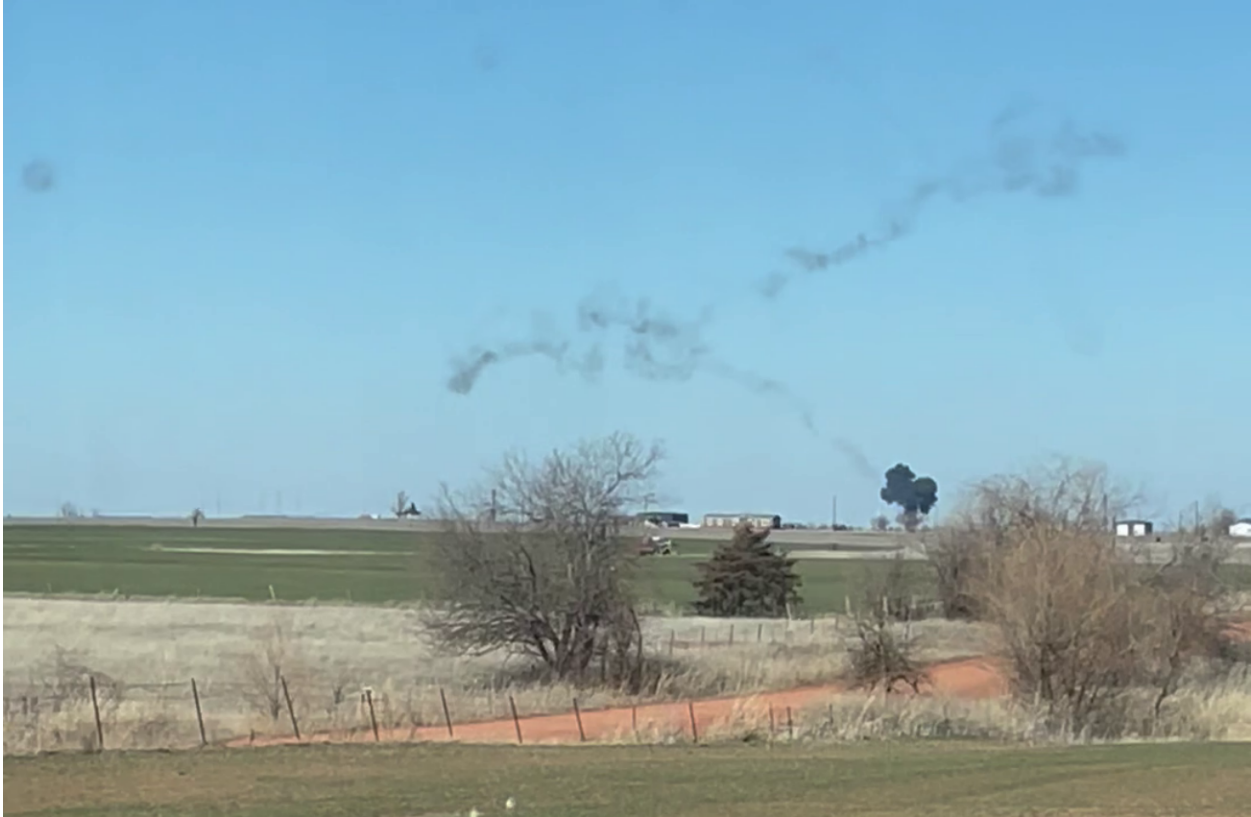
According to witnesses, the airplane was seen trailing black smoke before it rolled over and dove into the ground. A witness provided cell phone video confirmed the presence of the black smoke and an explosion after impact (Figure 1).

Figure 1. Still frame image from witness provided cell phone video.

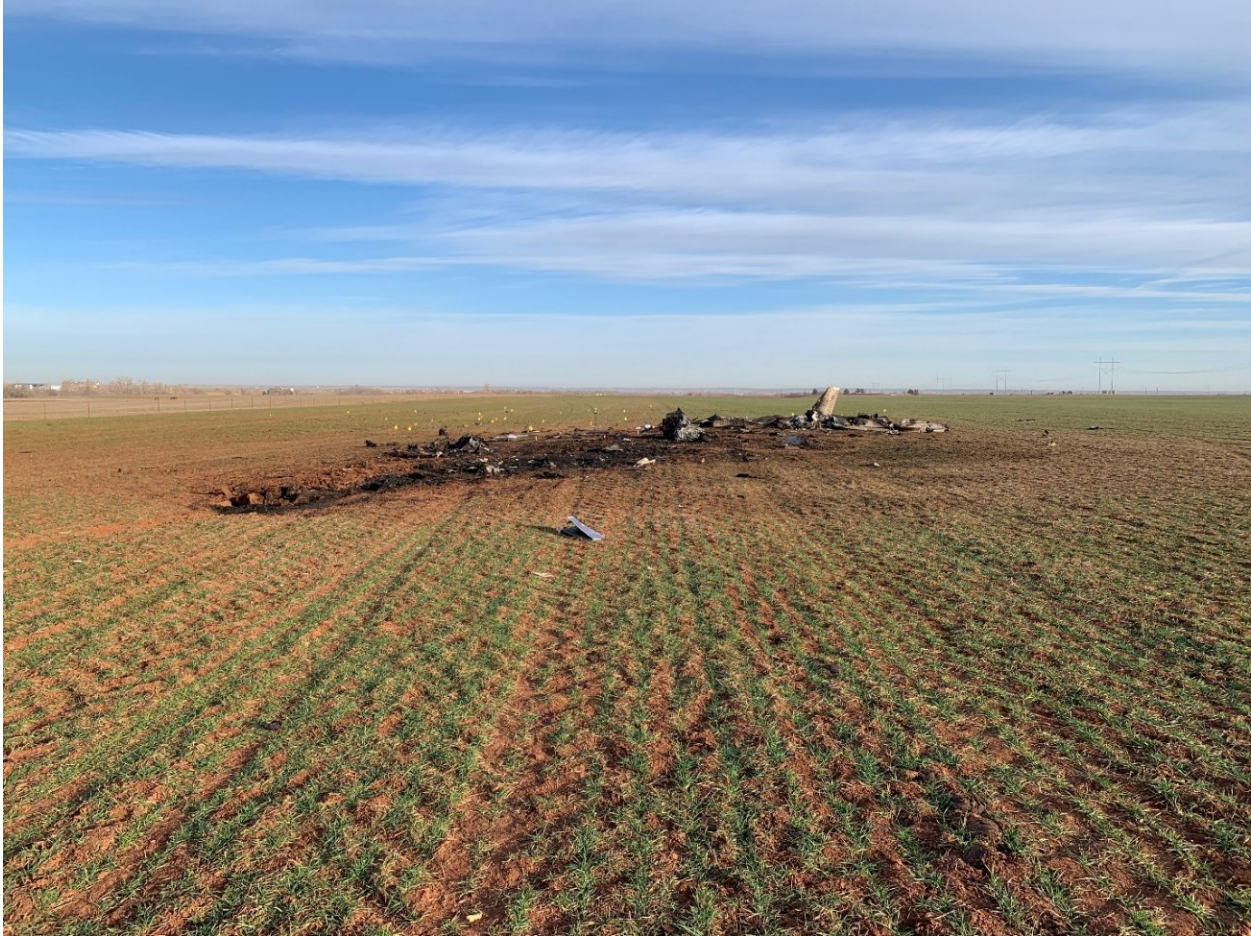
The airplane impacted a firm level field with little vegetation. The initial impact location was a crater that contained the airplane's propeller. The rotation axis of the propeller was near vertical, indicating that the airplane impacted the ground in a near vertical attitude. All components of the airplane were in the immediate vicinity of the accident site. (Figure 2)

Figure 2. Overall view of the accident scene (NTSB Photo).

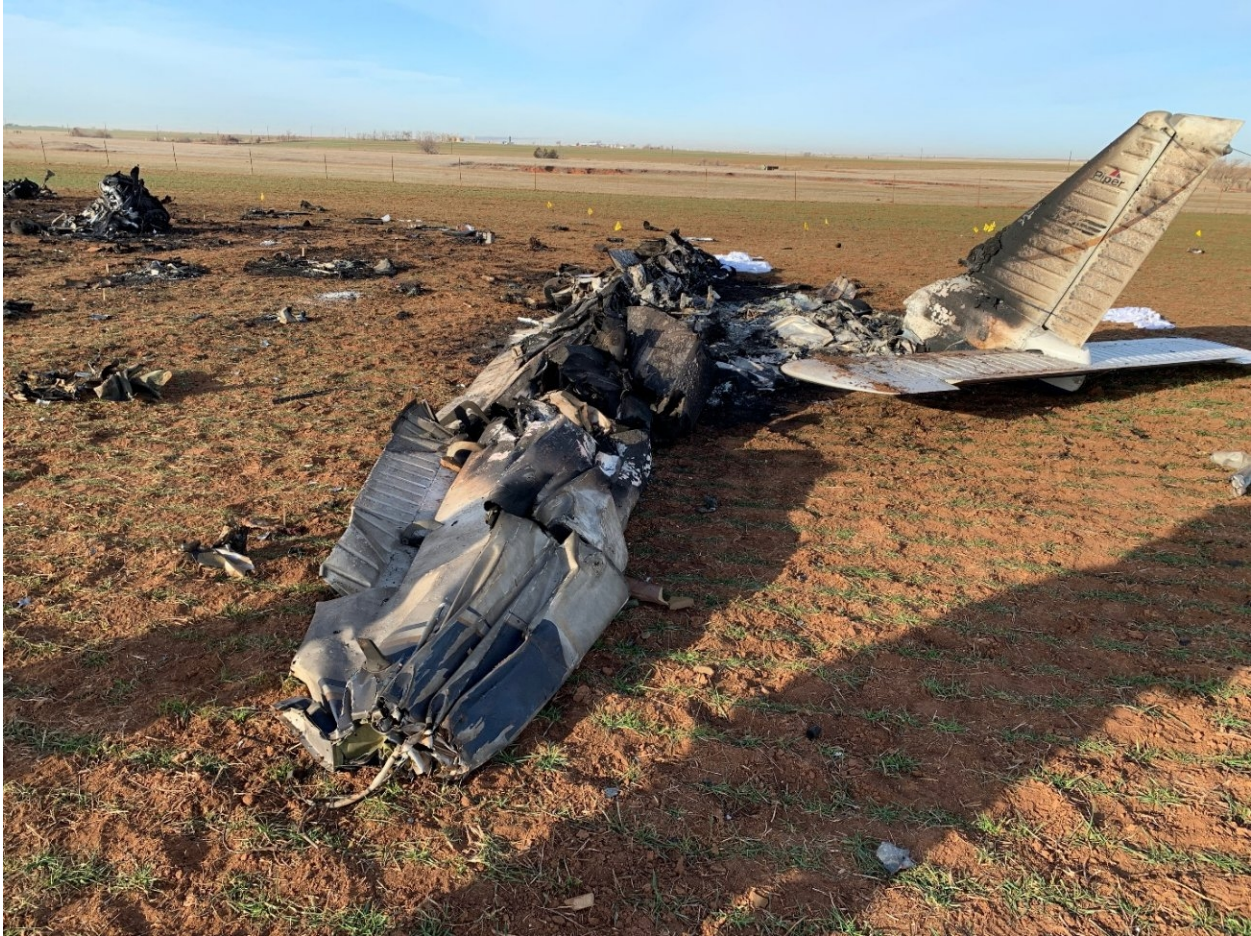
The main portion of the fuselage, wings, and tail surfaces came to rest about 100 ft. north of the initial impact point. The wings were damaged from impact but continuous from tip to tip except for the center spar section which was melted and consumed by fire. The ailerons and flaps remained attached to the wing. The wing leading edge was crushed aft and all four fuel tanks were ruptured. The fuselage forward of the tail surfaces was almost completely consumed by fire. The aft fuselage from the leading edge of the vertical stabilizer and aft was intact with the tail surfaces still attached. The vertical tail surfaces were intact and the horizontal tail surfaces were intact but with impact damage to the right tip. Control continuity was confirmed from all surfaces to the cockpit with all breaks in the control system consistent with impact damage.

Figure 3. Main wreckage at the accident site (NTSB Photo).
