Aviation Investigation Final Report

Location:	Shreveport, Louisiana	Accident Number:	CEN23LA087
Date & Time:	January 20, 2023, 16:34 Local	Registration:	N71SN
Aircraft:	WORLD AIRCRAFT CO WA-3	Aircraft Damage:	Substantial
Defining Event:	Fuel related	Injuries:	1 None
Flight Conducted Under:	Part 91: General aviation - Personal

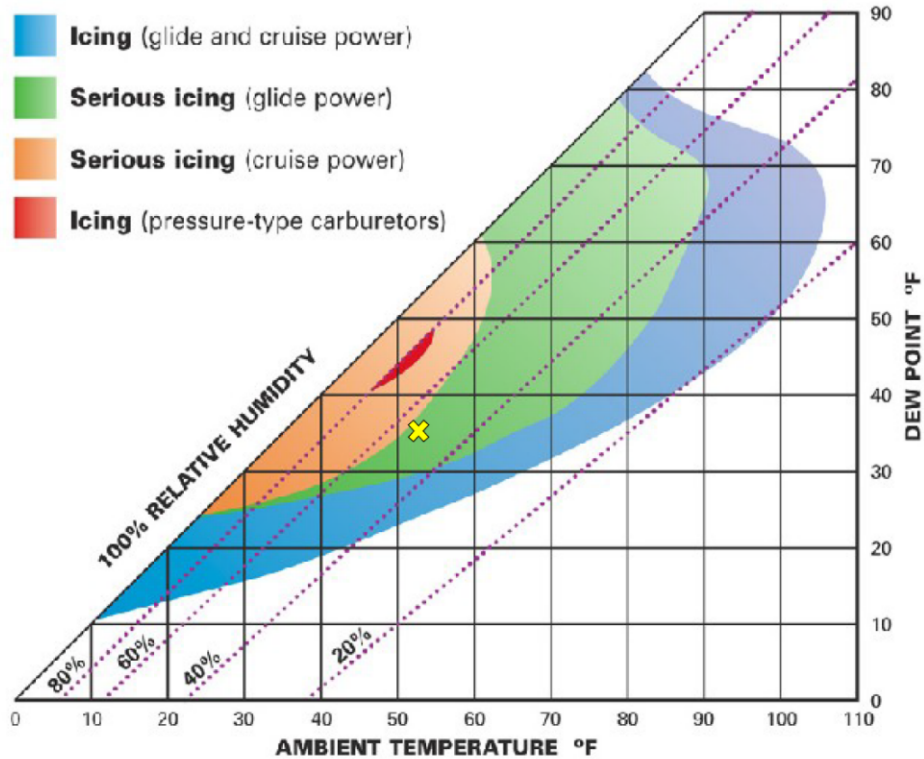
Figure 1. Carburetor Icing Probability Chart

A review of the Carburetor Icing Probability Chart located in the FAA's Special Airworthiness Information Bulletin CE-09-35, *Carburetor Icing Prevention*, dated June 30, 2009, found that the airplane was operating in an area conducive to the formation of serious icing at glide power settings and close to the area of serious icing at cruise power. The airplane was fueled with 93-octane automotive fuel which, as noted below, could make carburetor icing more likely. Additionally, the airplane was not equipped with a carburetor temperature gauge or a carburetor heat control, nor was it required to be by the FAA.

According to Transport Canada TP 10737 (Use of Automotive Gasoline [Mogas] in Aviation), Mogas is generally higher in volatility than Avgas and will thus absorb more heat from the mixing air when vaporizing, resulting in ice accumulation at higher ambient temperatures. It goes on to say that “the likelihood of carb icing while flying on Mogas is higher,” and advises that, “[a]lthough the severity of the carb icing and the methods to deal with it are similar for both Avgas and Mogas, its ONSET is likely to occur at HIGHER AMBIENT TEMPERATURES and at LOWER HUMIDITY with Mogas. In other words, conditions under which a pilot may feel there is only a slight risk for carb icing on Avgas may in fact be ideal for the formation of ice while using more volatile Mogas. This will result in the need to select ‘carb heat on’ in less severe icing conditions and for a longer duration while using Mogas.”
