Aviation Investigation Final Report

Location:	Honolulu, Hawaii	Incident Number:	DCA23LA133
Date & Time:	January 23, 2023, 16:10 Local	Registration:	N774UA (A1); N145KA (A2)
Aircraft:	Boeing 777-222 (A1); Cessna 208B (A2)	Aircraft Damage:	None (A1); None (A2)
Defining Event:	Runway incursion veh/AC/person	Injuries:	301 None (A1); 2 None (A2)
Flight Conducted Under:	Part 121: Air carrier - Scheduled (A1); Part 135: Air taxi & commuter - Non-scheduled (A2)

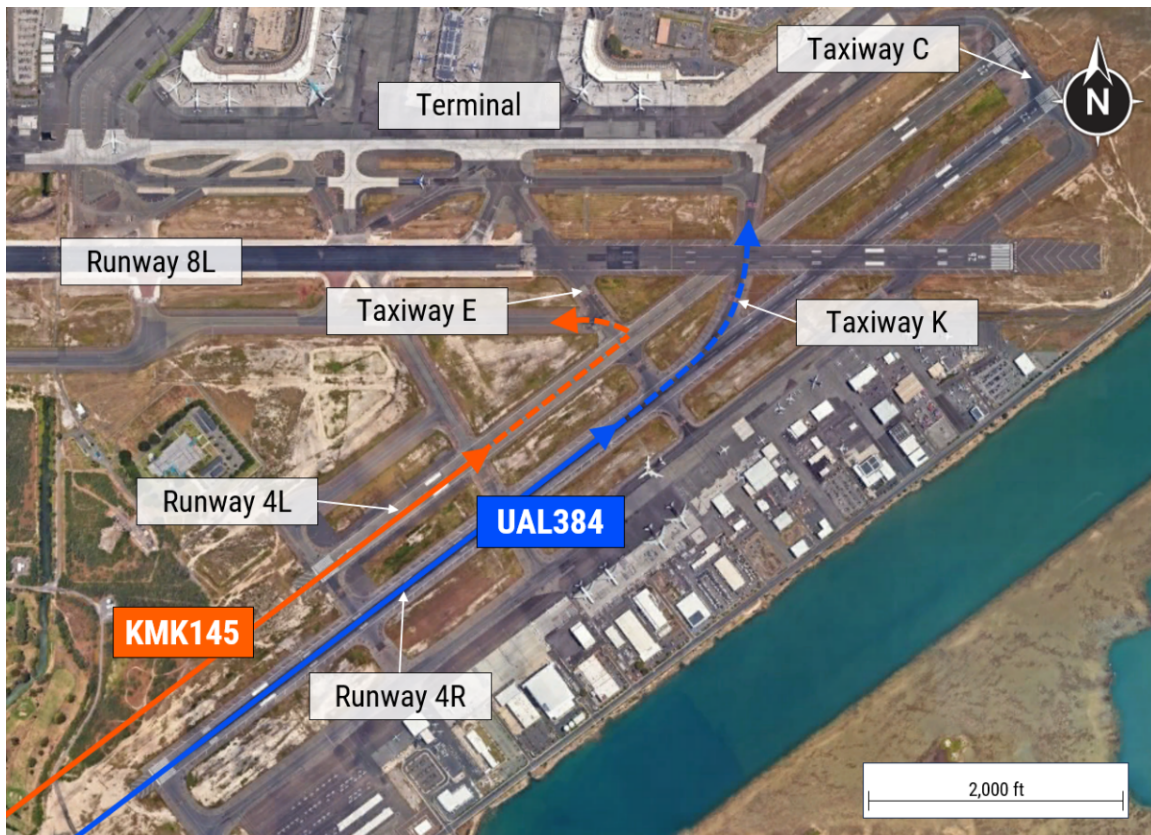
The first officer responded, “turn left on Kilo.” The controller then instructed the UAL flight crew to hold-short of runway 4L (which was parallel to runway 4R) on taxiway K, and the first officer acknowledged the hold-short instruction. However, by the time the captain realized the airplane had passed the hold-short line, they were already crossing runway 8L, which intersected runways 4R and 4L, see figure 1.

Figure 1. Overhead view showing HNL airport. The blue line shows UAL384’s ground track and the orange line shows KMK145’s ground track.

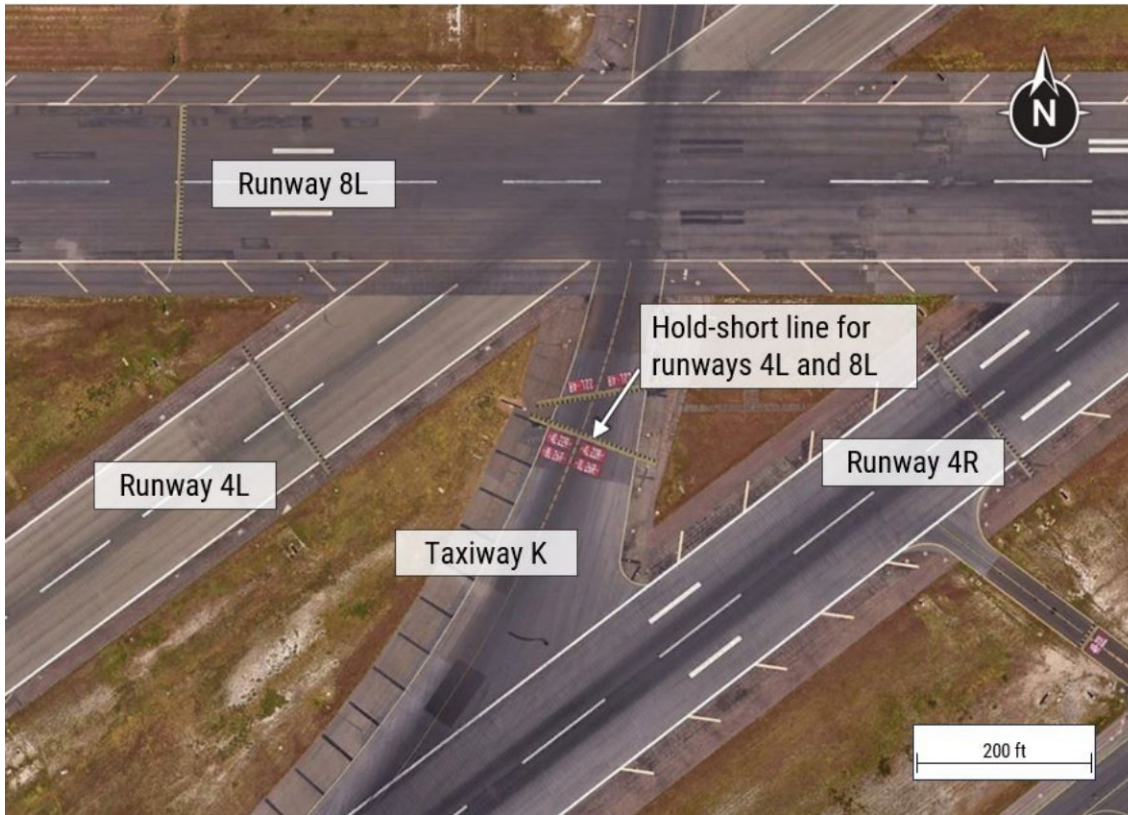
The captain also stated they were busy setting up for the new approach and he failed to open the hot spot (HS2) note and read that “aircraft landing on runway 4R and exiting left onto taxiway K sometimes fail to hold short of runway 4L/22R and runway 8L/26R”. He also indicated that the first officer mentioned this HS2 note during the approach briefing but it didn’t register with him. He stated that his expectation bias was that they would probably be too fast to exit at taxiway K and that they would most likely roll to the end and exit at taxiway C.

Figure 2. HS2 hot spot area involving taxiway K and surrounding runways. The arrow points to the hold-short line for runways 4L and 8L.

a “Runway Incursion Hot Spots” section of the chart. The hot spot labeled HS2 was located at the convergence of runways 4L/22R, 4R/22L, and 8L/22R and taxiway K, as shown in figure 2. (As previously mentioned, the text description of HS2 stated, “Aircraft landing Rwy 4R and exiting left onto Twy K sometimes fail to hold short of Rwys 4L/22R and 8L/26R.) The airport diagram had a ball note that stated the following: “Wide body and four engine turbojets landing rwy 4R roll to the end of rwy, no left turn at twy K without tower approval.”

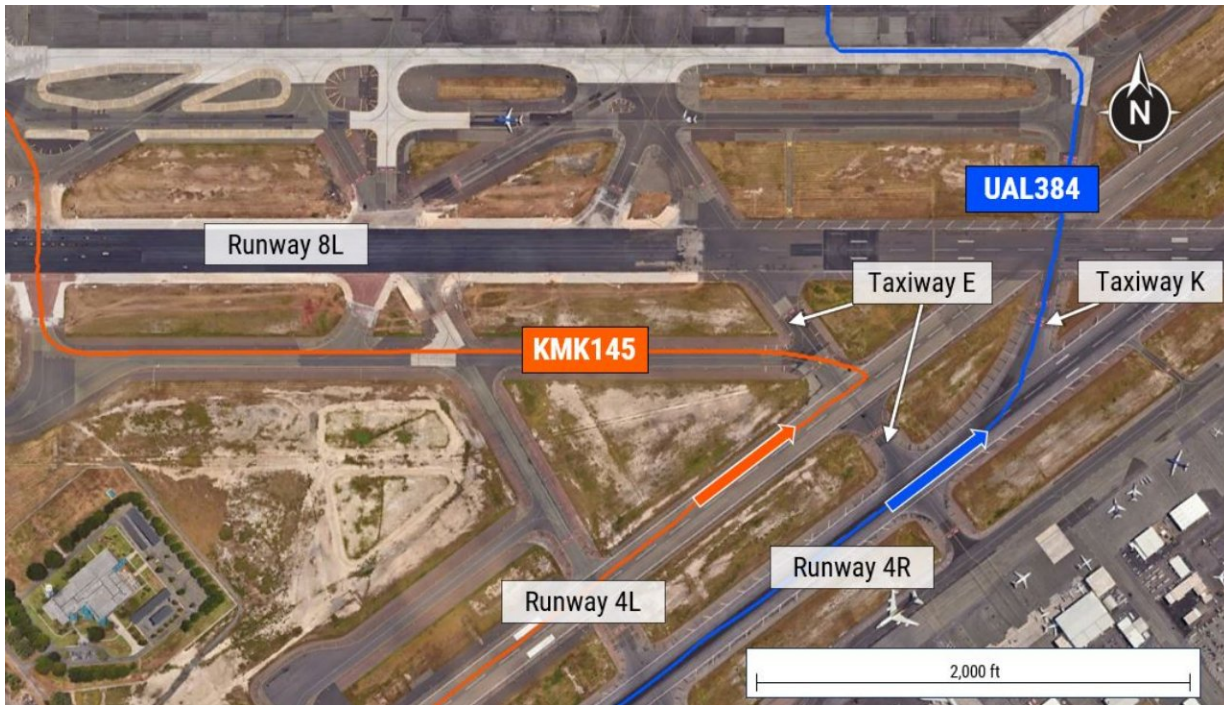
Between 1615:23 and 1616:20, the ground controller and the KMK145 pilot communicated regarding taxi instructions to the airplane's assigned gate. Figure 3 shows the ground tracks of UAL384 and KMK145 along with the runway and taxiway environment.

Figure 3. Ground tracks for UAL384 and KMK145 in relation to runways 4L, 4R, and 8L and taxiways E and K.

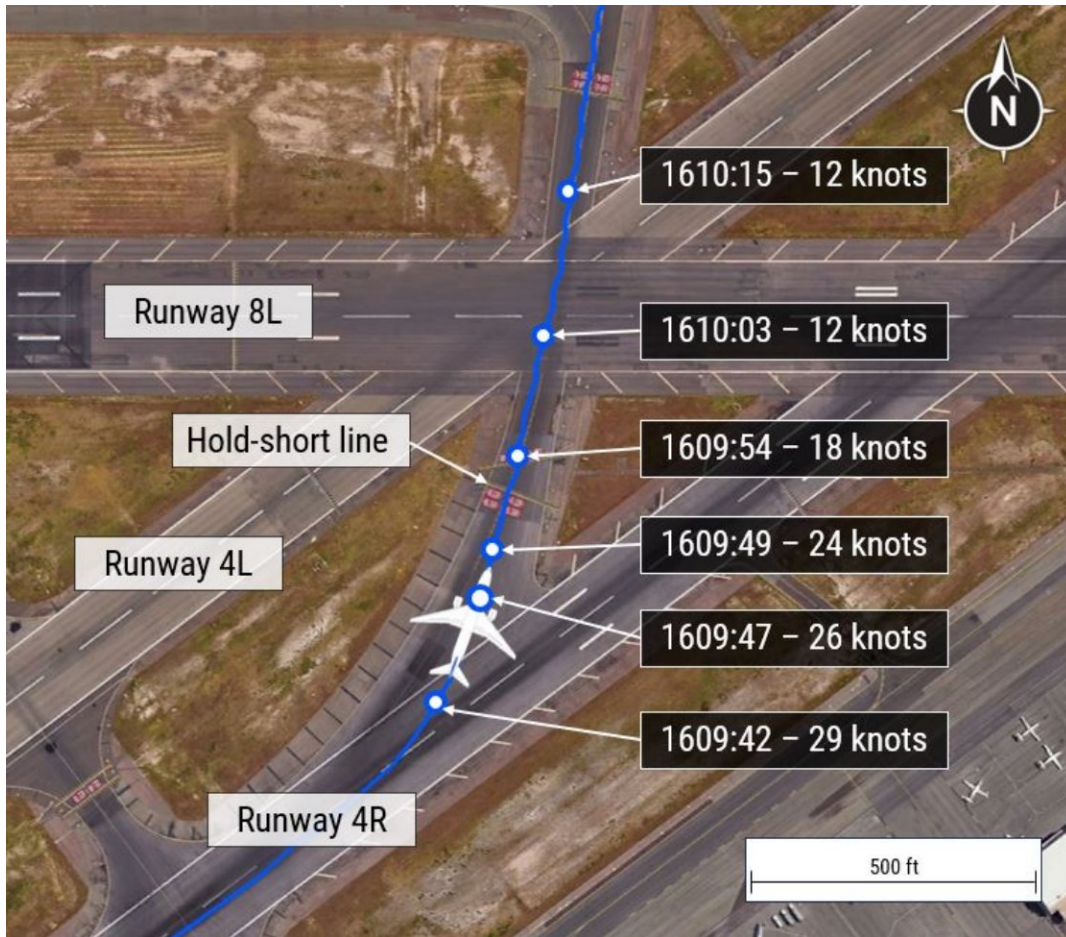
In his postincident statement, the captain of UAL384 reported that he “lost situational awareness” as the airplane exited runway 4R. He thought that “there was more distance between the runways [4R and 4L] than there actually was.” The captain was concerned about clearing runway 4R and the hold-short line at taxiway K. The captain added that “there doesn’t appear to be enough room” for a 210-ft-long Boeing 777 airplane to “be fully clear of” runway 4R and “still hold short of” runway 4L. Figure 4 shows the airplane’s position when it was 100 ft from the hold-short line (at 1609:47).

Figure 4. UAL384 airplane’s positions and groundspeeds after turning onto taxiway K.

By the time that the captain realized that the airplane was passing the hold-short line markings on taxiway K, the airplane had already crossed runway 4L and was on runway 8L. The captain stated that he was “startled by how quickly” the airplane reached runways 4L and 8L after exiting runway 4R.

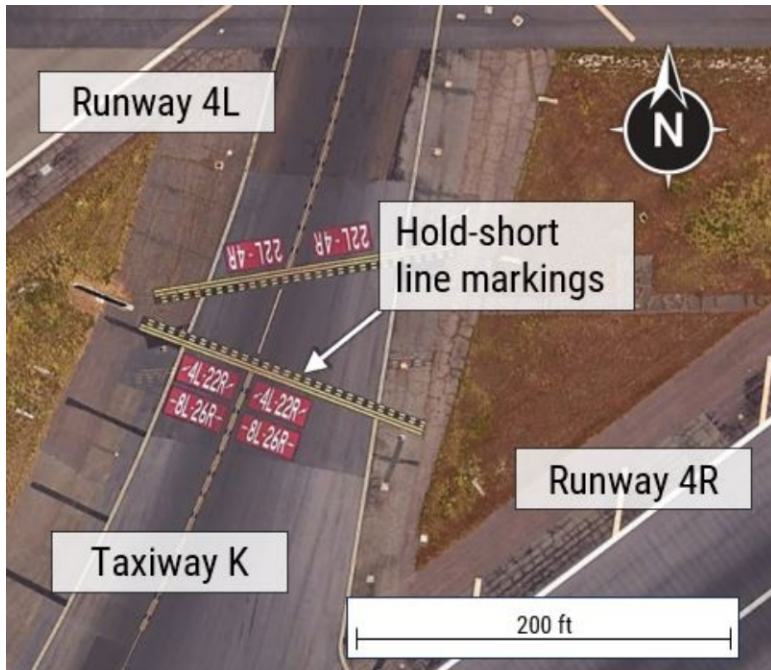
The hold-short line for runway 4L was located less than 200 ft from the edge of runway 4R at the widest point (the west side of the hold-short line to the runway 4R centerline), which would not have accommodated a Boeing 777 airplane clearing the active landing runway. According to the post incident interview with the local controller, controllers were aware that airplanes may still be on runway 4R when they must hold short of runways 4L and 8L on taxiway K and to account for this the controllers increase the spacing between approaching aircraft for runway 4R.

HNL had four paved landing surfaces; 4L/22R, 4R/22L, 8L/26R, and 8R/26L. Runway 4L/22R was 6,955 ft long and 150 ft wide. Runway 4L/22R and runway 4R/22L were closely spaced parallel runways that were separated by 500 ft (from centerline to centerline). Runway 4R/22L was 9,002 ft long and 150 ft wide. Runway 4L/22R and runway 4R/22L intersected runway 8L/26R at an angle. Hold-short markings appeared on runway 4R at taxiway K, as shown in figure 5.

Figure 5. Close-up view of hold-short line markings on runway 4R at taxiway K. The hold-short line for runway 4L was located less than 200 ft from the edge of runway 4R at the widest point (from the west side of the hold-short line to the runway 4R centerline.) Taxiway K was an angled (45°) taxiway to the left of runway 4R; it was not a high-speed taxiway.
