Aviation Investigation Final Report

Location:	Yuma, Arizona	Accident Number:	WPR23LA107
Date & Time:	February 6, 2023, 21:35 Local	Registration:	N36FA
Aircraft:	Bell OH-58A	Aircraft Damage:	Substantial
Defining Event:	Unknown or undetermined	Injuries:	1 Minor
Flight Conducted Under:	Part 137: Agricultural

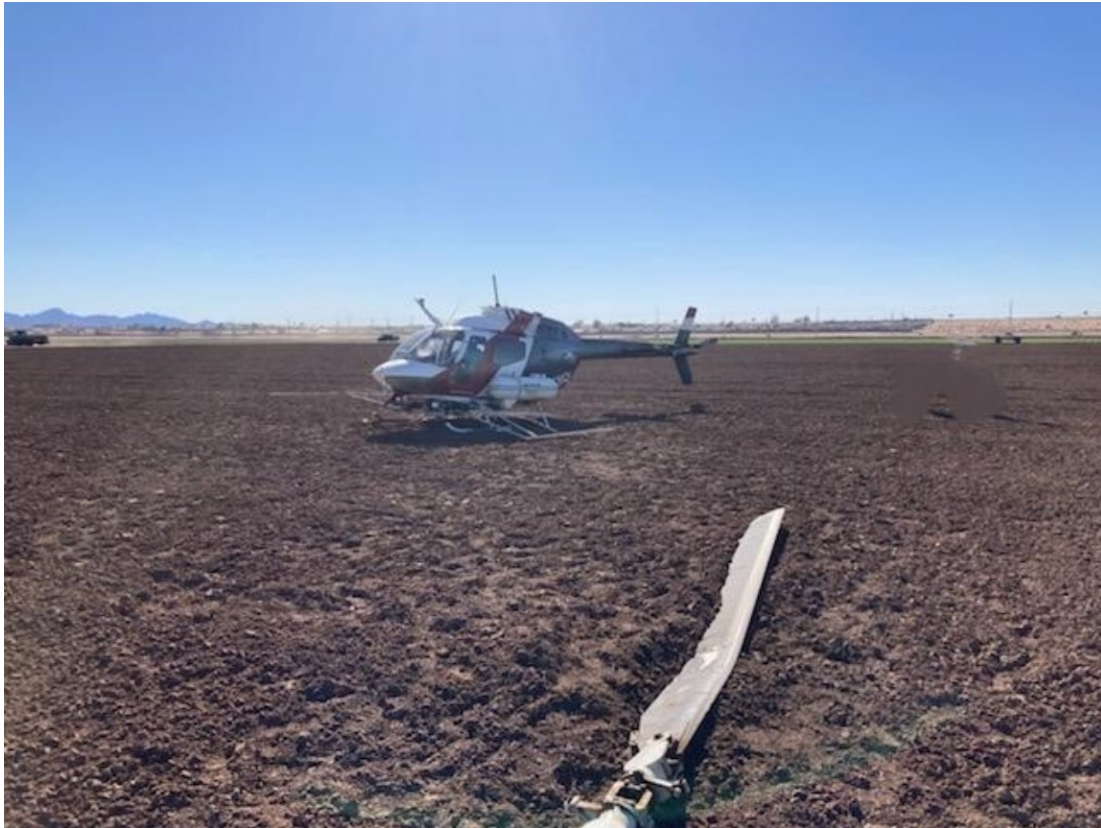
The pilot stated that he landed in night conditions on the load truck and the chemical hopper was filled with 50 gallons of water to rinse out the applicator system. The pilot departed from the load truck toward an open field about 200 yards away. While maneuvering about 40 ft above ground level, with a speed near effective translational lift, and about 80% transmission torque, the helicopter suddenly started to bounce and yaw. The pilot stated that, when the spray tank was almost empty, the helicopter began to “bounce and tilt in all directions,” then “fish-tailed” before the engine lost total power. The pilot arrested the helicopter’s forward movement by pulling back on the control stick and leveled the helicopter while lowering the collective. Unable to judge his height above the ground, the pilot alternately raised and lowered the collective to control the descent, and the helicopter landed hard in the dirt field, and a main rotor blade struck and severed the tail rotor driveshaft. The main rotor and blades assembly separated from the mast and landed about 100 ft from the upright helicopter, as shown in Figure 1.

Figure 1 - Main rotor yoke and blades (Photo courtesy of operator)
