Aviation Investigation Final Report

Location:	Rochester, New York	Accident Number:	ERA23LA126
Date & Time:	February 11, 2023, 12:50 Local	Registration:	N600C
Aircraft:	GATES LEARJET CORP 55	Aircraft Damage:	Substantial
Defining Event:	Hard landing	Injuries:	6 None
Flight Conducted Under:	Part 91: General aviation - Personal

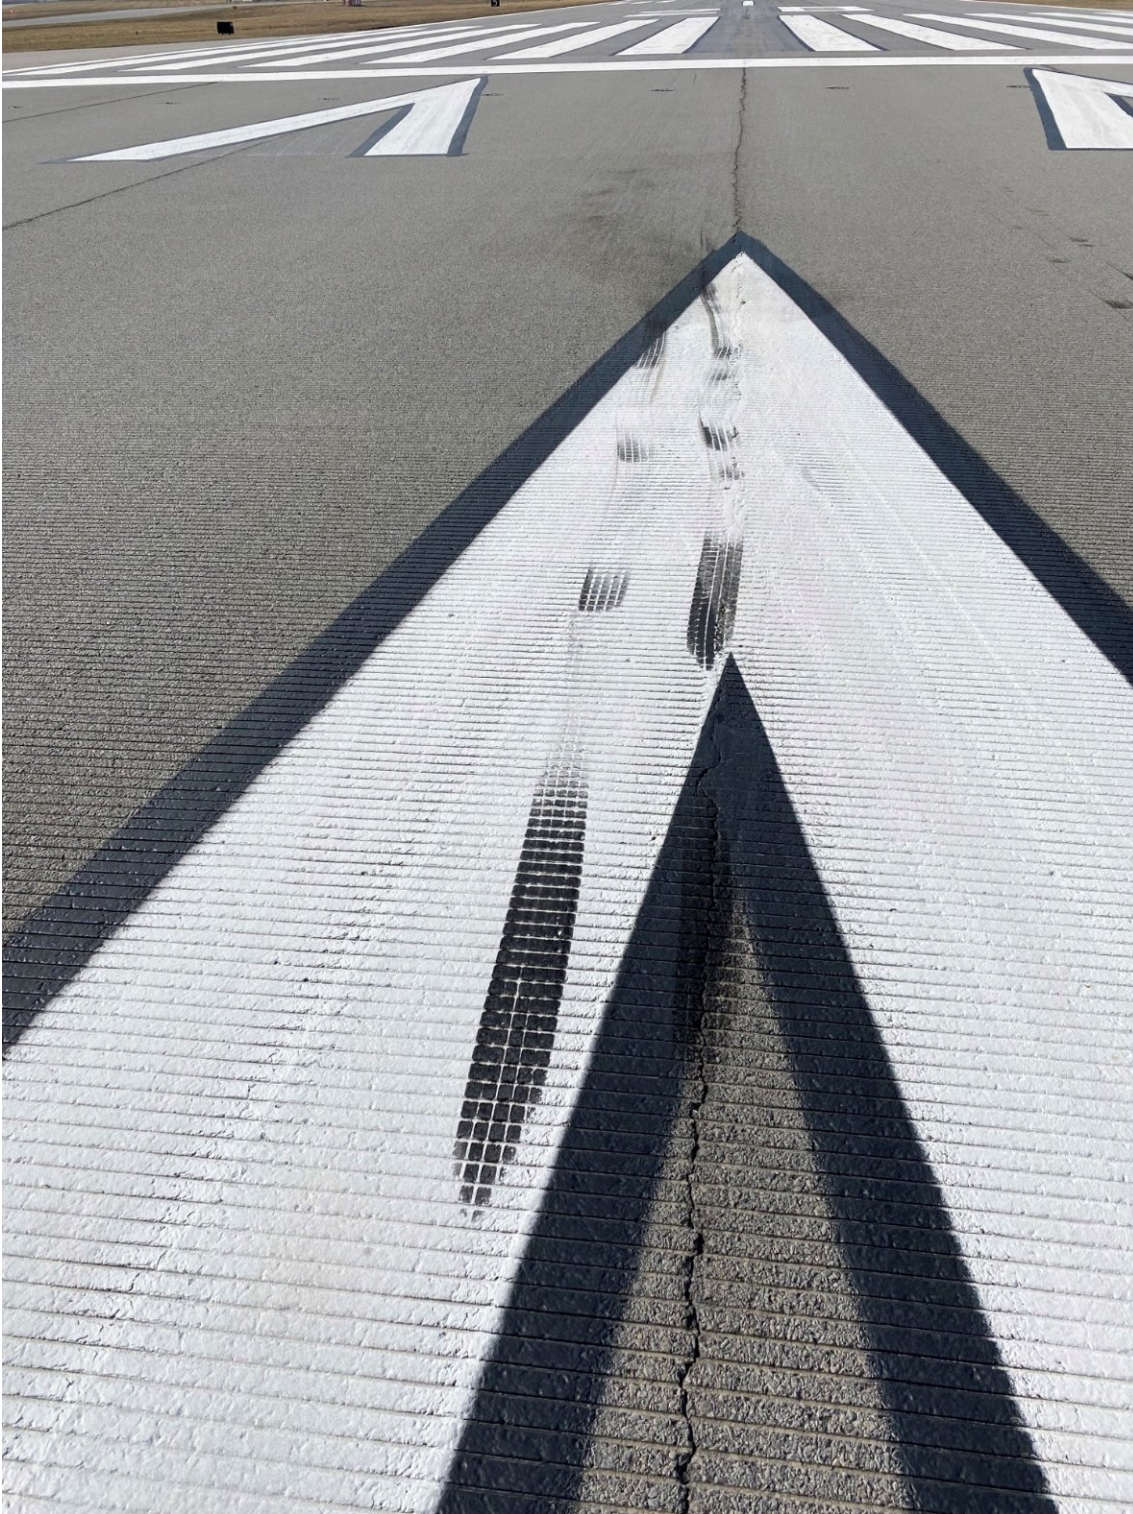
A review of airport surveillance video revealed that the airplane touched down around the runway 28 displaced threshold before the landing surface of the runway, bounced, and continued about 270 ft before it touched down and rolled out on the runway (see Figure 1).

Figure 1 - View of Ground Scars and Rubber Transfer Marks Consistent with Left Main Landing Gear

The initial ground scar and skid marks, which were consistent with the dimensions of the left main landing gear tires, began in the displaced threshold about 110 ft before the landing surface of the runway. The fractured parts were scattered over and beyond the ground scars and tire markings. One of the FAA inspectors described the structural and skin damage to the left wing and provided photographs of the torn structure, fractured hardware, and “sheared-off” rivets of the left-wing aft spar. Visual examination of the fracture surfaces depicted in the photographs revealed signatures consistent with overstress.

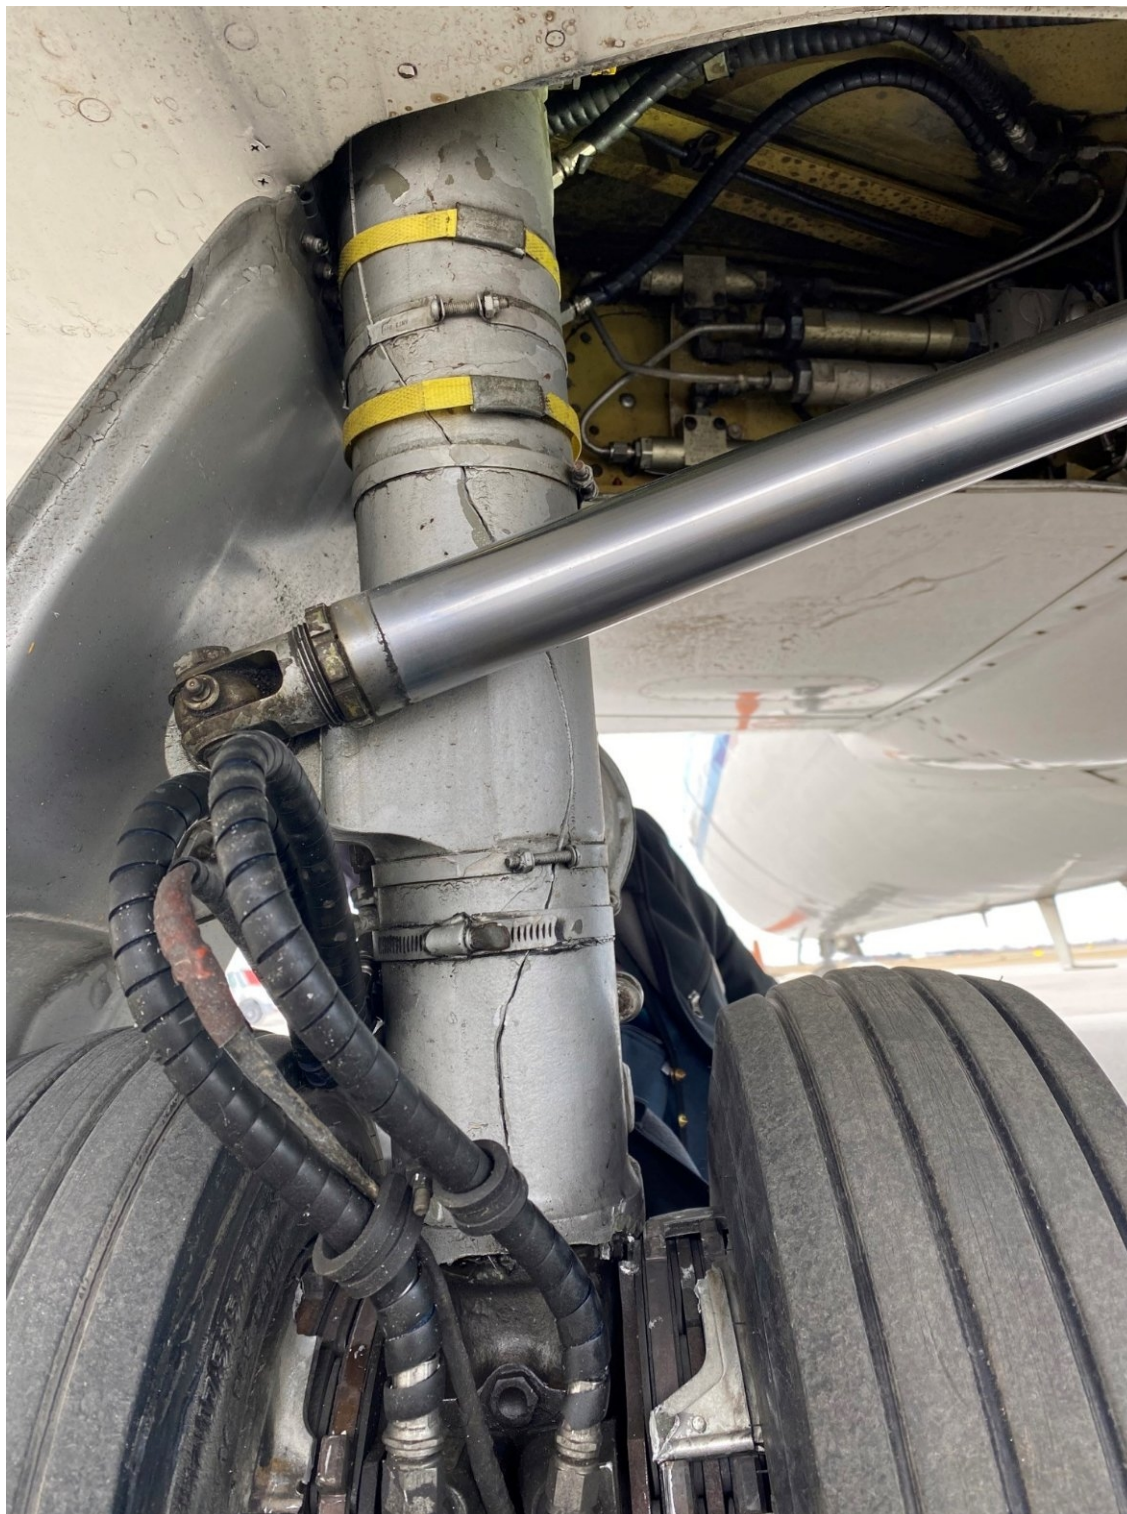
Examination of photographs revealed skid marks, ground scars, and fractured and broken parts associated with the left main landing gear wheel assembly, the retaining system for its

brakes, a fractured piece from the strut cylinder and a fractured piece of its snap ring (retainer) (see Figure 2).

Figure 2 - View of Fractured Landing Gear Leg and Fractured Brake Caliper Retention Caps
