# Aviation Investigation Final Report

<b>Location:</b>	Kahului, Hawaii	<b>Incident Number:</b>	DCA23LA172
<b>Date &amp; Time:</b>	December 18, 2022, 14:51 Local	<b>Registration:</b>	N212UA
<b>Aircraft:</b>	Boeing 777	<b>Aircraft Damage:</b>	None
<b>Defining Event:</b>	Altitude deviation	<b>Injuries:</b>	281 None
<b>Flight Conducted Under:</b>	Part 121: Air carrier - Scheduled

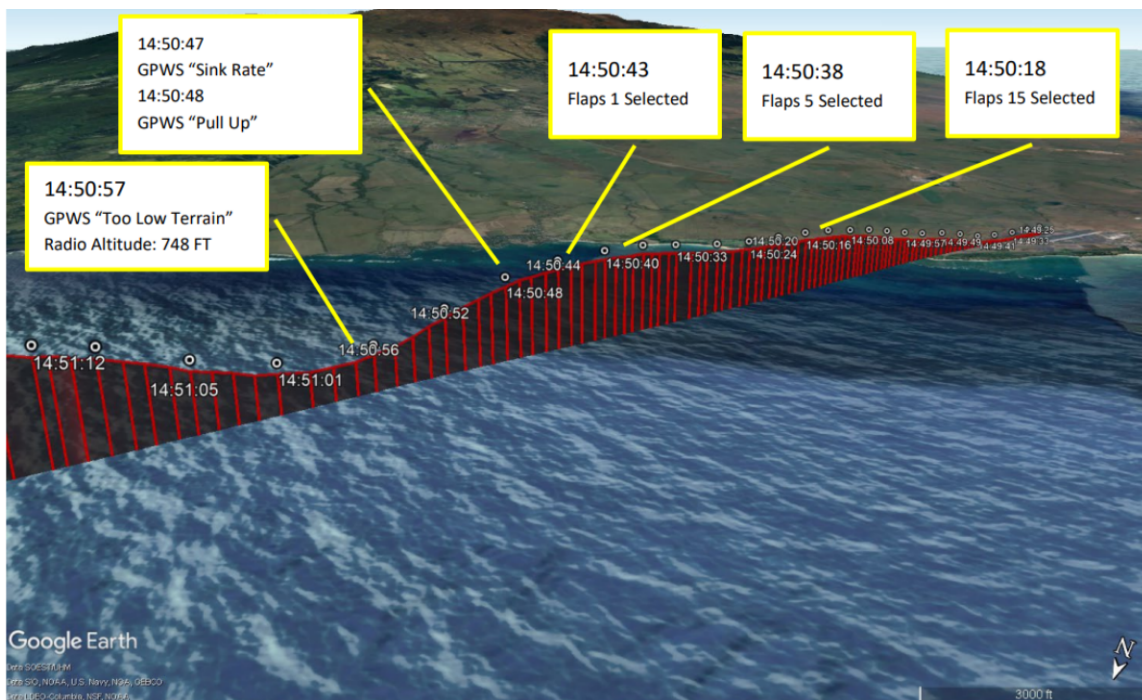
Figure 1- Flight Track with Annotations

United flight 1722 lost altitude about 1 minute after departure while in instrument meteorological conditions, which included heavy rain. The airplane descended from 2,100 ft to about 748 ft above the water before the crew recovered from the descent. No injuries were reported, and the airplane was not damaged. The NTSB was not originally notified of the event, since it did not meet the requirements of Title 49 *Code of Federal Regulations* Part 830.5. However, the NTSB learned of the event about 2 months later and chose to open an investigation. By that time, both the cockpit voice and flight data recorder durations had been exceeded. The investigation utilized flight crew statements and other records as information sources.

Figure 1 shows a perspective view of the flight track.

The flight crew's failure to manage the airplane's vertical flightpath, airspeed, and pitch attitude following a miscommunication about the captain's desired flap setting during the initial climb.

As a result of the event, United Airlines modified one of their operations training modules to address this occurrence and issued an awareness campaign about flight path management at their training center.
