Aviation Investigation Final Report

Location:	Grass Valley, California	Accident Number:	WPR23FA110
Date & Time:	February 19, 2023, 13:35 Local	Registration:	N420PF
Aircraft:	WILLMAN LOREN LOREN'S AIRCAM	Aircraft Damage:	Substantial
Defining Event:	Aerodynamic stall/spin	Injuries:	2 Fatal
Flight Conducted Under:	Part 91: General aviation - Personal

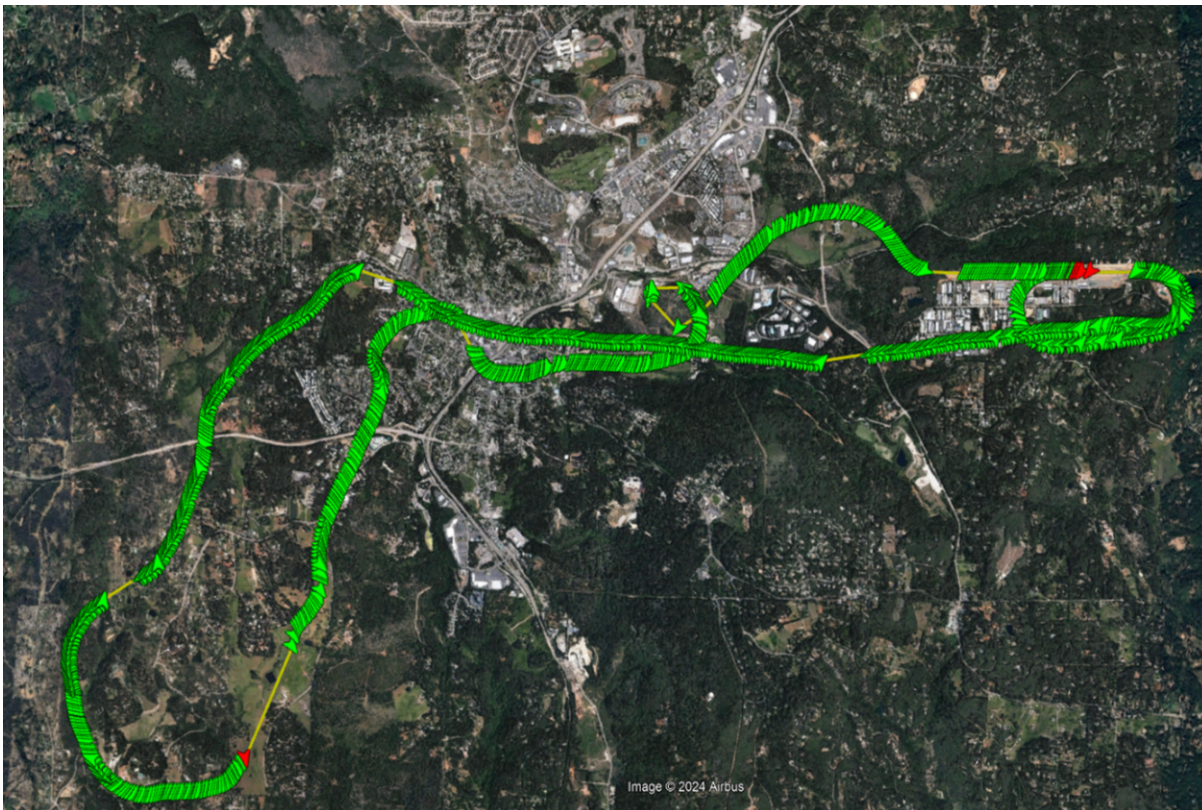
Figure 1. Google Earth image showing the ADS-B track of the flight with the pilot's brother-in-law as a passenger.

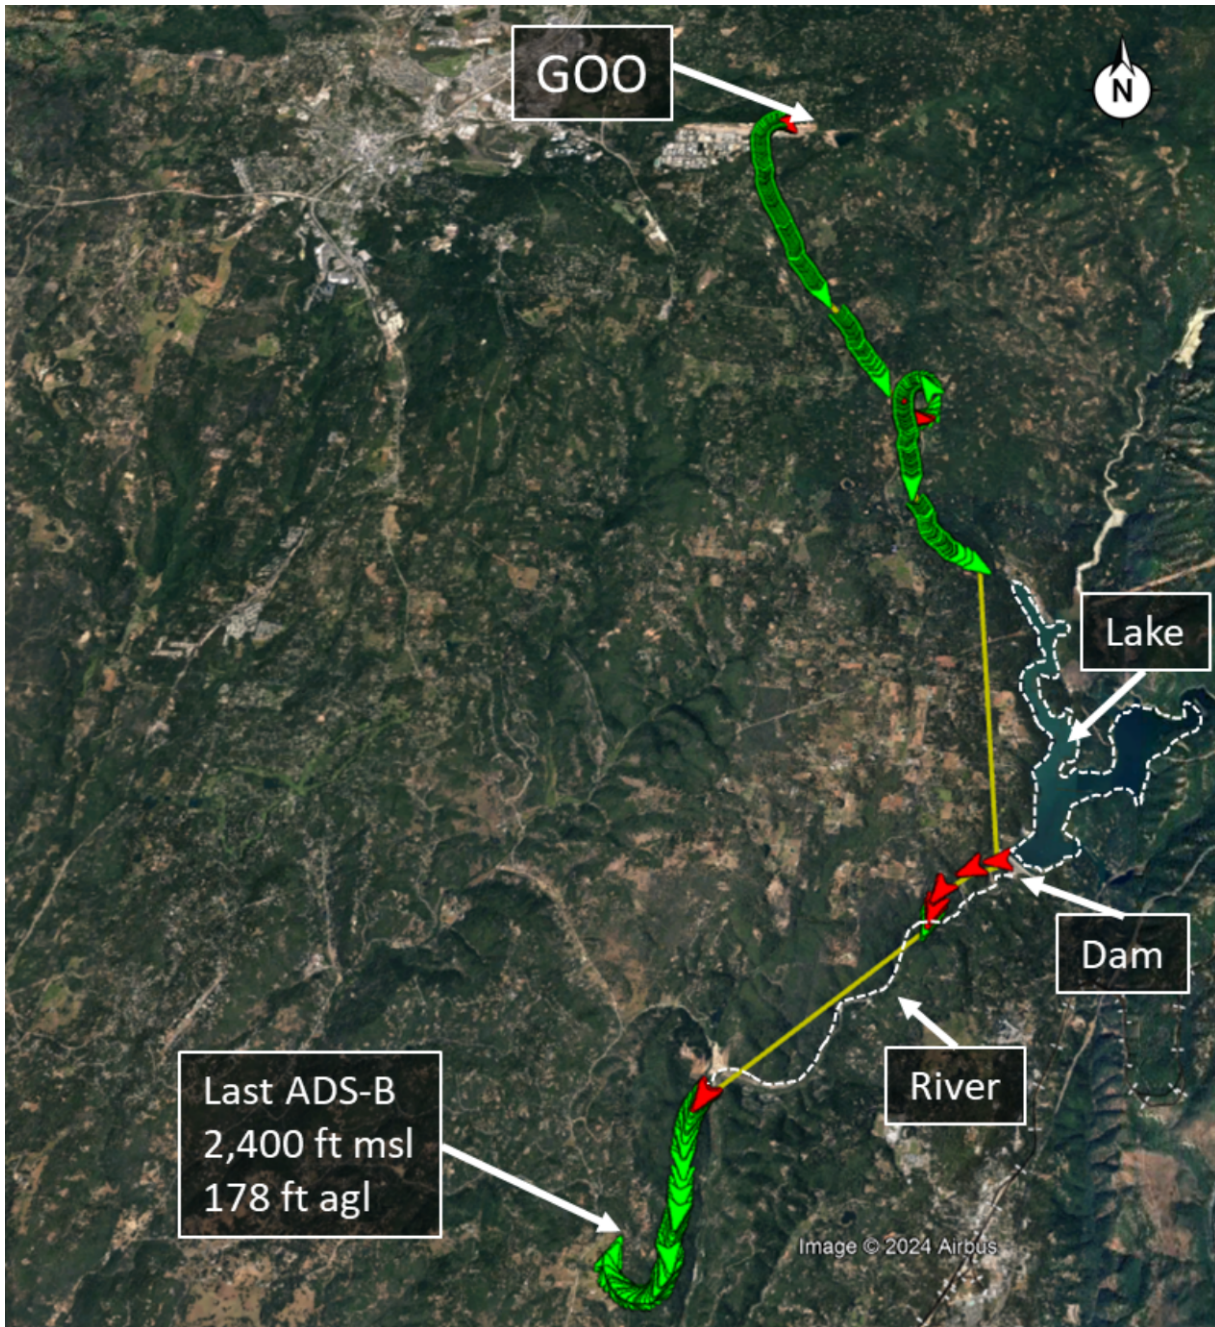
ADS-B data for the accident flight showed that the airplane departed GOO on runway 25 about 1309 and proceeded to the south. The recorded airplane altitudes and the intermittent ADS-B reception were consistent with low-altitude, maneuvering flight. About 3 minutes after takeoff, the airplane circled a large field near private property while about 200 to 300 ft agl. The airplane then proceeded southward to the north end of Rollins Reservoir. ADS-B data was lost temporarily about 1315 and regained about 1318 when the airplane was past the south end of the reservoir, above a dam. The flight continued along a river where ADS-B data was again lost about 1319. ADS-B data was regained about 1322 and showed that the airplane travelled about 1.7 miles southwest of the dam. About 1323 the airplane began a right 180° turn and crossed over a ridgeline. About this time, multiple witnesses reported observing the airplane operating at a low altitude, described as about 50 to 100 ft above the trees to about 200 ft and at an estimate speed of about 45 to 50 miles per hour. ADS-B data stopped at the completion of the 180° turn. The last data point recorded the airplane about 2,400 ft above mean sea level, or about 178 ft agl, about 2005 ft southeast of the accident site. A witness reported seeing the airplane as it traveled in a straight line, over her house, about 100 ft from the ground and about 50 mph. She saw the airplane's wing tilt to the right, then the airplane "nosed-dived straight down." Another witness said that it was going really slow and had a wobble, followed by a descent he described as, "nose first and the tail was straight up."

Figure 2. Google Earth image showing ADS-B data for the entire accident flight. The dashed lines highlight the lake and the river.

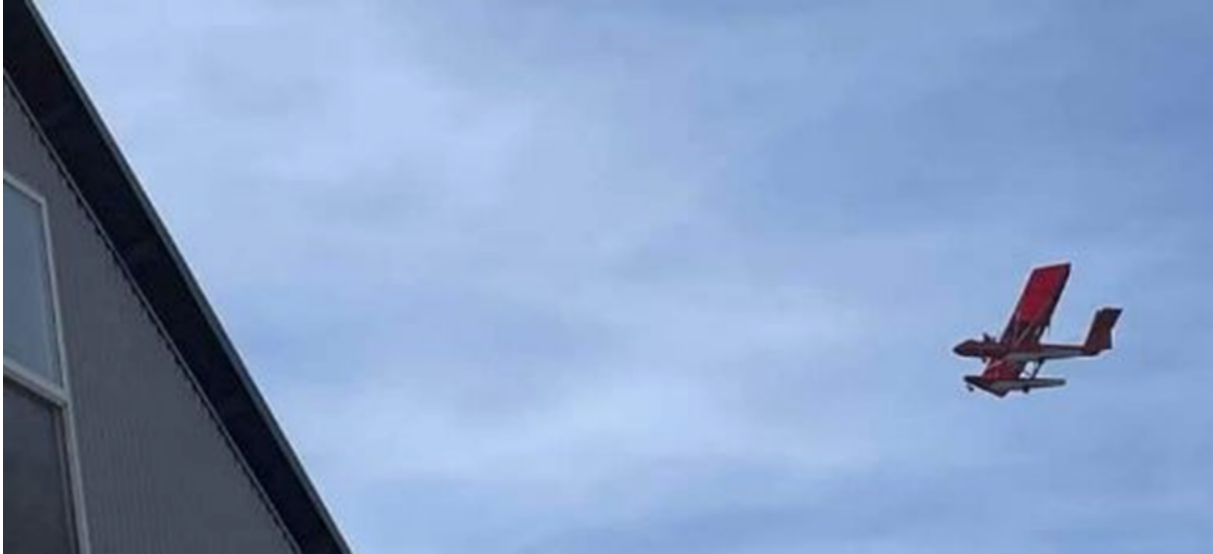
Another witness provided a photograph of the accident airplane that was taken on the day of the accident (Figure 3). A section of a house roof was visible in the frame. One witness stated that the female passenger lived in a house very close to the accident site.

Figure 3. Photo taken of the accident airplane on the day of the accident. (Source: witness)
