Aviation Investigation Final Report

Location:	Grass Valley, California	Accident Number:	WPR23FA110
Date & Time:	February 19, 2023, 13:35 Local	Registration:	N420PF
Aircraft:	WILLMAN LOREN LOREN'S AIRCAM	Aircraft Damage:	Substantial
Defining Event:	Aerodynamic stall/spin	Injuries:	2 Fatal
Flight Conducted Under:	Part 91: General aviation - Personal

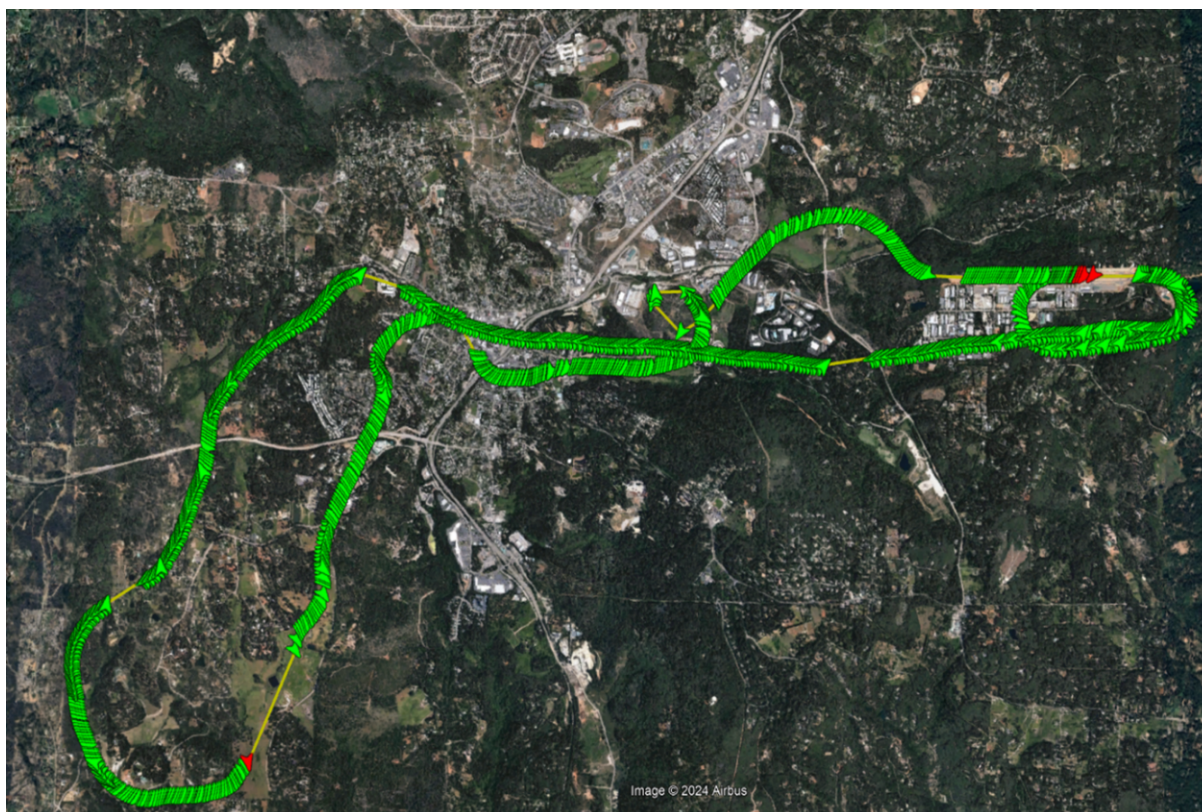
According to the pilot's brother-in-law, before the accident, the pilot took him on a local flight and stayed within five miles of the Nevada County Airport (GOO), Grass Valley, California. He estimated that the lowest altitude that they flew at was about 800 ft agl. ADS-B data showed this flight originated about 1219 and terminated about 1237. Most of the flight was calculated to have been about 250 to 500 ft agl. A Google Earth image with ADS-B data showing the flight with the brother-in-law is shown in Figure 1. The ADS-B track showed multiple areas of lost coverage.

Figure 1. Google Earth image showing the ADS-B track of the flight with the pilot's brother-in-law as a passenger.

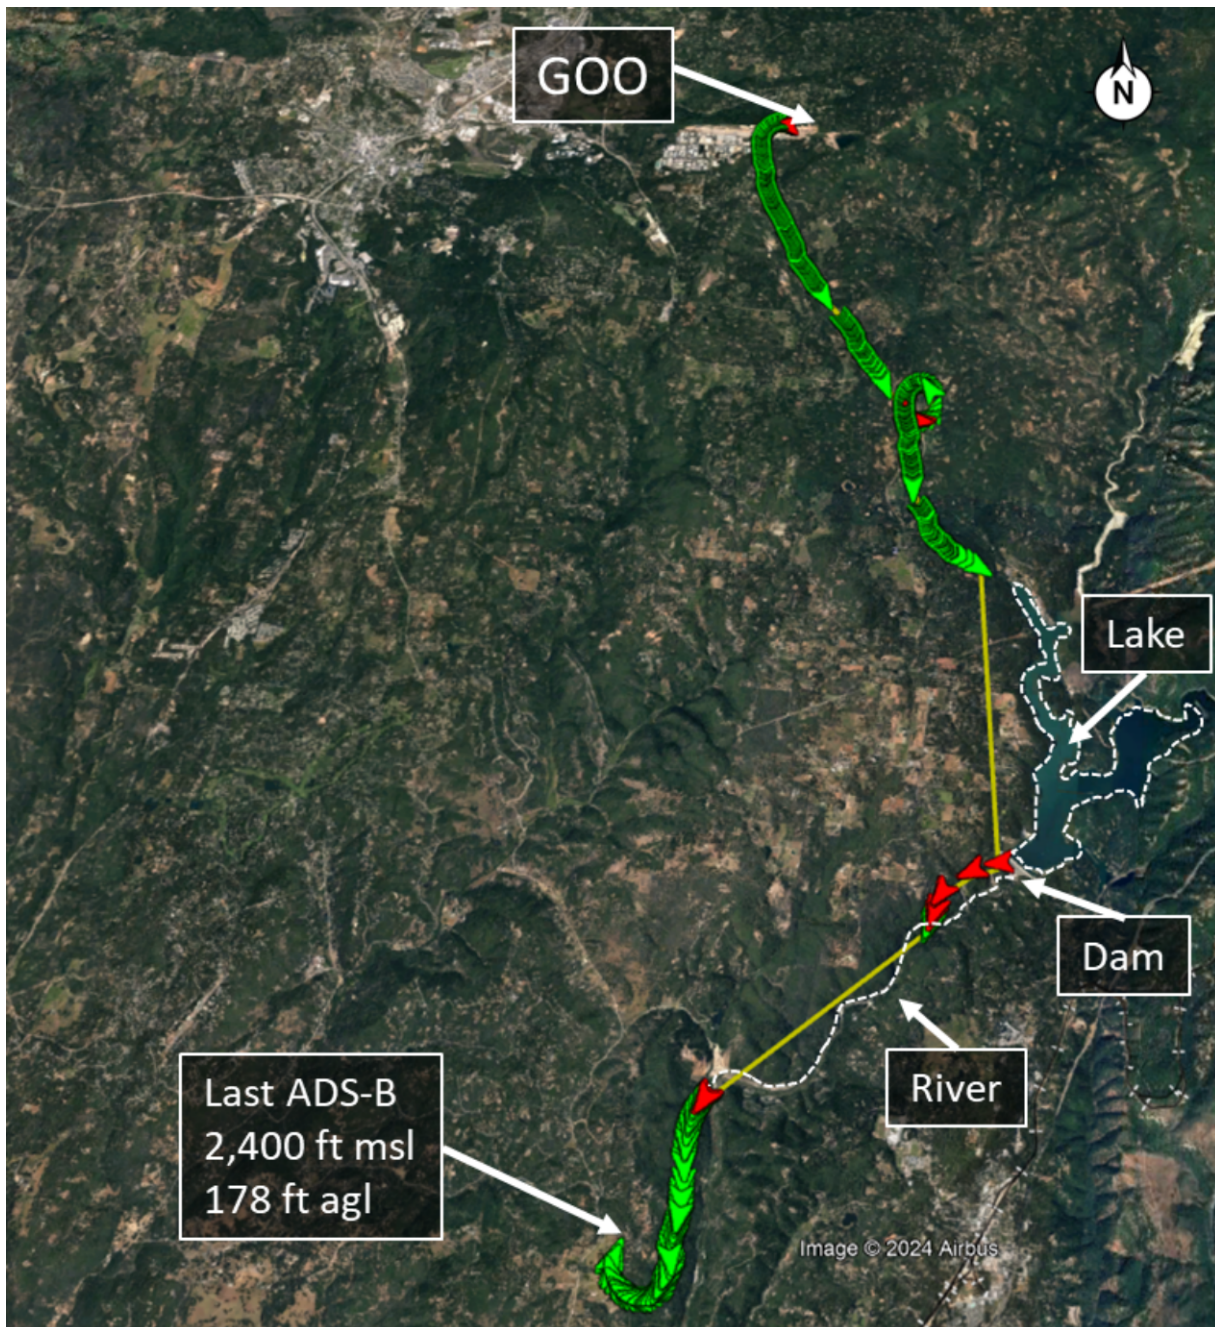
ADS-B data for the accident flight showed that the airplane departed GOO on runway 25 about 1309 and proceeded to the south. The recorded airplane altitudes and the intermittent ADS-B reception were consistent with low-altitude, maneuvering flight. About 3 minutes after takeoff, the airplane circled a large field near private property while about 200 to 300 ft agl. The airplane then proceeded southward to the north end of Rollins Reservoir. ADS-B data was lost temporarily about 1315 and regained about 1318 when the airplane was past the south end of the reservoir, above a dam. The flight continued along a river where ADS-B data was again lost about 1319. ADS-B data was regained about 1322 and showed that the airplane travelled about 1.7 miles southwest of the dam. About 1323 the airplane began a right 180° turn and crossed over a ridgeline. About this time, multiple witnesses reported observing the airplane operating at a low altitude, described as about 50 to 100 ft above the trees to about 200 ft and at an estimate speed of about 45 to 50 miles per hour. ADS-B data stopped at the completion of the 180° turn. The last data point recorded the airplane about 2,400 ft above mean sea level, or about 178 ft agl, about 2005 ft southeast of the accident site. A witness reported seeing the airplane as it traveled in a straight line, over her house, about 100 ft from the ground and about 50 mph. She saw the airplane's wing tilt to the right, then the airplane "nosed-dived straight down." Another witness said that it was going really slow and had a wobble, followed by a descent he described as, "nose first and the tail was straight up."

Figure 2. Google Earth image showing ADS-B data for the entire accident flight. The dashed lines highlight the lake and the river.

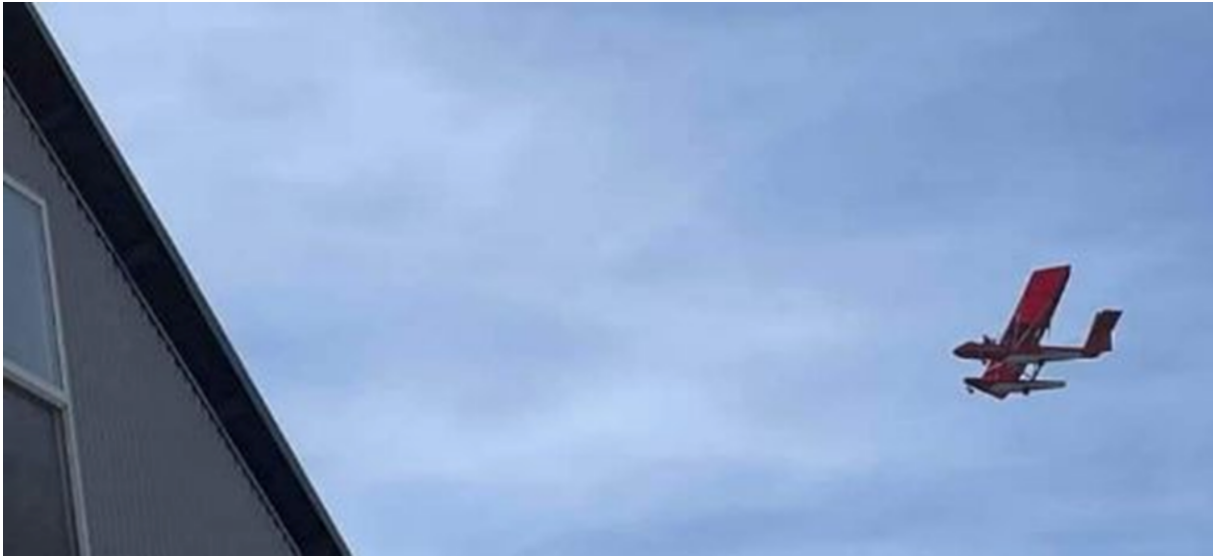
Another witness provided a photograph of the accident airplane that was taken on the day of the accident (Figure 3). A section of a house roof was visible in the frame. One witness stated that the female passenger lived in a house very close to the accident site.

Figure 3. Photo taken of the accident airplane on the day of the accident. (Source: witness)
