Aviation Investigation Final Report

Location:	Little Rock, Arkansas	Accident Number:	CEN23FA113
Date & Time:	February 22, 2023, 11:56 Local	Registration:	N55PC
Aircraft:	Beech B200	Aircraft Damage:	Destroyed
Defining Event:	Loss of control in flight	Injuries:	5 Fatal
Flight Conducted Under:	Part 91: General aviation - Business

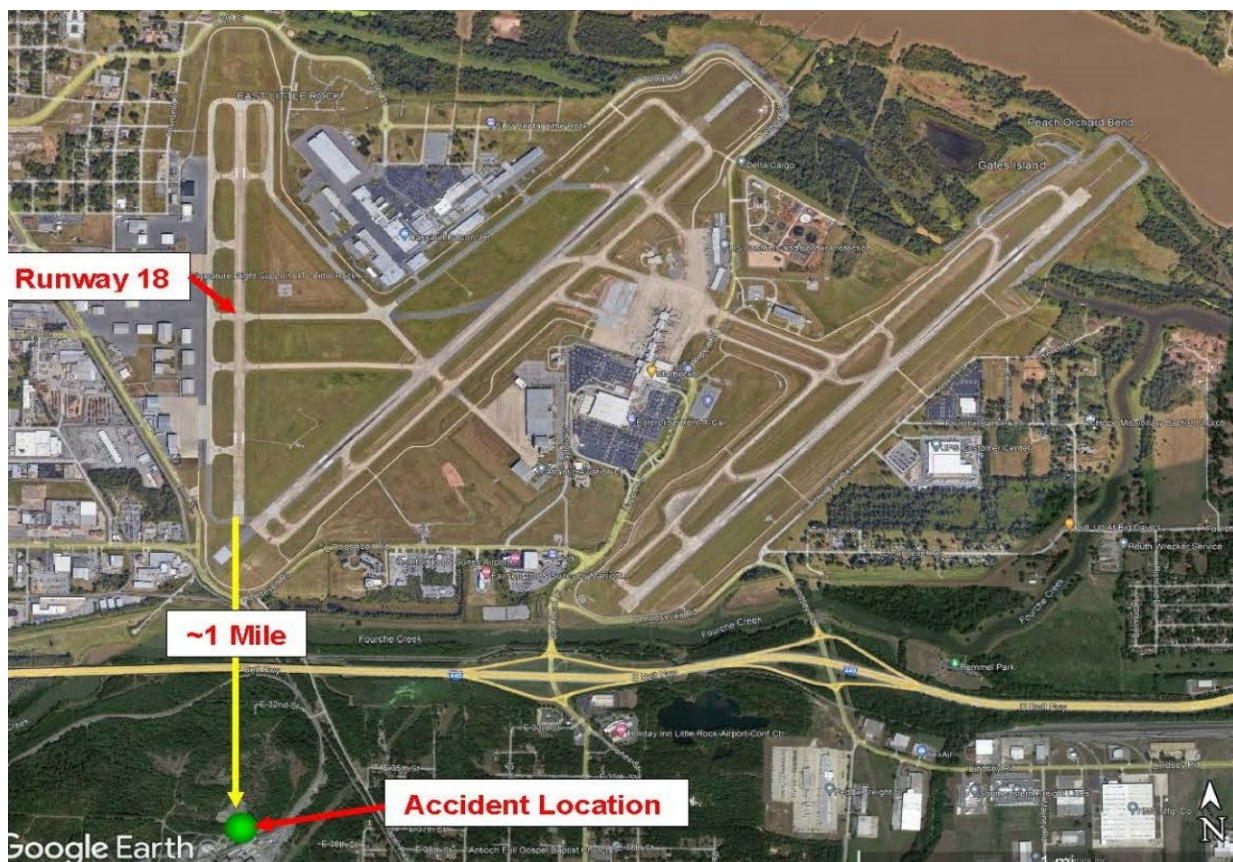
The wreckage of the airplane was found amidst heavily wooded terrain adjacent to a factory about 1 mile south of the departure end of runway 18. (See Figure 1.)

Figure 1. Accident location (green dot) in reference to runway 18 at LIT.

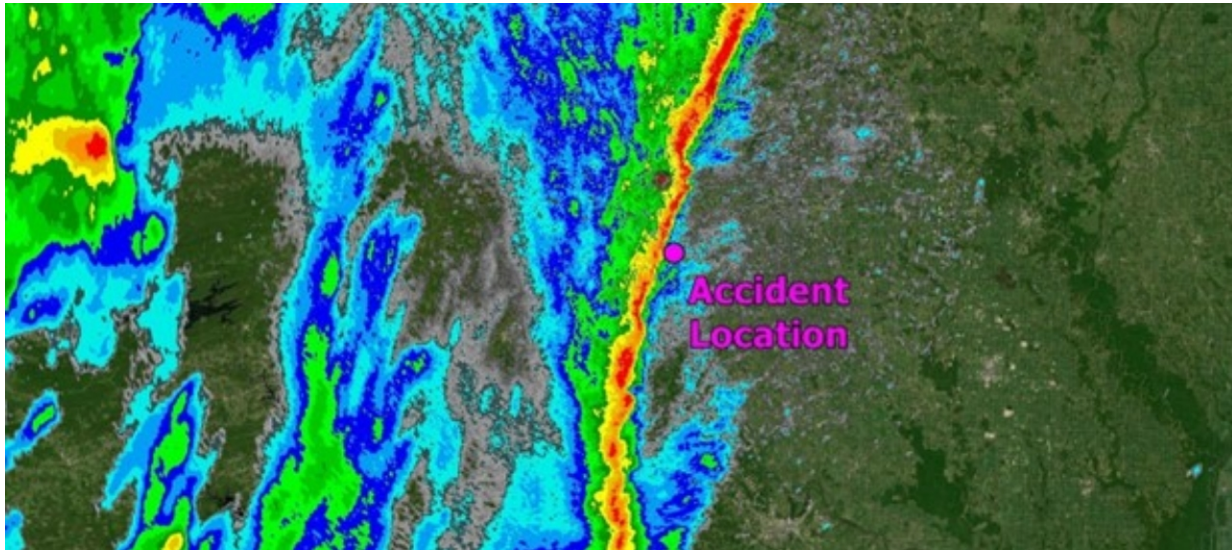
Weather radar imagery identified a line of extreme-intensity precipitation approaching LIT from the west during the period before the accident. (See Figure 2.) Velocity imagery depicted the accident location along a line of radial wind shift about the accident time.

Figure 2. Weather Radar Image. The accident site is depicted by a pink dot.

According to the National Weather Service, based on information gathered by radar, a wind shift occurred about 1 nautical mile to 1.10 nautical miles ahead of the 25dBz precipitation values in the vicinity of the accident site.

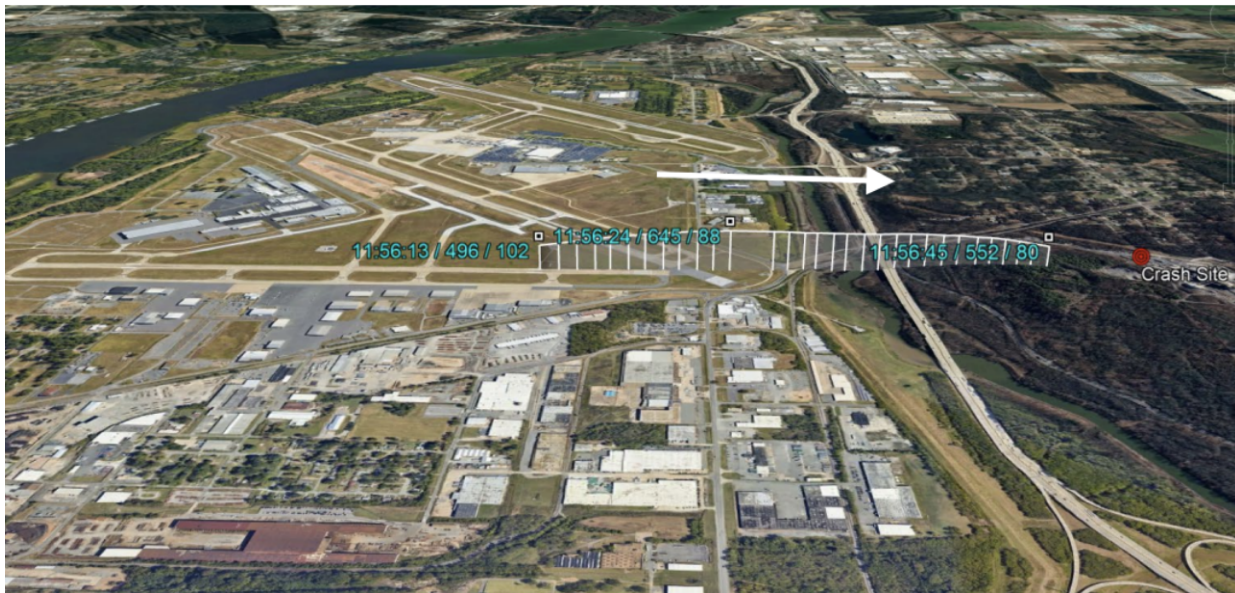
Video of the accident takeoff indicated that the airplane became airborne within the first 2,500 ft of the runway, consistent with normal takeoff performance specified in the POH. The video showed the landing gear being retracted, but the flap position could not be determined. ADS-B data captured the airplane beginning at 1156:13, when the airplane was 237 ft above the runway and about 5,005 ft from the runway threshold. The data lasted 32 seconds, with the airplane's groundspeed decreasing for the duration of the recorded data. The airplane reached a peak altitude of 650 ft msl (386 ft above the runway) at 1156:25. The total energy calculated (kinetic plus potential) peaked at 1156:20, about 5 seconds before the airplane reached its

peak altitude. A simplified mathematical model of the airplane was used to calculate thrust and horsepower; both thrust, and horsepower showed sharp decreases at 1156:20, consistent with a decrease in total energy. Each of the airplane's engines was rated at 850 shaft horsepower (hp) for a total of 1700 hp. The actual power delivered to the airframe will be less than the total because the engines and propellers are not 100% efficient. During the accident takeoff, the maximum value calculated was only about 900 hp, and after 1156:20, the value was less than 400 hp. A profile view of the airplane's flight path can be seen in Figure 3 below.

Figure 3. Profile view of the accident takeoff with direction of flight denoted by white arrow.
