Aviation Investigation Preliminary Report

Location:	Little Rock, AR	Accident Number:	CEN23FA113
Date & Time:	February 22, 2023, 11:56 Local	Registration:	N55PC
Aircraft:	Beech B200	Injuries:	5 Fatal
Flight Conducted Under:	Part 91: General aviation - Business

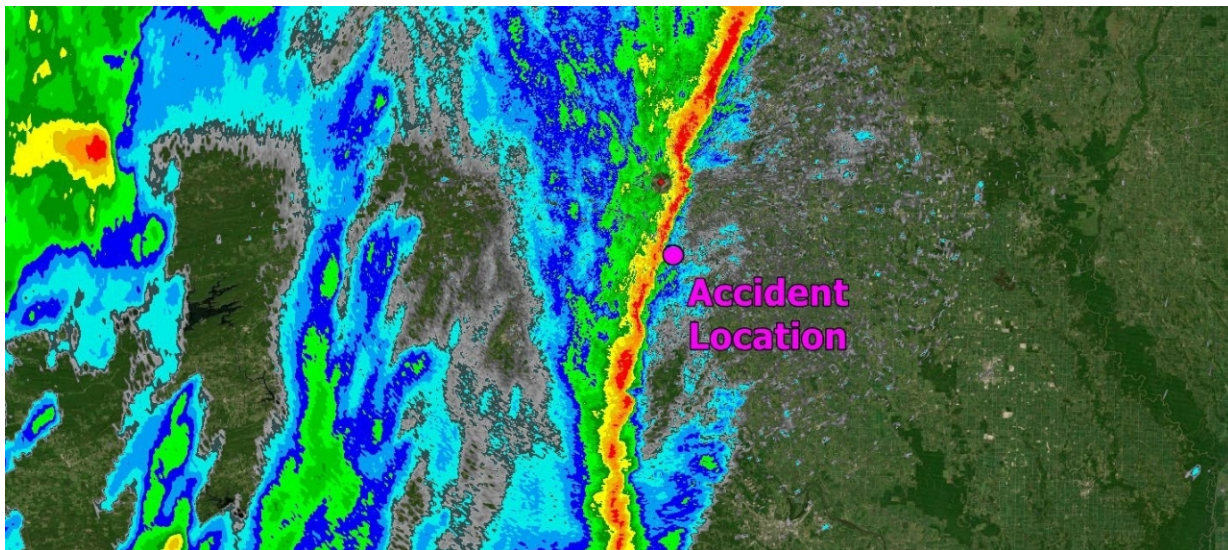
Also, weather radar imagery showed a front moving from west to east just before the takeoff. See Figure 1.

Figure 1. The weather radar imagery from about the accident time depicts the accident location (pink dot) coincident with a convective line moving from west to east.

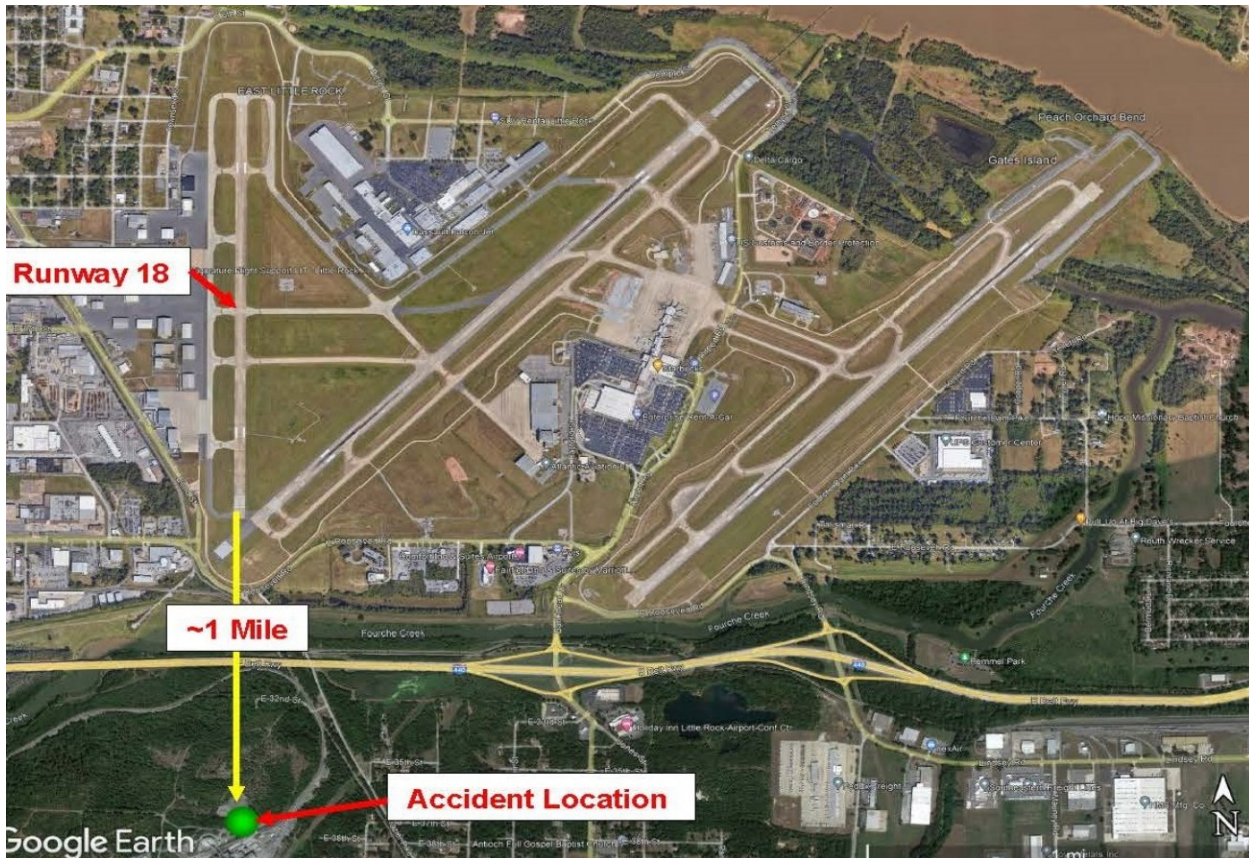
The airplane wreckage was found amidst heavily wooded terrain adjacent to a 3M factory, about 1-mile south of the departure end of runway 18. See Figure 2.

Figure 2. Accident location (green dot) in reference to runway 18.
