Aviation Investigation Final Report

Location:	Riyadh,	Incident Number:	ENG22LA049
Date & Time:	March 31, 2022, 19:05 UTC	Registration:	9H-VIG
Aircraft:	Bombardier Global 7500	Aircraft Damage:	Minor
Defining Event:	Fire/smoke (non-impact)	Injuries:	
Flight Conducted Under:	Non-U.S., commercial

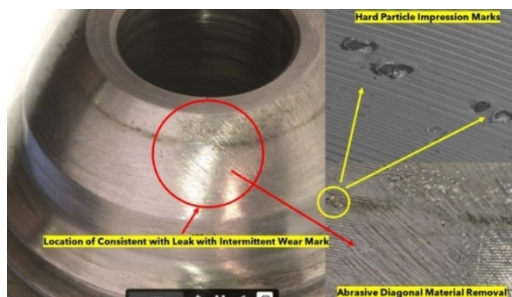
Fuel nozzle No. 18 male bullnose sealing surface exhibited galling along with an elliptical and intermediate contact marks, indicative of misalignment contact with the fuel manifold female ferrule sealing surface. There were also signs of contaminants (hard particles) on the fuel nozzle male bullnose sealing surface in the form of craters, indentations, and imbedded material on the sealing surface, along with diagonally orientated abrasive material marks/material removal consistent with what appears to be previous repair (**PHOTO 3**). According to GE, there

was no record of a repair operation being performed on this specific nozzle at the fuel nozzle manufacturer or at the engine assembly site which would account for the observed abrasive material removal; therefore, GE concluded that this possible repair may have occurred sometime during engine assembly. The engine manual does not allow for any nicks or scratches but does allow for blending. However, blending is only allowed in the circumferential direction for conical/cylindrical parts; the blend/abrasive material removal marks on fuel nozzle No. 18 male bullnose sealing surface were in the diagonal direction along the axis of the part. Therefore, the observed blending in the area would be inconsistent with the engine manual blending instructions.

PHOTO 3: No. 18 FN MALE BULLNOSE WITH ABRASIVE MARKS AND PARTICLE IMPRESSION

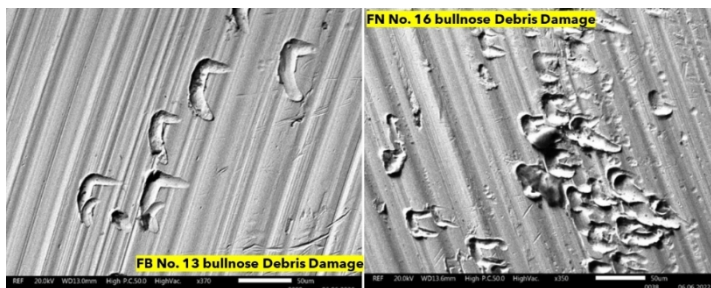
Only the fuel nozzle No. 18 male bullnose sealing surface showed evidence of rework/repair; however, hard particle damage was also observed on the male bullnose seal surfaces of fuel nozzles Nos. 12, 13, and 16 (PHOTO 4). GE was unable to confirm the source of the contaminates.

PHOTO 4: HIGH MAGNIFICATION OF SIMILAR SHAPED DEBRIS DAMAGE ON FUEL NOZZLE MALE BULLNOSE SEALING SURFACE ON NOS. 13 AND 16
