Aviation Investigation Final Report

Location:	Sarasota, Florida	Incident Number:	DCA23LA179
Date & Time:	February 16, 2023, 20:59 Local	Registration:	N976NN (A1); C-FJQH (A2)
Aircraft:	Boeing 737-823 (A1); Airbus 321 (A2)	Aircraft Damage:	None (A1); None (A2)
Defining Event:	Air traffic event	Injuries:	178 None (A1); 194 None (A2)
Flight Conducted Under:	Part 121: Air carrier - Scheduled (A1); Part 129: Foreign (A2)

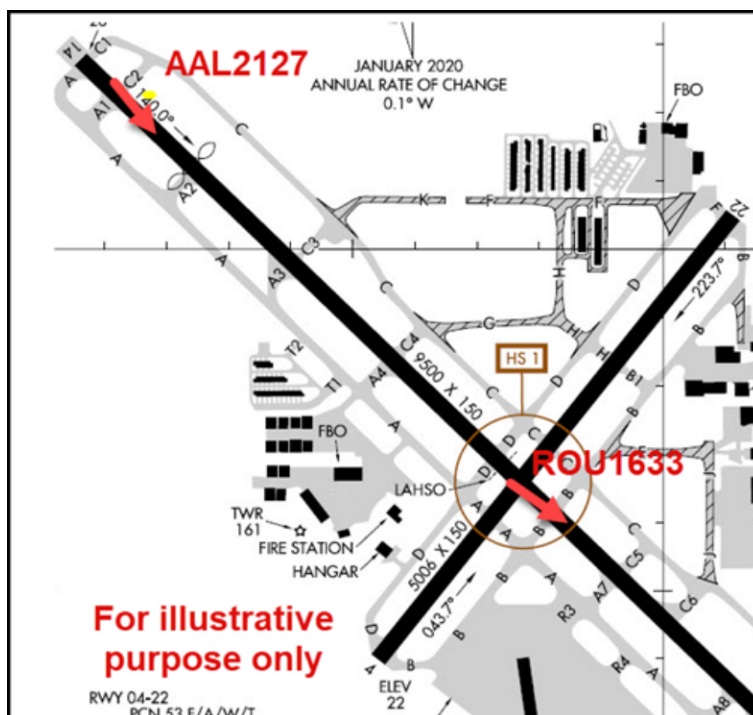
The controller relied on visually monitoring both airplanes to ensure that their courses diverged, and that lateral separation was assured. However, the local controller turned his attention to a lower priority task before confirming that ROU1633 had departed.

The estimated closest proximity between ROU1633 and AAL2172 was 0.6 miles horizontally and about the same altitude; ROU1633 was departing runway 14 and climbing through 100 feet, and AAL2172 was about 100 feet, and crossing over the runway 14 numbers.

Figure 1. Position of aircraft involved when local controller looked up and outside the ATCT cab after hearing AAL2172 report “going around”.

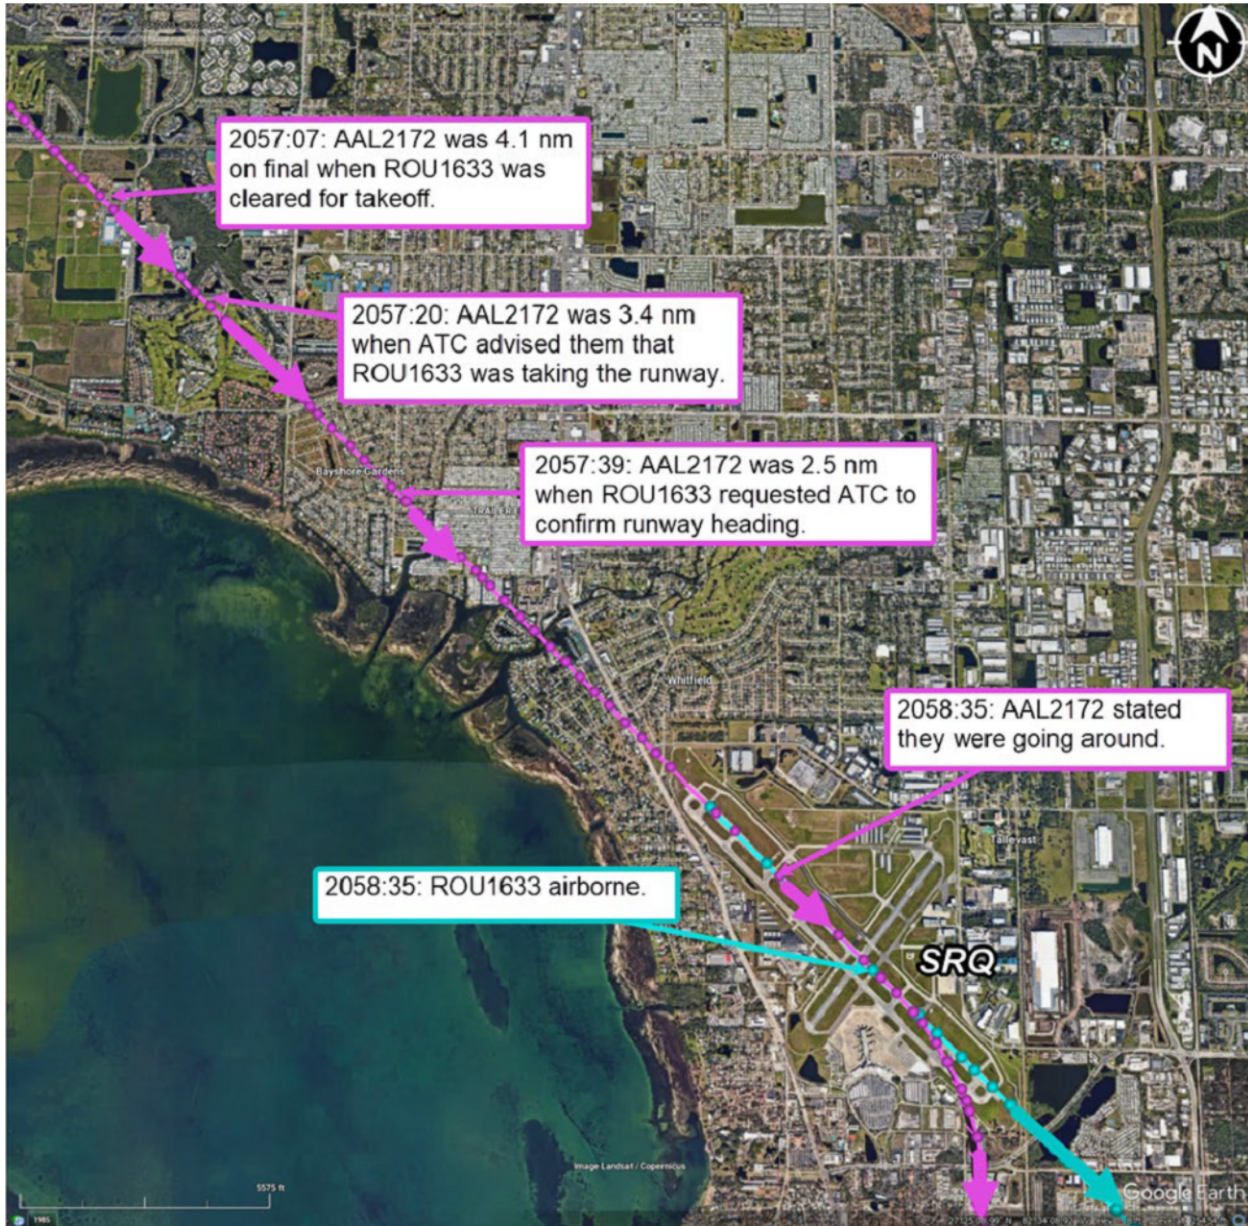
At 2057:07, the LC controller instructed the crew of ROU1633 to fly runway heading, cleared the flight for takeoff runway 14, and advised them that traffic (AAL2172) was on a 3-mile final. The crew read back “cleared for takeoff runway 14”, and at the time ADS-B data indicated that AAL2172 was about 4.1 nm from the threshold of runway 14, see figure 2.

Figure 2. Graphic depicts the location of AAL2172 and ROU1633 during noted times.

At 2057:20, the LC controller informed the crew of AAL2172 that an Airbus will be departing runway 14. The crew then acknowledged by stating their call sign. ADS-B data indicated that AAL2172 was about 3.4 nm from the threshold of runway 14.

At 2057:39, the crew of ROU1633 asked the LC controller to confirm they were to fly runway heading. The LC controller stated, “affirmative, fly runway heading”. ADS-B data showed that at the time AAL2172 was about 2.5 nm from the threshold of runway 14.
