Aviation Investigation Preliminary Report

Location: Stagecoach, NV Accident Number: WPR23MA113

Date & Time:February 24, 2023, 21:14 LocalRegistration:N273SM

Aircraft: Pilatus PC-12/45 Injuries: 5 Fatal

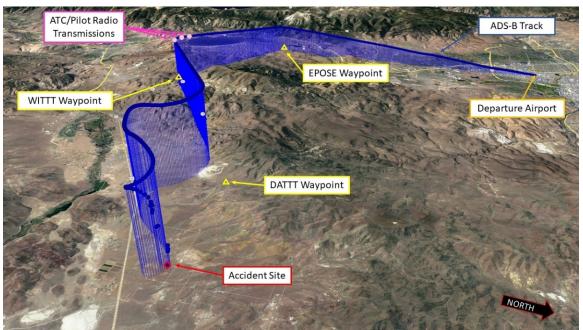
The airplane continued to ascend to about 18,300 ft msl and made a right turn to a southeasterly heading at 2111:37, about 2 miles southeast of the DATTT waypoint. The ADS-B data showed that the airplane remained on this heading for about 47 seconds, and ascended to 18,900 ft msl, before a left turn to a northeasterly heading was initiated. The airplane continued a northeasterly heading and had ascended to about 19,100 ft, before a descending right turn was observed at 2113:31. The data showed

that the airplane remained in a descending right turn until ADS-B contact at was lost at 2114:01 at an altitude of about 11,100 ft msl.

Figure 1: ADS-B flight track data with waypoint, accident site, and radio communication reference points annotated.
