Aviation Investigation Final Report

Location:	Windsor Locks, Connecticut	Accident Number:	ERA23LA135
Date & Time:	March 3, 2023, 16:00 Local	Registration:	N300ER
Aircraft:	BOMBARDIER INC BD-100-1A10	Aircraft Damage:	Minor
Defining Event:	Loss of control in flight	Injuries:	1 Fatal, 4 None
Flight Conducted Under:	Part 91: General aviation - Personal

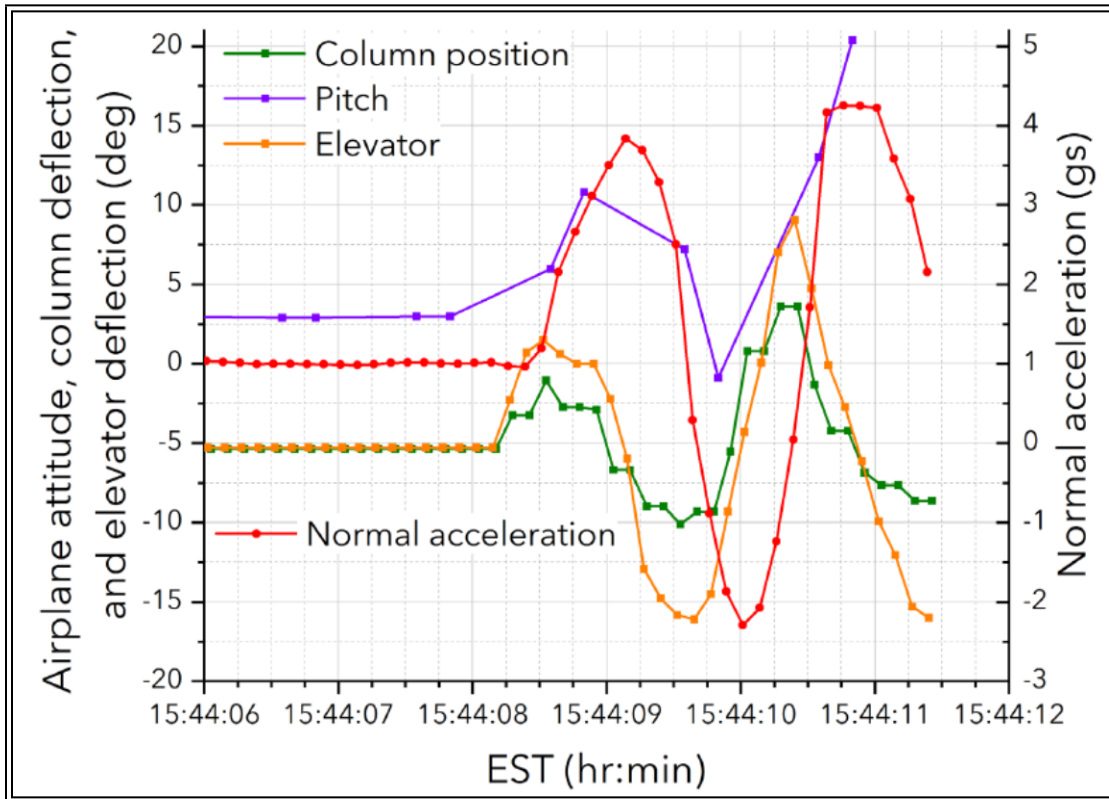
The study found that before the autopilot disengagement, the autopilot was holding an elevator deflection of 5.3° airplane nose-down to balance the airplane's pitching moments and acceleration due to the nose-up horizontal stabilizer position. Following the autopilot disengagement, the elevators rapidly moved to neutral, and the airplane, which had been in a 3° nose-up pitch attitude, rapidly increased pitch to 11° nose-up in one second, and the normal acceleration increased to 4g. The control column was subsequently pushed forward by the PIC with at least 90 lbs of force, the airplane pitched down to a near nose-level attitude, and the normal acceleration was reduced to -2.3g. The control column was then pulled back through neutral, and the airplane again rapidly pitched to over 20° nose up and more than 4g of normal

acceleration. The FDR then stopped recording, as the inertial g switch was triggered by the loading. As a result, the full extent of the pitch event was not recorded. Figure 1 provides an overview of the airplane pitch, column position, and elevator deflection, versus time and normal acceleration for the event. The dots on each respective line trace each sample of the FDR channel.

Figure 1: Airplane pitch, column position, and elevator deflection versus time and normal acceleration for event. The dots on each trace show each sample of the FDR channel.

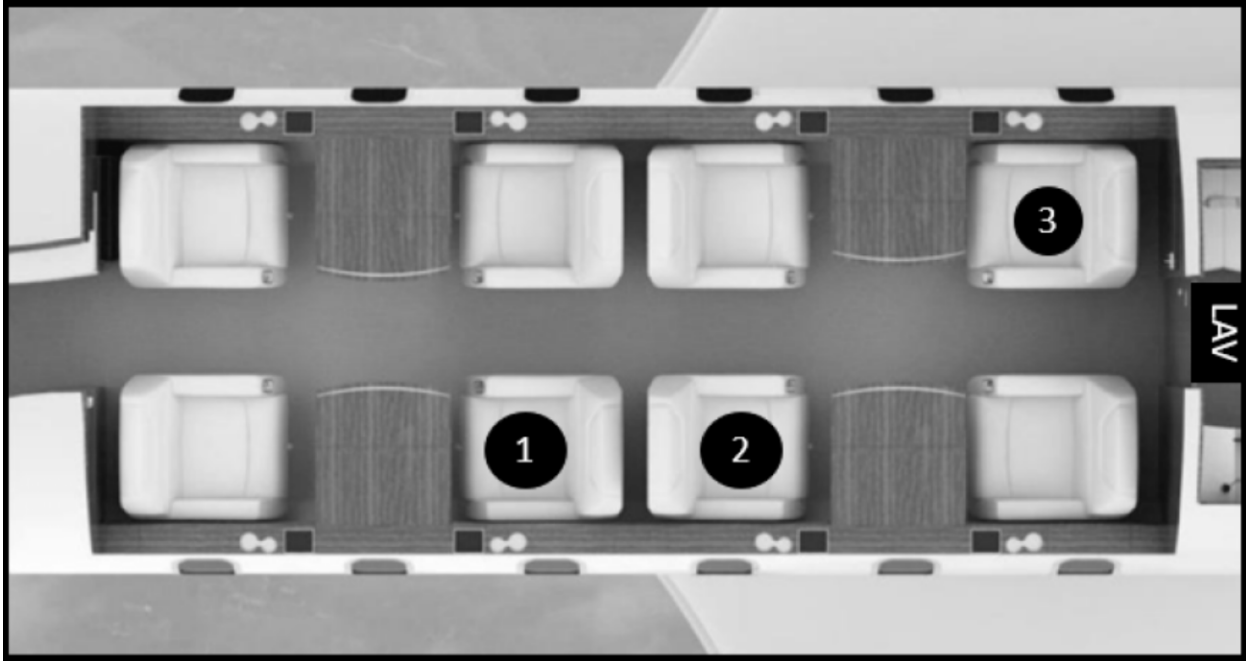
The fatally injured passenger’s seatbelt was not fastened at the time of the in-flight upset. The PIC reported that the seatbelt sign was on for the entire flight, and that his regular practice was to never turn it off. The in-flight upset occurred near 23,000 ft, about 9 minutes into the flight. It is likely that the passengers had no expectation for the seatbelt sign to be turned off at any time during the flight, given that they regularly flew with this flight crew. As a result, the passengers had to use their own judgement regarding whether it was safe to get up and move about the cabin.

Figure 2 shows the reported seating location for each passenger; the fatally injured passenger was No. 3. The cockpit is to the left in the figure, with the lavatory and aft section of the airplane to the right, annotated as "LAV."

Figure 2: Seating Configuration with passenger seating locations annotated.

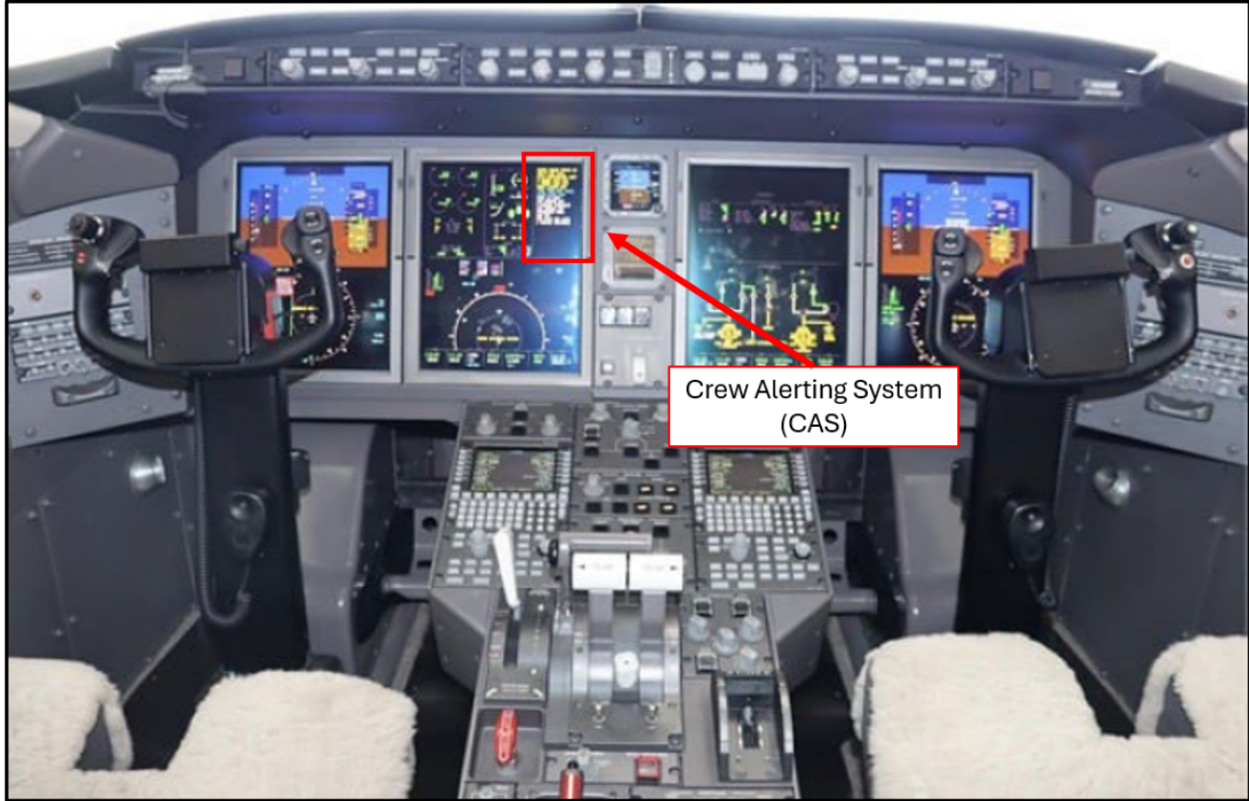
According to the FCOM, Chapter 1, "General," the airplane was equipped with an Engine Indication and Crew Alerting System (EICAS). The EICAS system was designed to show system status with specified colors. The "Crew Alerting System" portion of the EICAS displayed indications within the CAS window, which was in the upper right portion of the same display (see Figure 3).

Figure 3: View of the cockpit in the accident airplane with the CAS location annotated (Source of Photo: Aircraft.com)

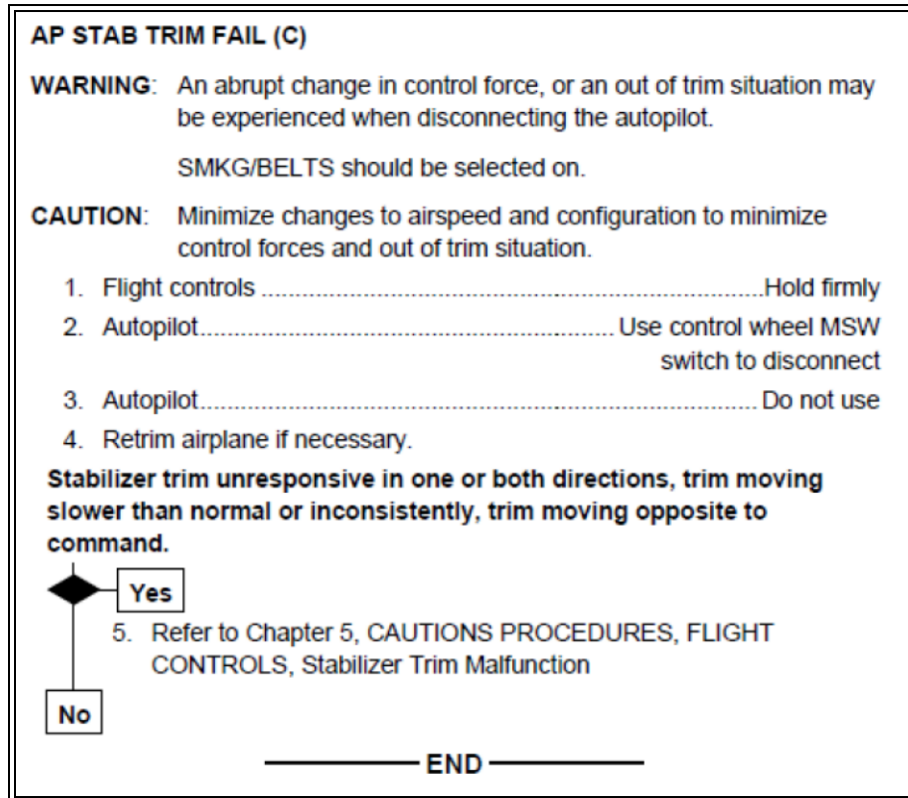
Figure 6: Temporary revision for AP STAB TRIM FAIL.

The TR included an additional step noted as item 5 within the checklist and reordered items 3 and 4. The TR also included the addition of “Trim Malfunction procedures” and “STAB TRIM FAULT (A) procedures.”
