Aviation Investigation Final Report

Location:	Lindenhurst, New York	Accident Number:	ERA23FA137
Date & Time:	March 5, 2023, 14:59 Local	Registration:	N8149R
Aircraft:	Piper PA-28-161	Aircraft Damage:	Destroyed
Defining Event:	Fire/smoke (non-impact)	Injuries:	1 Fatal, 2 Serious
Flight Conducted Under:	Part 91: General aviation - Instructional

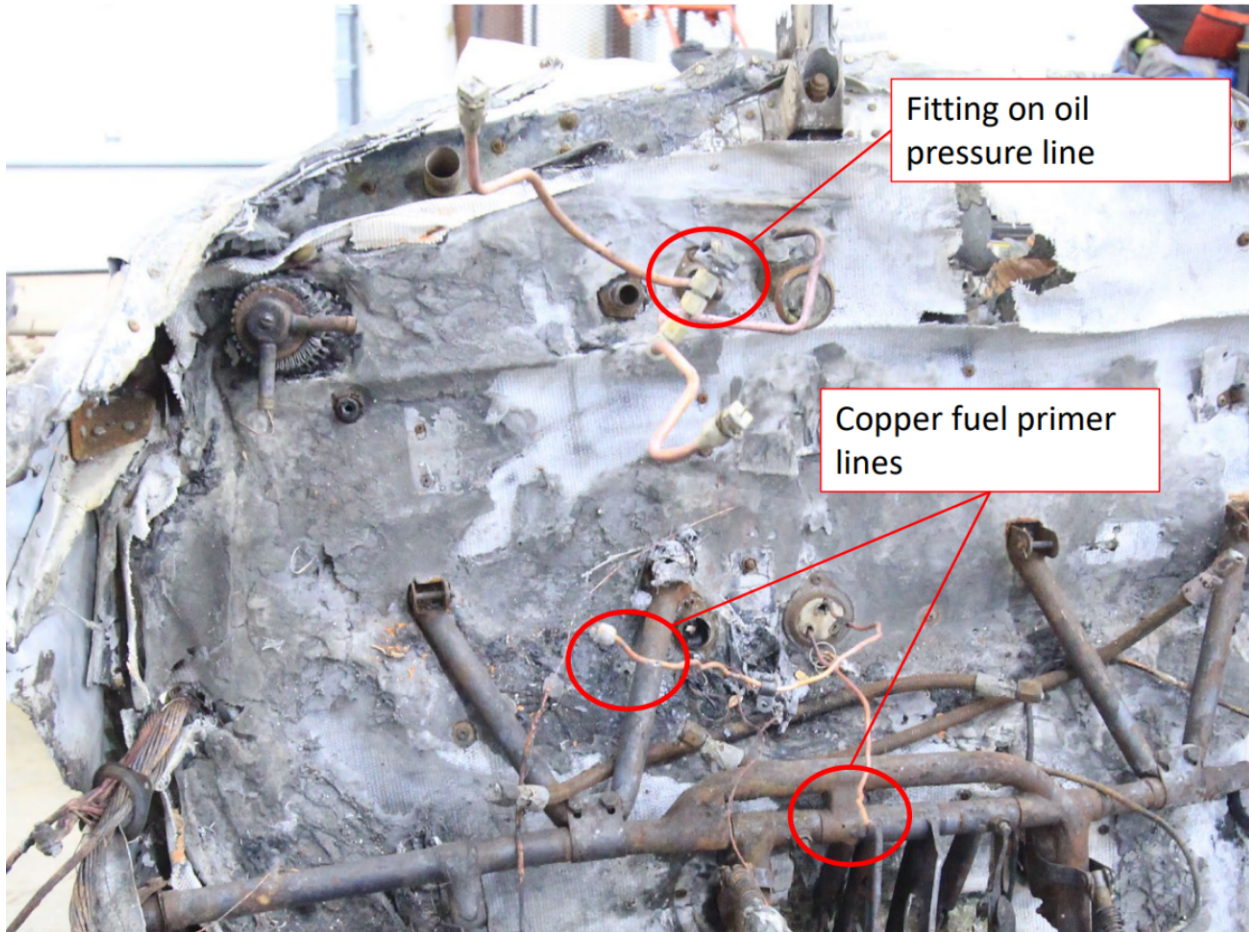
Examination of the firewall and components remaining attached to the cockpit side of the firewall did not reveal any concentrated thermal damage on the firewall panel but did identify two copper tubes associated with the fuel primer pump and a fitting on a copper tube associated with the oil pressure line that exhibited localized areas of melting. (See Figure 1.) These components exhibited a sharp demarcation between the melted area and the adjacent material. The fuel primer lines were standard equipment consistent with the aircraft design. The fitting on the oil pressure line was not standard equipment and was not consistent with the design of the original oil pressure line. Both the fuel primer lines and the fitting on the oil pressure line were retained for further examination.

Figure 1. Cockpit side of engine firewall exhibiting overall thermal damage, with localized areas of melting identified.

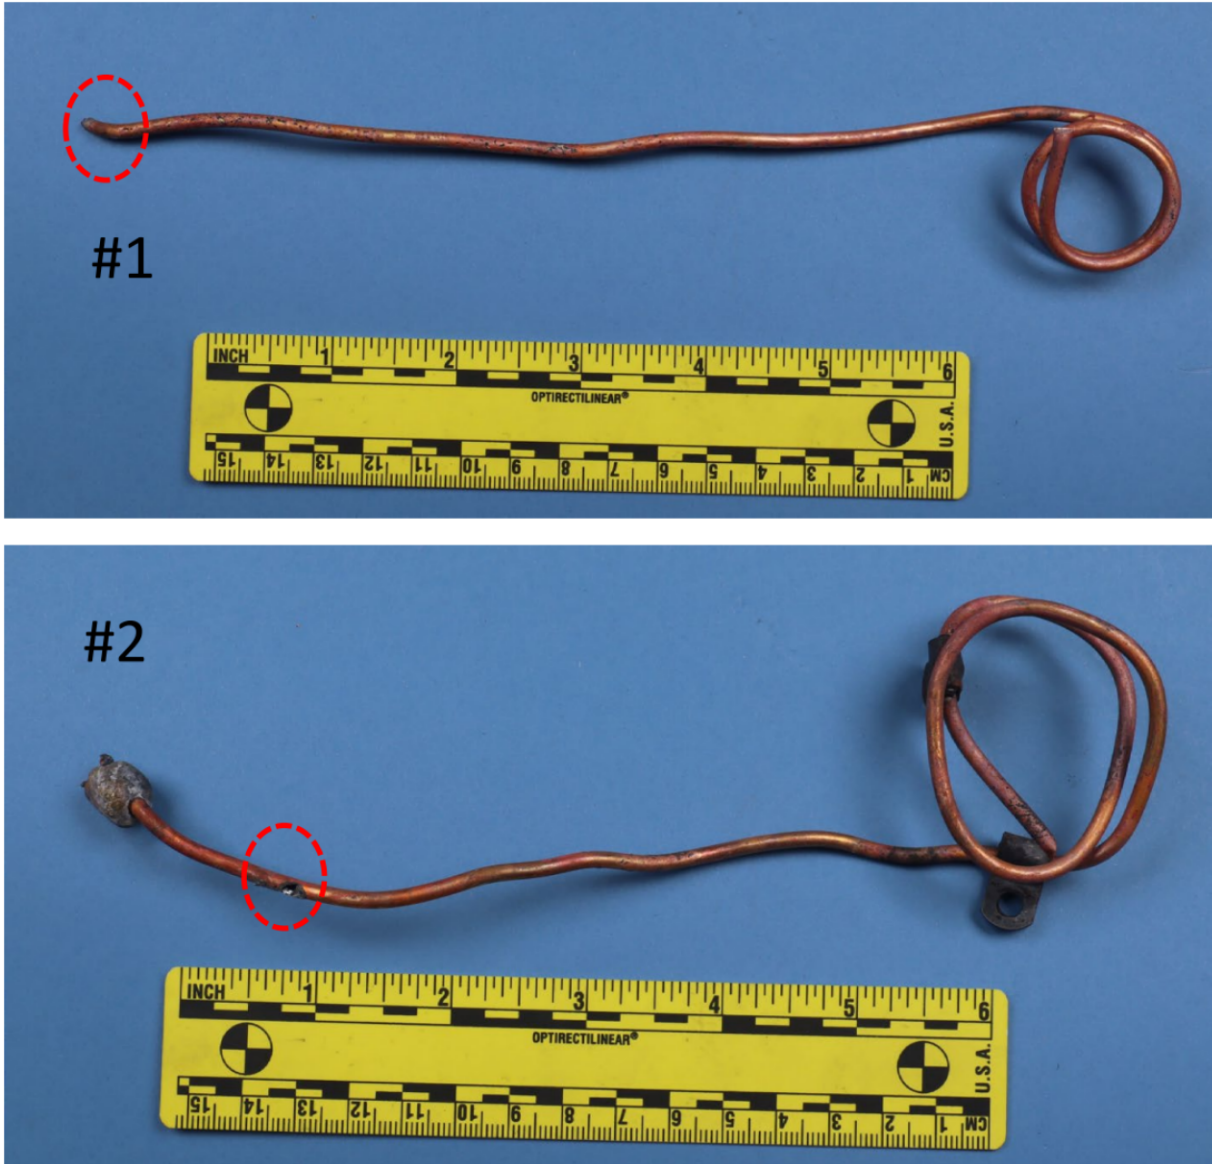
Additional examination revealed that the fuel primer lines comprised 99.6% copper tubing that measured about 0.125 inches in diameter. The lines could not be positively correlated to the suction and pressure sides of the pump. One of the lines exhibited a melted and tapered end. The other line exhibited areas of varying damage, including areas consistent with melting and re-solidification, as well as an area where the damage had penetrated the tubing through its full thickness. (See Figure 2.)

Figure 2. Localized melting of fuel primer lines

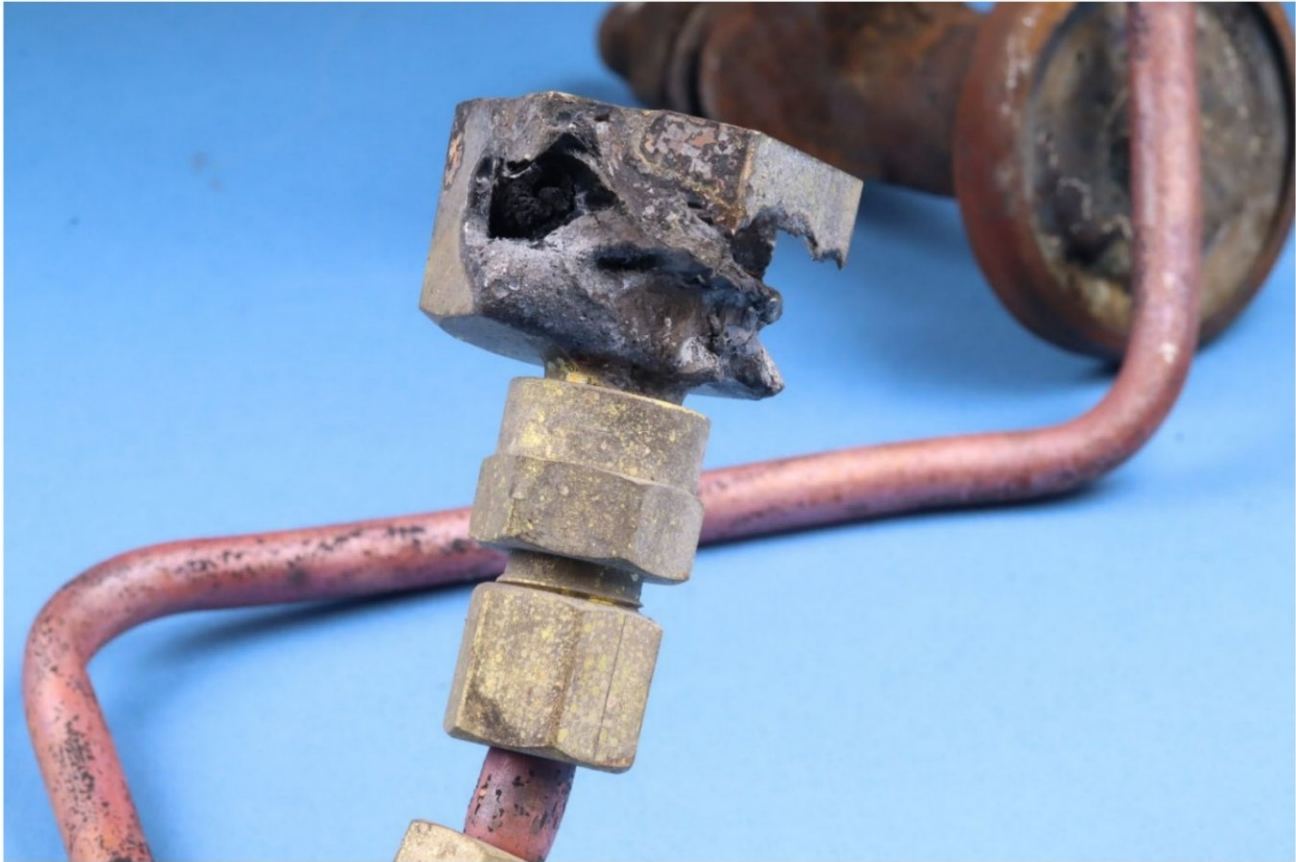
It is likely that an intermittent electrical short circuit took place involving the fitting on the end of the oil pressure indicating line. Repeated electrical arcing eventually compromised the fitting enough to allow oil leakage and eventual ignition of the leaking oil, which resulted in an in-flight fire.

The tee fitting exhibited a concentrated region of melted and missing material. In some areas, the melted region was flanked by intact material on either side. Some of the margins between the melted and intact material exhibited a scalloped-like appearance. (See Figure 3.) The morphology of the melting exhibited by the fitting was consistent with localized extreme temperature, such as that generated by electrical arcing. The tee fitting, branch line, and melted end fitting were not part of the original oil pressure line design, and what had been connected to the melted fitting was not determined.

Figure 3. Localized melting of oil pressure line tee fitting.
