# Aviation Investigation Final Report

<b>Location:</b>	Alcova, Wyoming	<b>Accident Number:</b>	WPR23FA137
<b>Date &amp; Time:</b>	March 21, 2023, 16:01 Local	<b>Registration:</b>	N314FR
<b>Aircraft:</b>	Cessna 182S	<b>Aircraft Damage:</b>	Substantial
<b>Defining Event:</b>	Loss of control in flight	<b>Injuries:</b>	1 Fatal
<b>Flight Conducted Under:</b>	Part 91: General aviation - Aerial observation

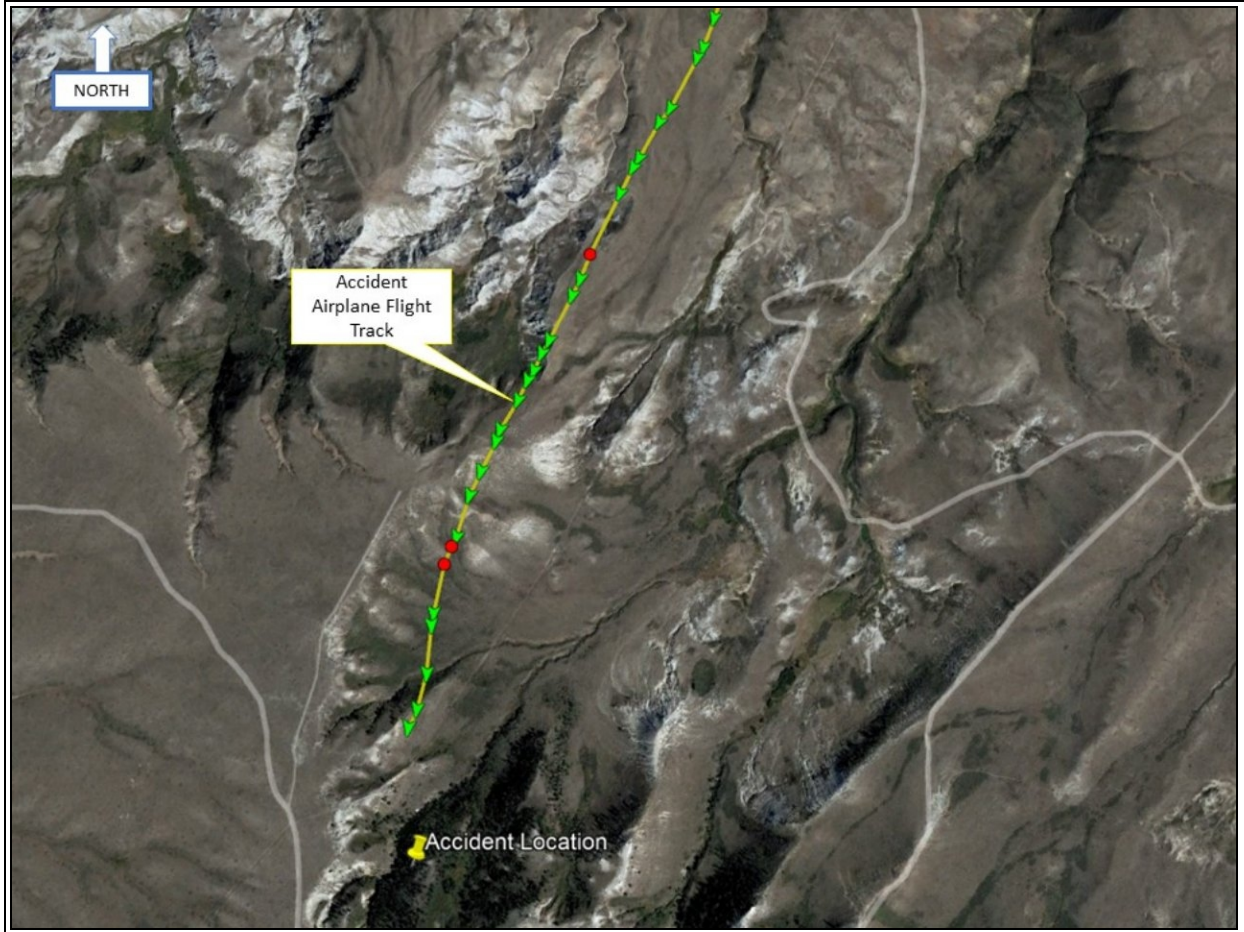
Recorded automatic dependent surveillance-broadcast (ADS-B) data showed that the accident airplane overflew Casper at 15:40:48 and turned to a southwest heading for about 30 miles until data was lost at 16:00:44, about 950 ft northwest of the accident site, as seen in Figure 1.

Figure 1. View of accident airplane ADS-B flight track data
