# Aviation Investigation Final Report

<b>Location:</b>	Nuevo, California	<b>Accident Number:</b>	ANC23FA031
<b>Date &amp; Time:</b>	March 24, 2023, 12:17 Local	<b>Registration:</b>	N14Z
<b>Aircraft:</b>	BELL HELICOPTER TEXTRON 407	<b>Aircraft Damage:</b>	Destroyed
<b>Defining Event:</b>	Low altitude operation/event	<b>Injuries:</b>	2 Fatal
<b>Flight Conducted Under:</b>	Part 91: General aviation - Personal

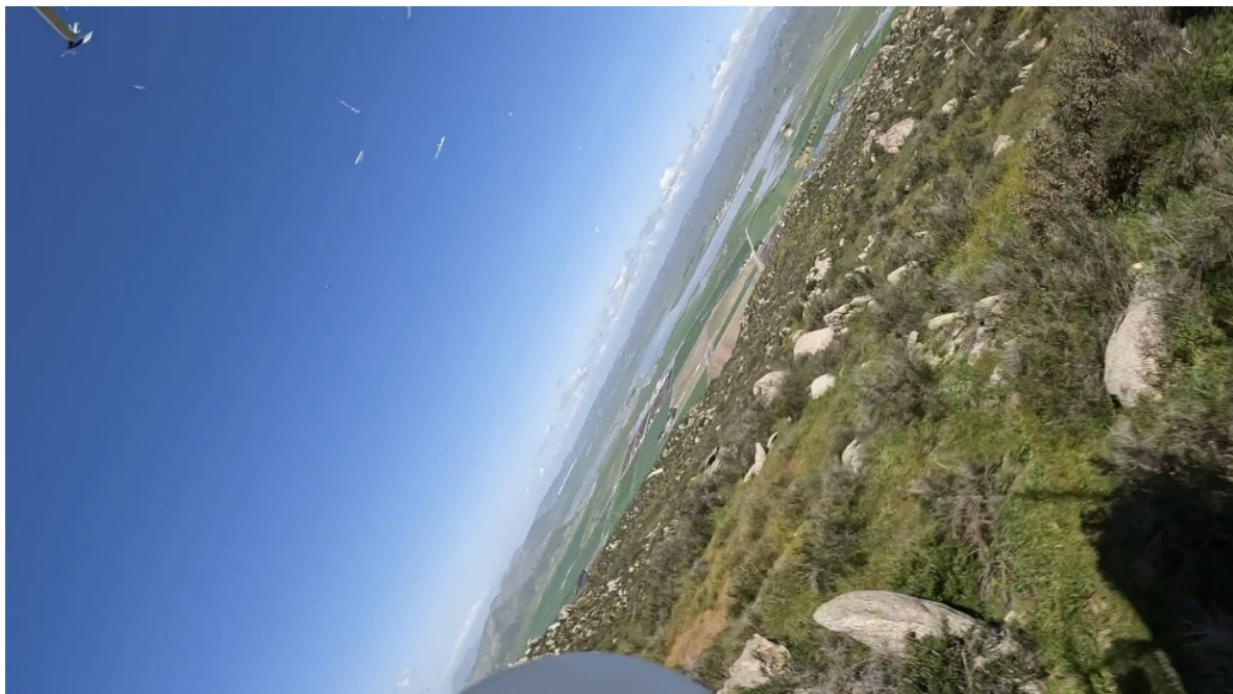
The pilot's decision to maneuver in a steep bank at a low altitude, which resulted in his failure to maintain clearance with terrain.

Moments later, as the helicopter passed over a rocky outcropping at the top of the hill, the main rotor blade contacted terrain and shards of main rotor blades can be seen on the video. See figure 2.

**Figure 2. Video frame from on board Go-Pro camera at point of impact, with portions of fragmented main rotor blade seen in upper left of photo.**
