# Aviation Investigation Final Report

<b>Location:</b>	Jesup, Georgia	<b>Accident Number:</b>	ERA23FA182
<b>Date &amp; Time:</b>	April 6, 2023, 07:50 Local	<b>Registration:</b>	N911TK
<b>Aircraft:</b>	CIRRUS DESIGN CORP SR22	<b>Aircraft Damage:</b>	Substantial
<b>Defining Event:</b>	Loss of control in flight	<b>Injuries:</b>	1 Fatal
<b>Flight Conducted Under:</b>	Part 91: General aviation - Personal

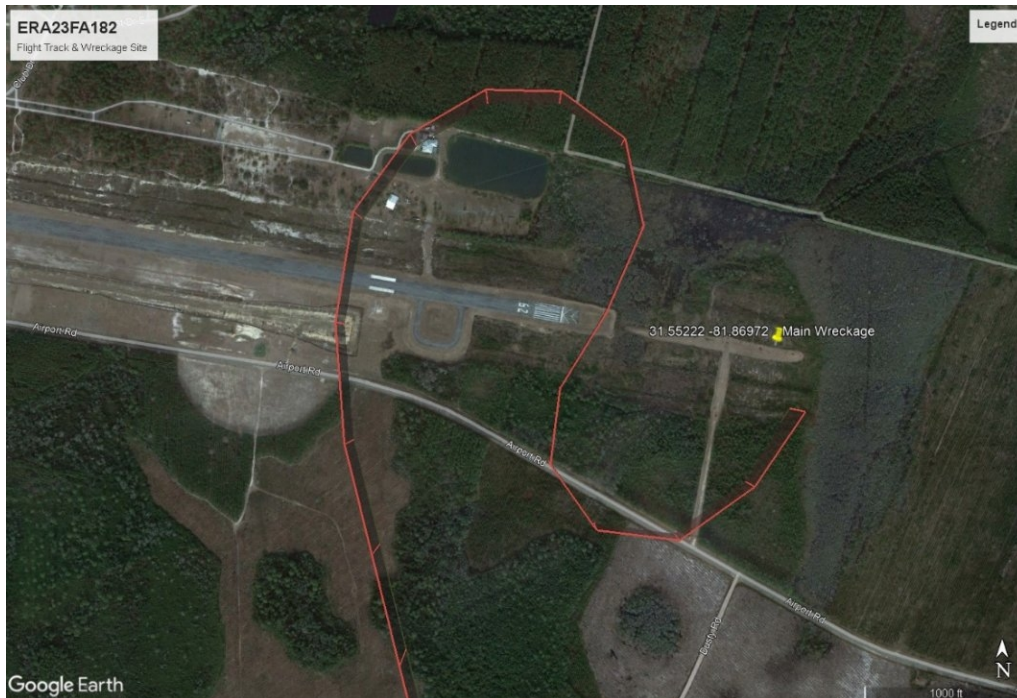
Figure 1 – Final Flight Track and Wreckage Location

According to recorded data from the airplane's primary flight display (PFD) and multi-function display (MFD), the airplane took off from Fernandina Beach Municipal Airport (FHB), Fernandina Beach, Florida, about 0728, climbed to about 1,800 ft, and flew to the north-northwest. About 0746, the airplane began descending. The pilot did not request any air traffic control services during the flight. As the airplane approached Jesup-Wayne County Airport (JES), Jesup, Georgia, from the south, it slowed to an indicated airspeed of about 75 knots (kts) and maintained this airspeed within  $\pm 5$  kts for the remainder of the recording. Track data showed that the airplane initially crossed over the approach end of runway 29 perpendicular to the runway heading (see Figure 1). At 07:50:03, the airplane began to roll right to an ultimate bank angle of about 40° at 07:50:37, and then immediately rolled left to 40°. The airplane subsequently began to roll slightly back towards wings level before it rolled left and pitched down. The MFD stopped recording at 07:51:00, and the PFD stopped recording at 07:51:09.

There was a published RNAV GPS approach to runway 29; however, the airplane’s recorded flight track was inconsistent with that instrument approach procedure. The lowest weather minimums for the approach required at least one mile visibility.
