Aviation Investigation Final Report

| Location: | Morgan, Utah | Accident Number: | WPR23LA149 |
| Date & Time: | April 8, 2023, 19:37 Local | Registration: | N17NK |
| Aircraft: | STEVENS KELLY C RV-7 | Aircraft Damage: | Substantial |

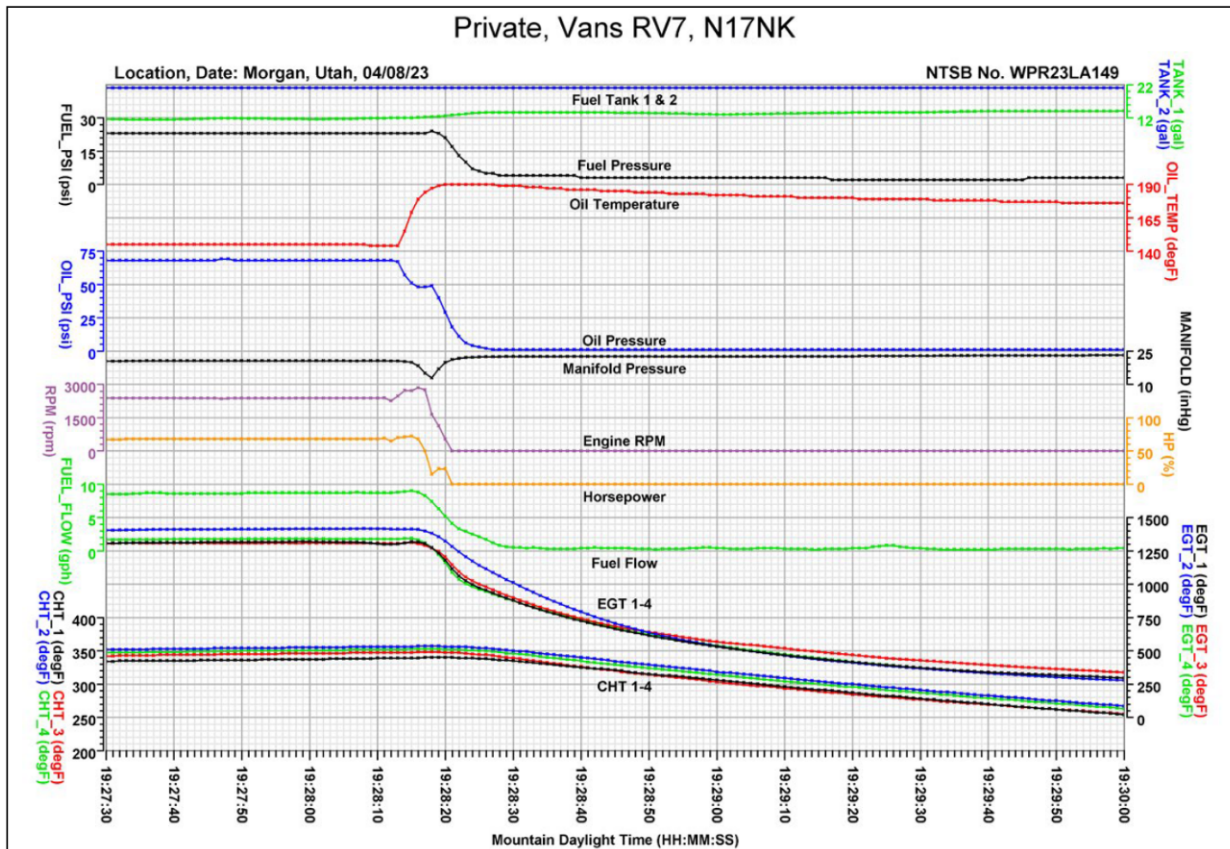
Data retrieved from two panel mounted flight displays revealed the cylinder head temperature, exhaust gas temperature, oil temperature, oil pressure, fuel pressure, and rpm were consistent with normal engine operation until 19:28:15. Between 19:28:15 and 19:28:18, engine rpm increased from about 2,300 rpm to 2,841 rpm before decreasing to 0 rpm 2 seconds later, as seen in Figure 1.

Figure 1: A portion of recorded engine data.
