Aviation Investigation Final Report

Location:	Climax, North Carolina	Accident Number:	ERA23FA188
Date & Time:	April 11, 2023, 11:32 Local	Registration:	N543GM
Aircraft:	MILLER GLENN F RV-12	Aircraft Damage:	Destroyed
Defining Event:	Loss of engine power (partial)	Injuries:	1 Fatal, 1 Serious
Flight Conducted Under:	Part 91: General aviation - Flight test

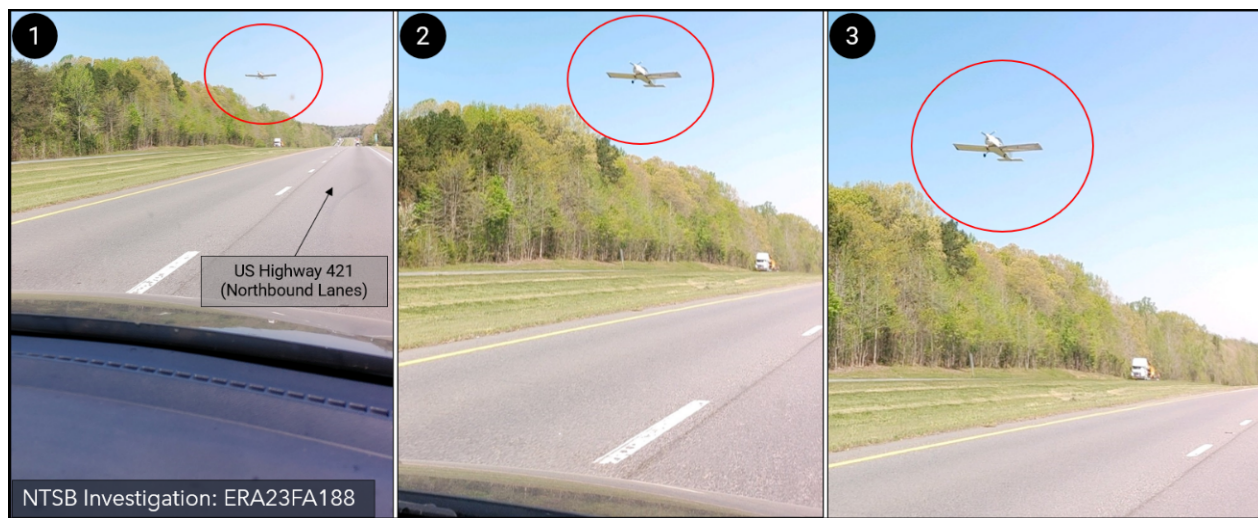
The witness provided three photographs from her position on the northbound lanes of the highway, which shows the airplane low over the highway about 500 ft from the overpass (see figure 1).

Figure 1 - Witness provided photographs of the airplane flying low over the highway about 500 ft from the overpass bridge.

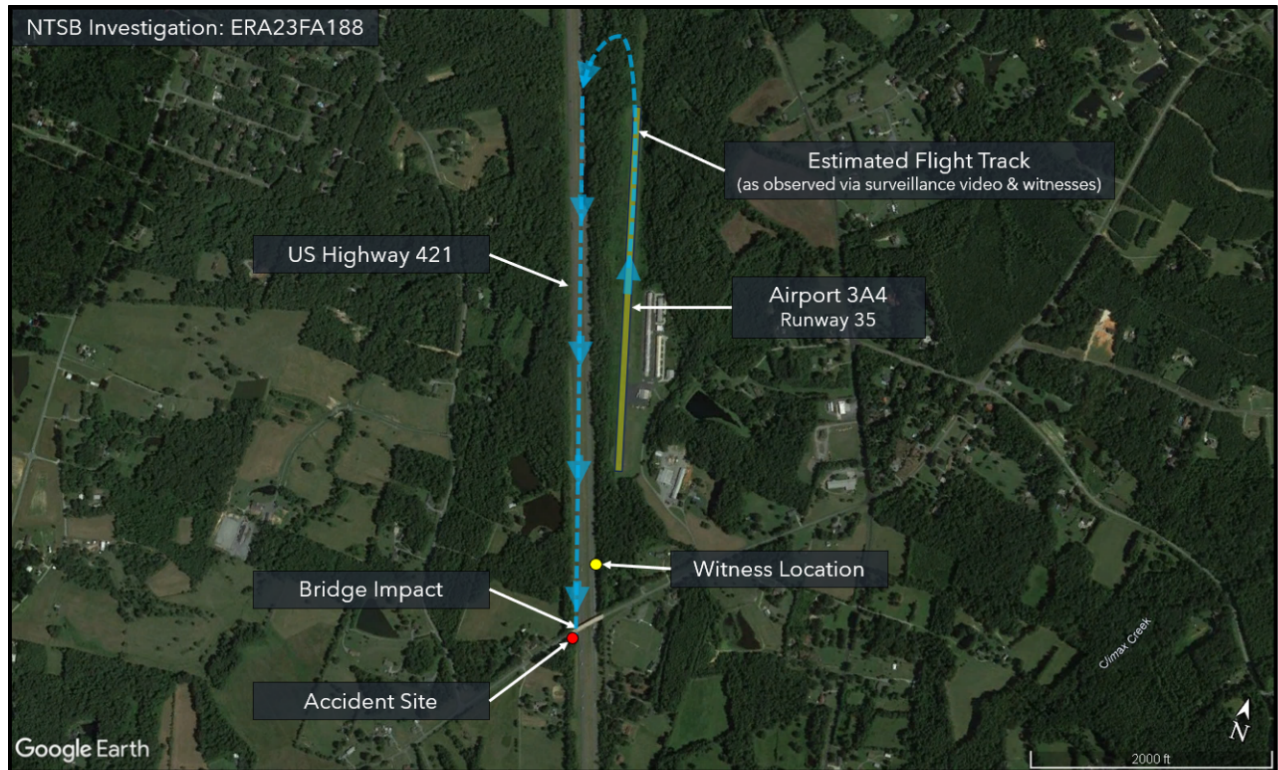
Figure 2 below provides an overview of the estimated flight track of the airplane as reported by the surviving pilot, surveillance video, and witnesses. The total distance the airplane traveled over the highway, from abeam the north end of runway 35 to the overpass, was about 4,300 ft. US Highway 421 was a 4-lane highway with a sloping grass median that was about 60 ft wide. Photographs reviewed at the time of the accident and witness reports found that the traffic was not heavy in either direction.

Figure 2 - Overview of the airplane's estimated flight track, witness location, and accident site.

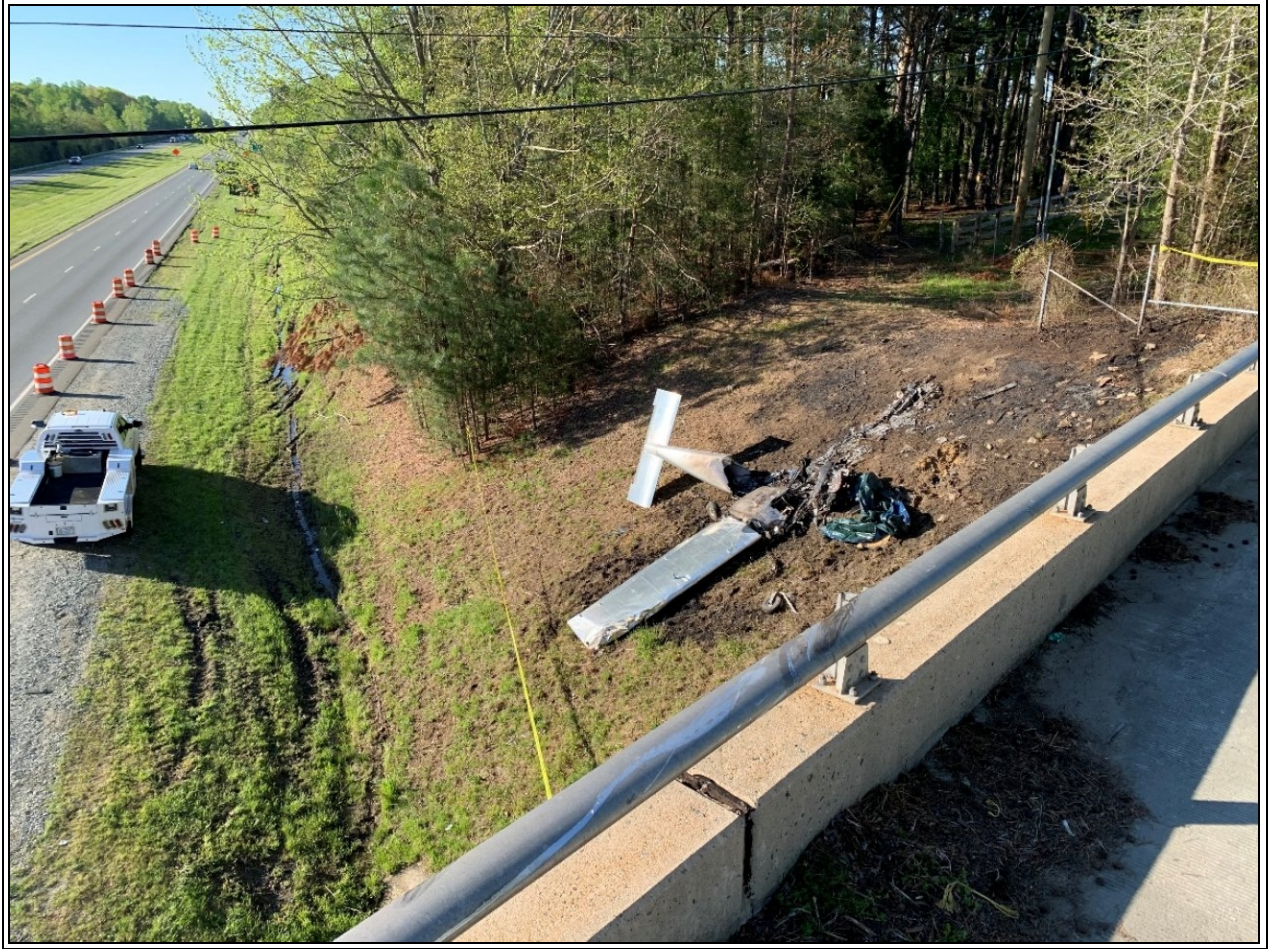
Flight control continuity was confirmed from the cockpit to the rudder and elevator surfaces. Multiple breaks consistent with impact-related forces and severe thermal damage were observed within the aileron control push-pull rods. All cockpit switches, instrumentation, the center fuel tank, and non-volatile memory were destroyed by the postimpact fire (see figure 3).

Figure 3 - Overview of the accident site as viewed from the overpass the airplane impacted. Note the powerlines above the overpass, which spanned across the entire highway from east to west.

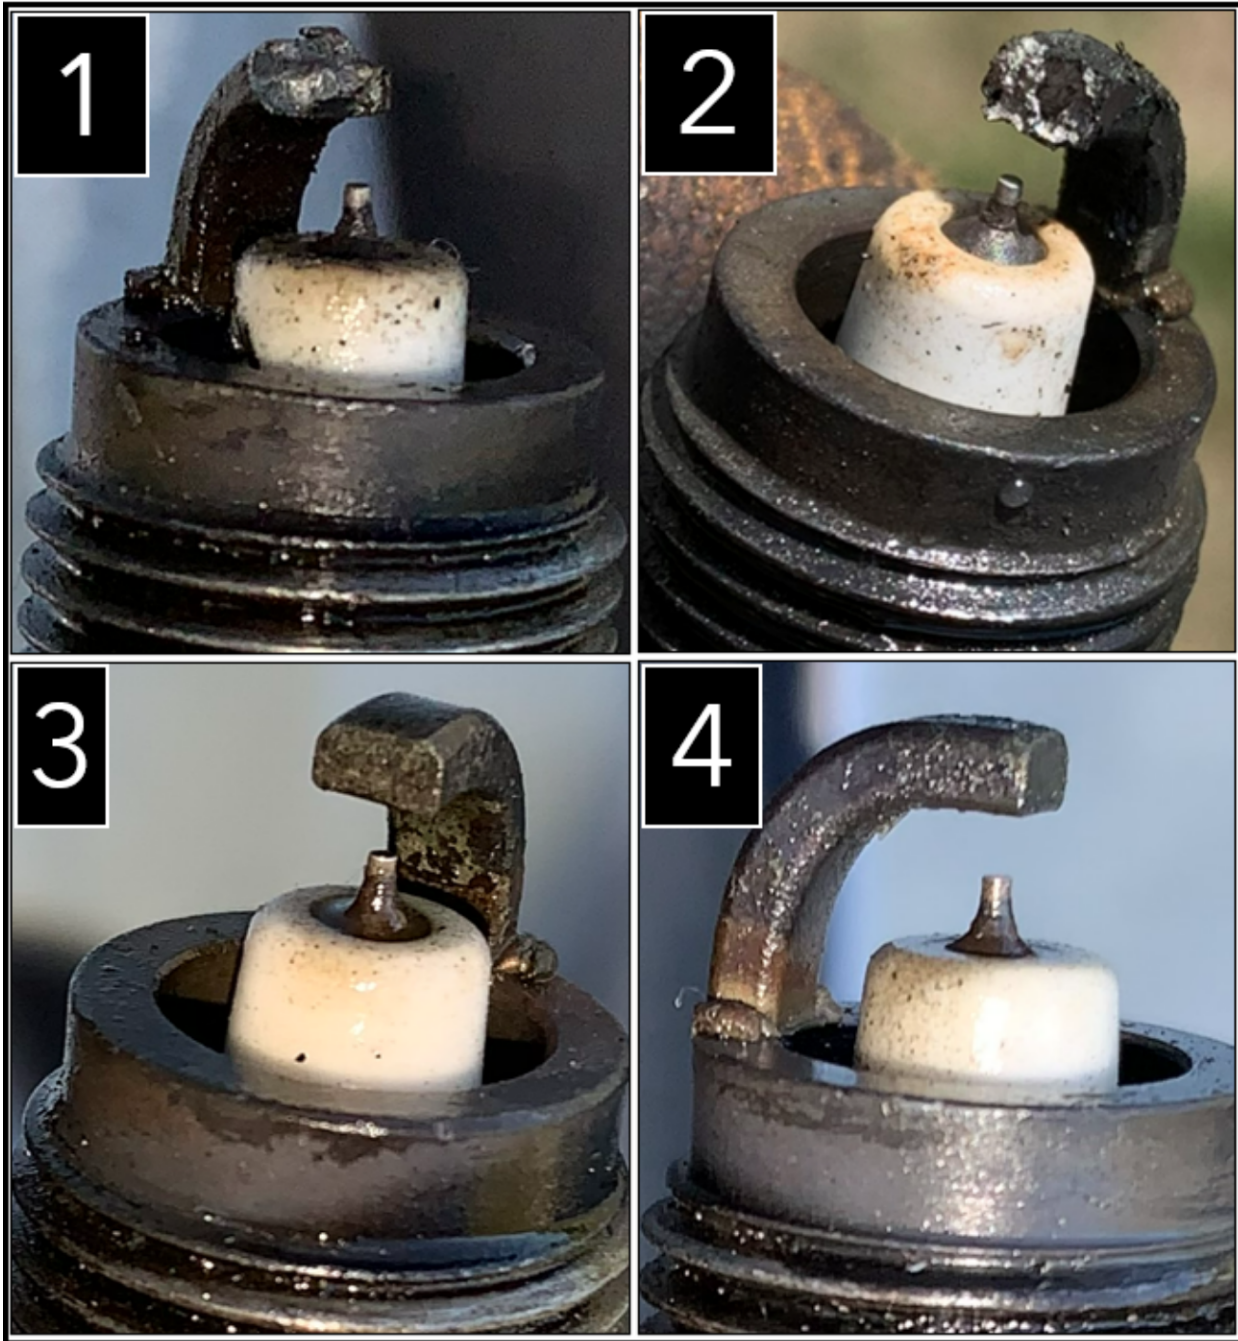
Examination of the engine found that the Nos. 1 and 2 cylinder spark plug electrode tips were obliterated. The Nos. 3 and 4 cylinder spark plug electrode tips remained intact, but were found blackened. There was no evidence that any of the spark plugs had sustained impact-related damage. A bench test of the spark plugs found that the Nos. 1 and 2 plugs would produce a spark at low compression, but would extinguish under the higher compression levels produced during normal engine operation. The Nos. 3 and 4 cylinder spark plugs produced normal spark at the bench test's maximum compression. It is likely that the partial loss of engine power was due to the damaged Nos. 1 and 2 spark plug electrode tips.

The airplane owner/builder's inappropriate use of a lower grade fuel than that required by the airplane and engine operations manual, which resulted in engine detonation and the degradation and eventual obliteration of the Nos. 1 and 2 cylinder spark plug electrode tips. Contributing to the outcome was the pilots' decision to continue flight at low altitude following a partial loss of engine power instead of performing an immediate precautionary landing, which resulted in collision with an overpass and terrain.

The NGK brand iridium spark plugs were found securely installed and were free of impact damage. When the spark plugs were removed and examined, the Nos. 1 and 2 cylinder spark plug ground electrode tips were found obliterated and the remainder of the electrodes on both spark plugs exhibited blackening. The Nos. 3 and 4 cylinder spark plugs were blackened; however, their electrode tips remained intact.

The Nos. 1 and 2 spark plugs exhibited a spark around 60 to 70 psi, but with compression at 70 to 80 psi both spark plugs would immediately lose their continuous spark and would extinguish.

The Nos. 3 and 4 spark plugs operated normally and produced a continuous spark throughout a range of low pressure up to 80 psi. Figure 4 provides an overview of the spark plug electrodes.

Figure 4: View of the spark plug electrode tips. Note the Nos. 1 and 2 cylinder spark plug tips were found obliterated.

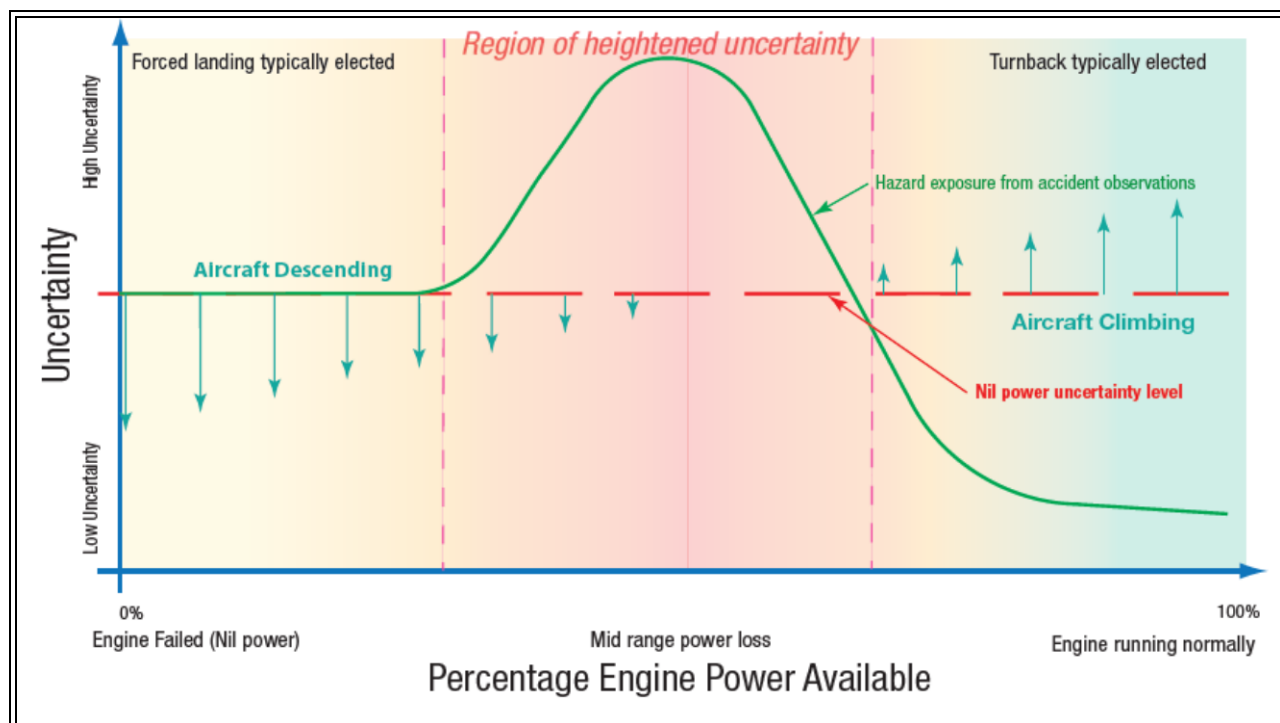
The research also provided a figure that shows the conceptual hazard following a partial loss of engine power after takeoff, drawn from the findings of ATSB fatal accident investigations. When the amount of power lost is close to that experienced with a complete loss, the pilot is likely to identify the severity of the situation readily and take action similar to that expected for a total power loss. At the other end of the spectrum, where the remaining engine power allows the aircraft to climb, more options are available to the pilot, such as climbing slowly into the airport traffic pattern or carefully turning back to the airport, while maintaining glide-speed and height. The region of heightened uncertainty is most prevalent with a mid-range power loss.

Figure 5 - Partial Loss of Engine Power Regions of Uncertainty Chart (ATSB Research, Canberra, 2013)
