Aviation Investigation Final Report

| Location: | Climax, North Carolina | Accident Number: | ERA23FA188 |
| Date & Time: | April 11, 2023, 11:32 Local | Registration: | N543GM |
| Aircraft: | MILLER GLENN F RV-12 | Aircraft Damage: | Destroyed |

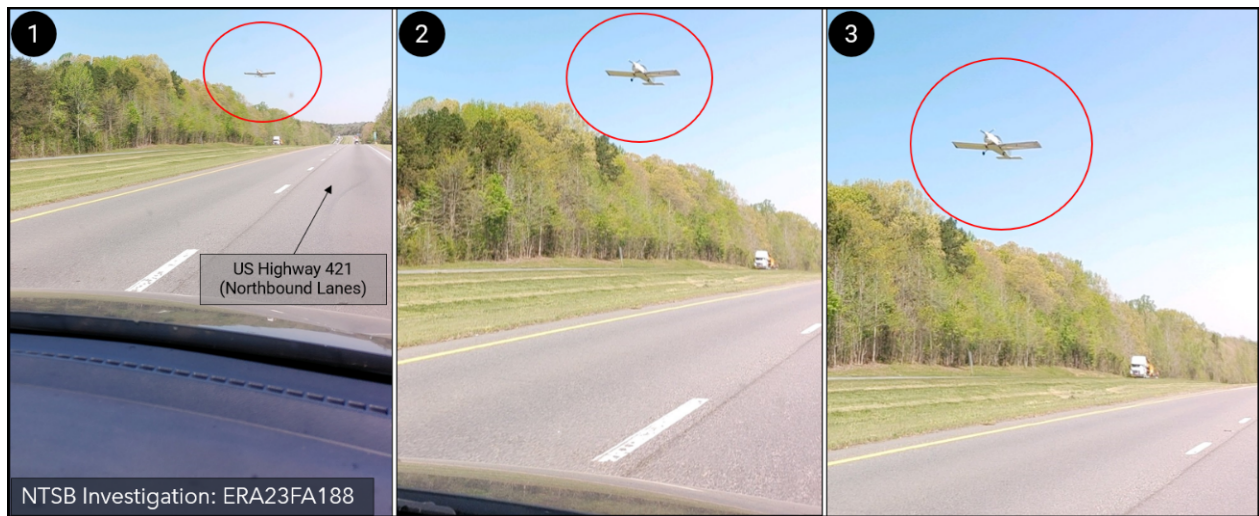
The witness provided three photographs from her position on the northbound lanes of the highway, which shows the airplane low over the highway about 500 ft from the overpass (see figure 1).

Figure 1 - Witness provided photographs of the airplane flying low over the highway about 500 ft from the overpass bridge.

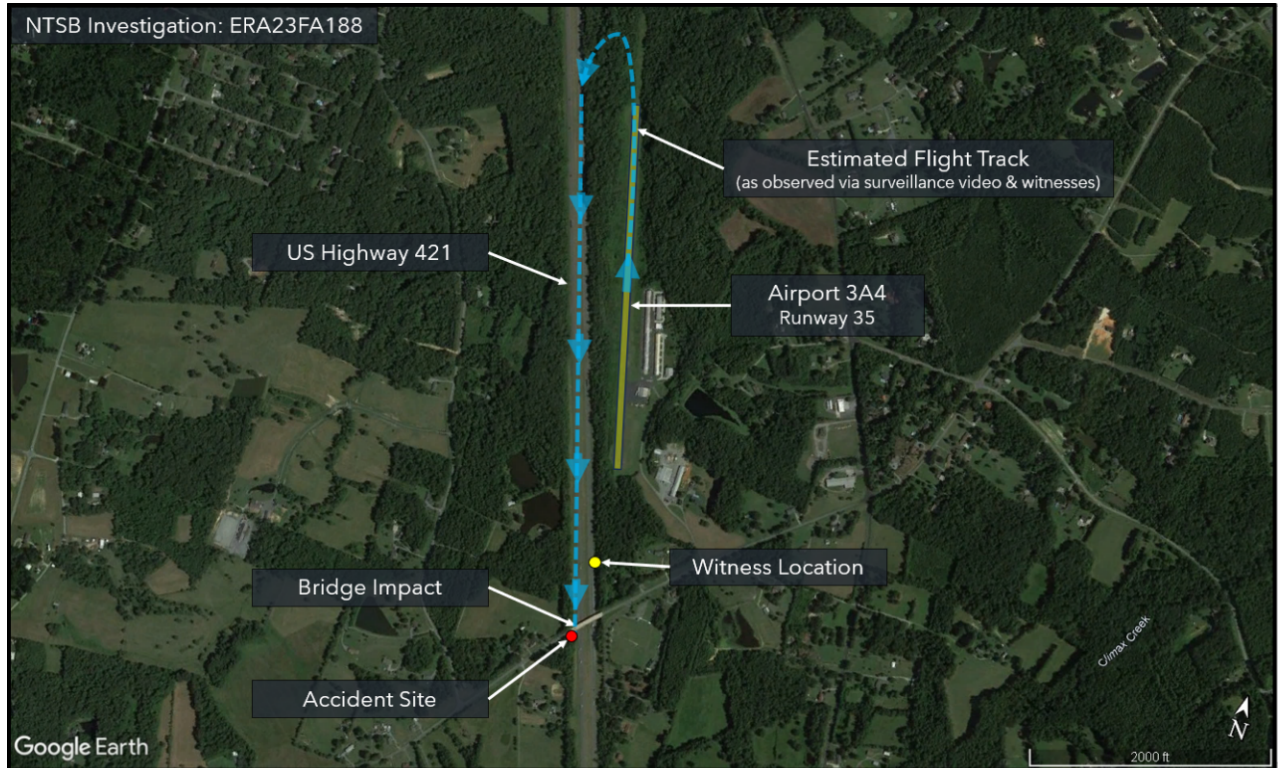
Figure 2 below provides an overview of the estimated flight track of the airplane as reported by the surviving pilot, surveillance video, and witnesses. The total distance the airplane traveled over the highway, from abeam the north end of runway 35 to the overpass, was about 4,300 ft. US Highway 421 was a 4-lane highway with a sloping grass median that was about 60 ft wide. Photographs reviewed at the time of the accident and witness reports found that the traffic was not heavy in either direction.

Figure 2 - Overview of the airplane's estimated flight track, witness location, and accident site.

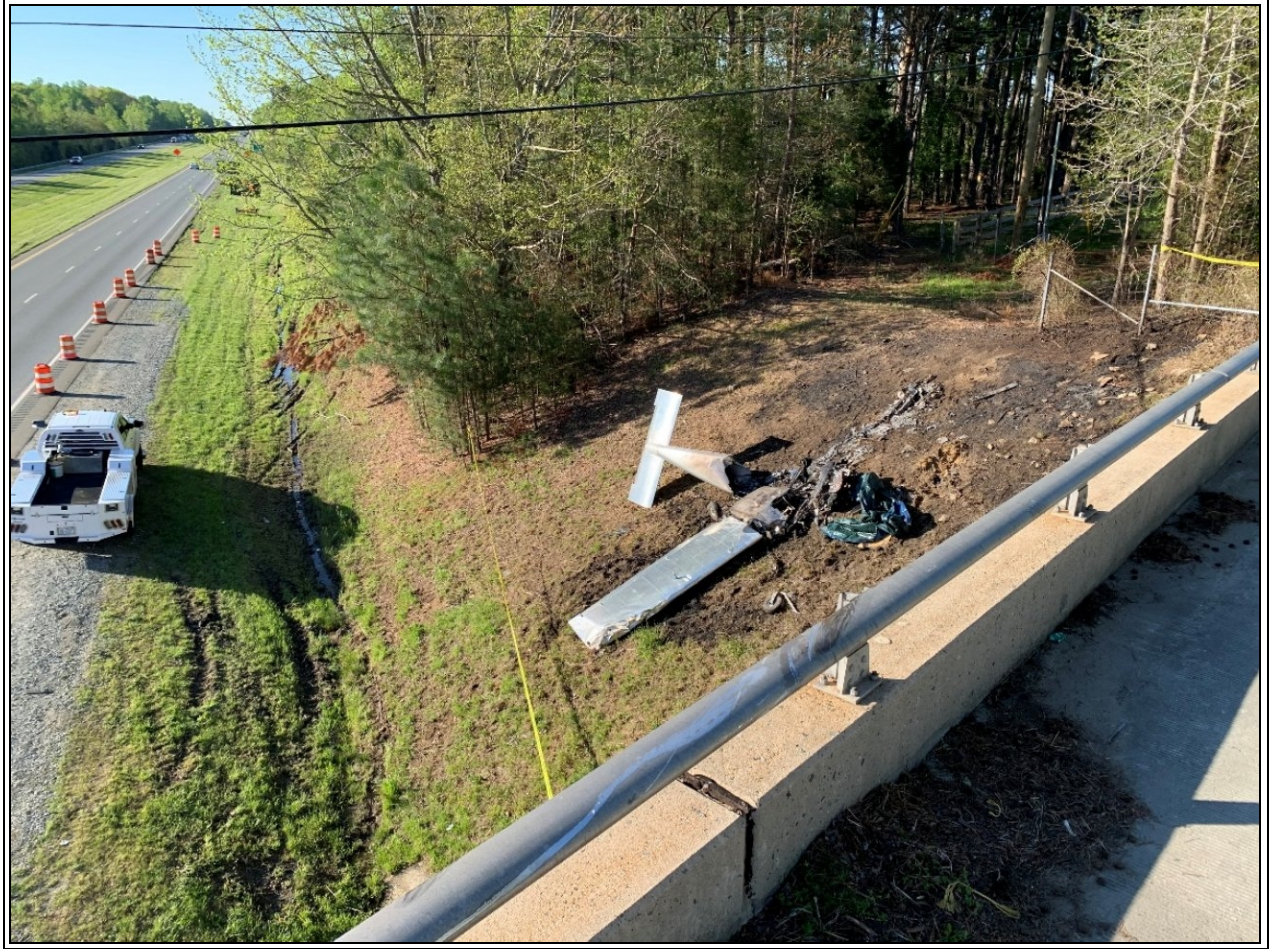
Flight control continuity was confirmed from the cockpit to the rudder and elevator surfaces. Multiple breaks consistent with impact-related forces and severe thermal damage were observed within the aileron control push-pull rods. All cockpit switches, instrumentation, the center fuel tank, and non-volatile memory were destroyed by the postimpact fire (see figure 3).

Figure 3 - Overview of the accident site as viewed from the overpass the airplane impacted. Note the powerlines above the overpass, which spanned across the entire highway from east to west.

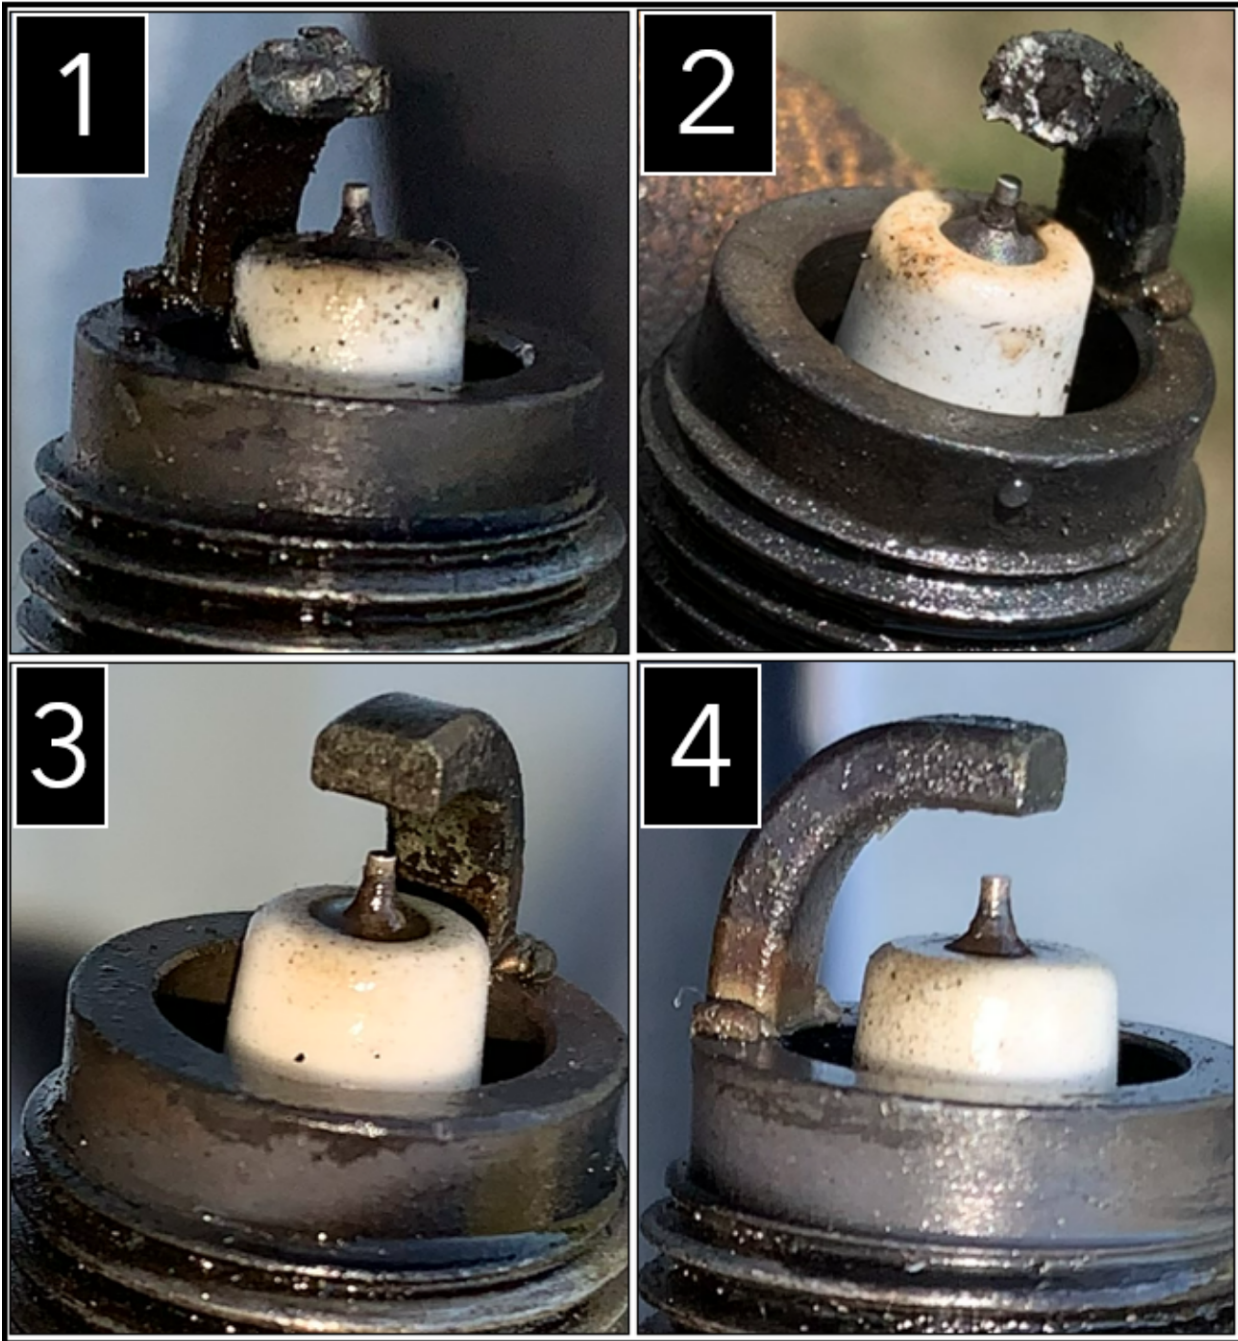
Examination of the engine found that the Nos. 1 and 2 cylinder spark plug electrode tips were obliterated. The Nos. 3 and 4 cylinder spark plug electrode tips remained intact, but were found blackened. There was no evidence that any of the spark plugs had sustained impact-related damage. A bench test of the spark plugs found that the Nos. 1 and 2 plugs would produce a spark at low compression, but would extinguish under the higher compression levels produced during normal engine operation. The Nos. 3 and 4 cylinder spark plugs produced normal spark at the bench test's maximum compression. It is likely that the partial loss of engine power was due to the damaged Nos. 1 and 2 spark plug electrode tips.

The airplane owner/builder's inappropriate use of a lower grade fuel than that required by the airplane and engine operations manual, which resulted in engine detonation and the degradation and eventual obliteration of the Nos. 1 and 2 cylinder spark plug electrode tips. Contributing to the outcome was the pilots' decision to continue flight at low altitude following a partial loss of engine power instead of performing an immediate precautionary landing, which resulted in collision with an overpass and terrain.

The NGK brand iridium spark plugs were found securely installed and were free of impact damage. When the spark plugs were removed and examined, the Nos. 1 and 2 cylinder spark plug ground electrode tips were found obliterated and the remainder of the electrodes on both spark plugs exhibited blackening. The Nos. 3 and 4 cylinder spark plugs were blackened; however, their electrode tips remained intact.

The Nos. 1 and 2 spark plugs exhibited a spark around 60 to 70 psi, but with compression at 70 to 80 psi both spark plugs would immediately lose their continuous spark and would extinguish.

The Nos. 3 and 4 spark plugs operated normally and produced a continuous spark throughout a range of low pressure up to 80 psi. Figure 4 provides an overview of the spark plug electrodes.

Figure 4: View of the spark plug electrode tips. Note the Nos. 1 and 2 cylinder spark plug tips were found obliterated.

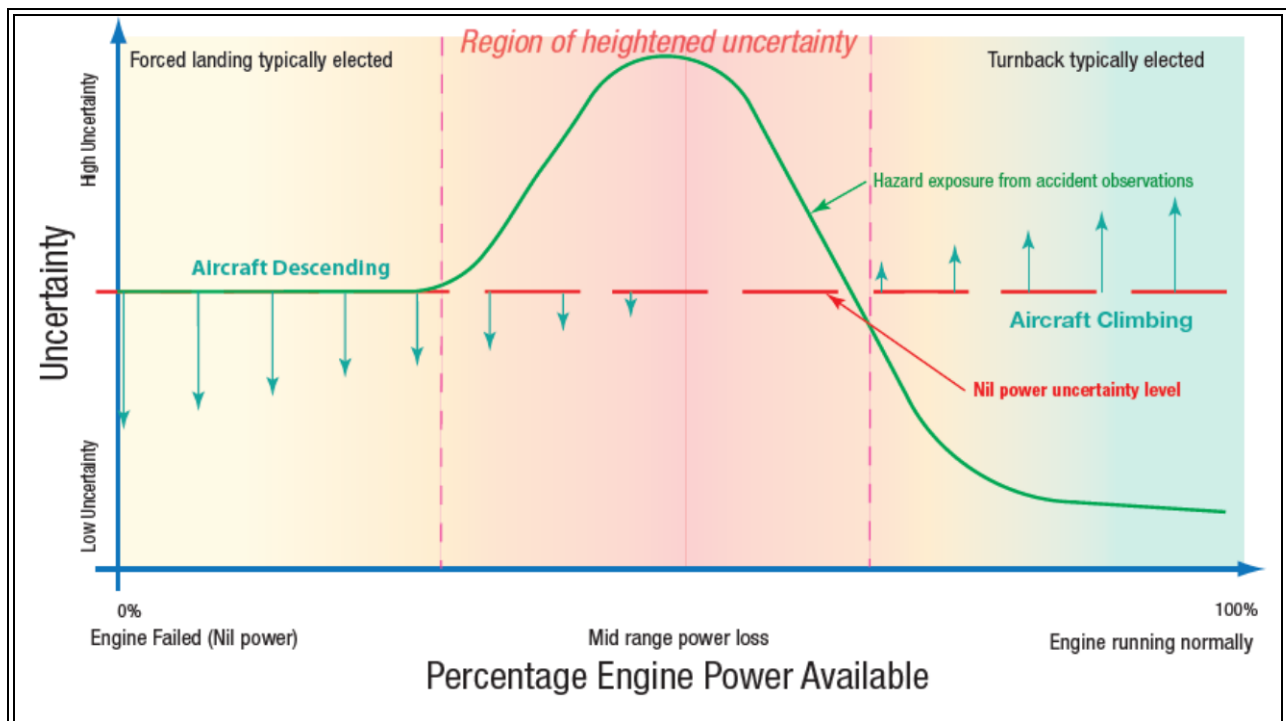
The research also provided a figure that shows the conceptual hazard following a partial loss of engine power after takeoff, drawn from the findings of ATSB fatal accident investigations. When the amount of power lost is close to that experienced with a complete loss, the pilot is likely to identify the severity of the situation readily and take action similar to that expected for a total power loss. At the other end of the spectrum, where the remaining engine power allows the aircraft to climb, more options are available to the pilot, such as climbing slowly into the airport traffic pattern or carefully turning back to the airport, while maintaining glide-speed and height. The region of heightened uncertainty is most prevalent with a mid-range power loss.

Figure 5 - Partial Loss of Engine Power Regions of Uncertainty Chart (ATSB Research, Canberra, 2013)
