# Aviation Investigation Final Report

<b>Location:</b>	Lewisville, Arkansas	<b>Accident Number:</b>	CEN23FA167
<b>Date &amp; Time:</b>	April 30, 2023, 17:00 Local	<b>Registration:</b>	N31311
<b>Aircraft:</b>	Titan TORNADO	<b>Aircraft Damage:</b>	Destroyed
<b>Defining Event:</b>	Loss of control in flight	<b>Injuries:</b>	1 Fatal
<b>Flight Conducted Under:</b>	Part 91: General aviation - Personal

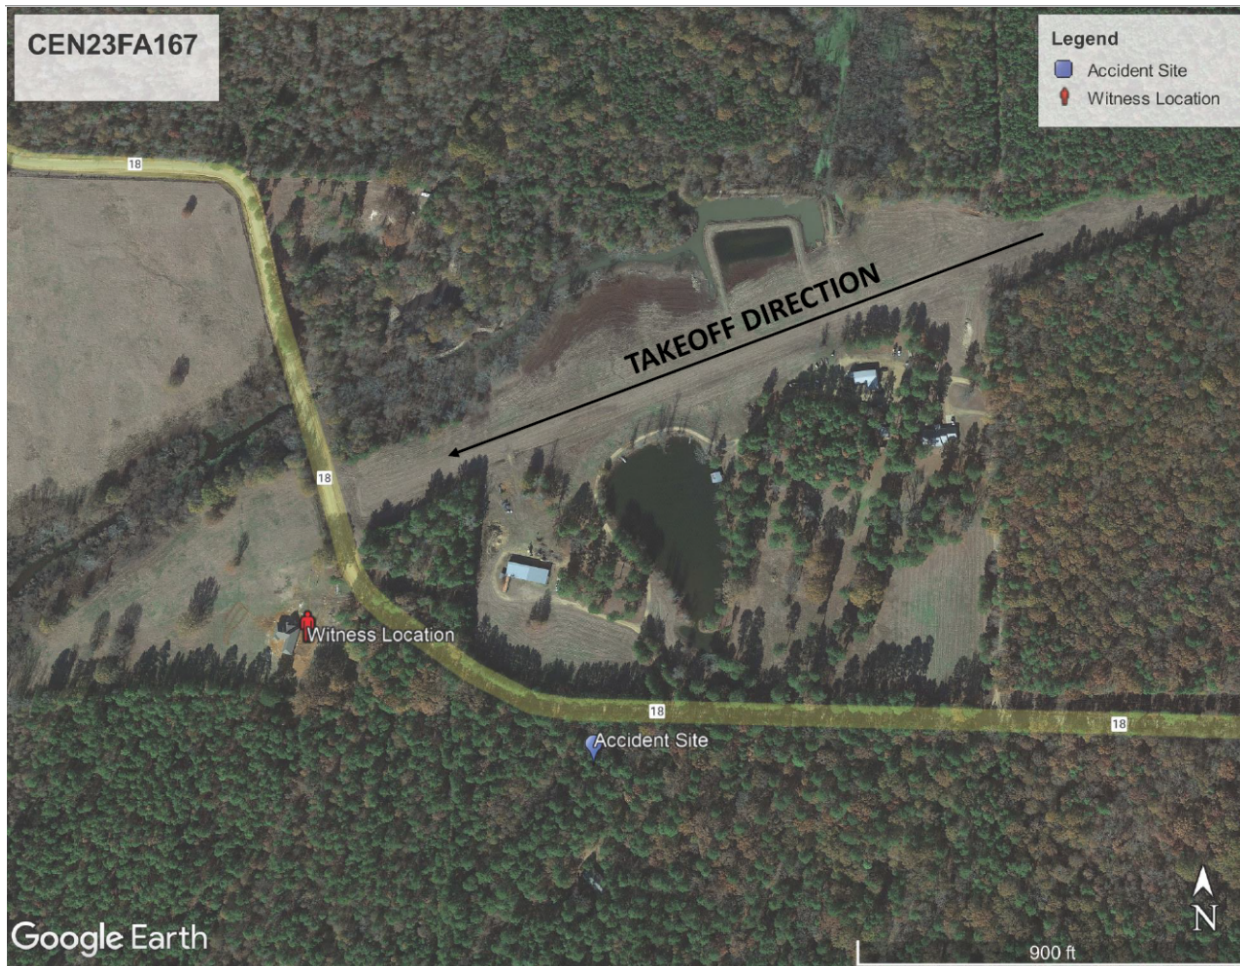
A witness, located at her residence near the departure end of the runway, reported that the first two airplanes appeared to depart normally before the accident airplane's departure. During the accident airplane's departure, the witness thought the airplane would impact a tree in her yard when it banked to the left at a low altitude, but the airplane impacted trees southeast of her residence (See Figure 1).

1. Accident site overview.

The main wreckage was located in a flat, wooded marsh south of the private airstrip. All major components of the airplane were accounted for at the accident site. The right wing separated from the fuselage when it impacted a tree about 80 ft from where the main wreckage came to rest on its right side. The left wing remained partially attached to the fuselage.
