# Aviation Investigation Final Report

<b>Location:</b>	Coldspring, Texas	<b>Accident Number:</b>	CEN23LA172
<b>Date &amp; Time:</b>	May 3, 2023, 13:29 Local	<b>Registration:</b>	N28HE
<b>Aircraft:</b>	Piper PA-34-200	<b>Aircraft Damage:</b>	Substantial
<b>Defining Event:</b>	Flight control sys malf/fail	<b>Injuries:</b>	2 Serious
<b>Flight Conducted Under:</b>	Part 91: General aviation - Instructional

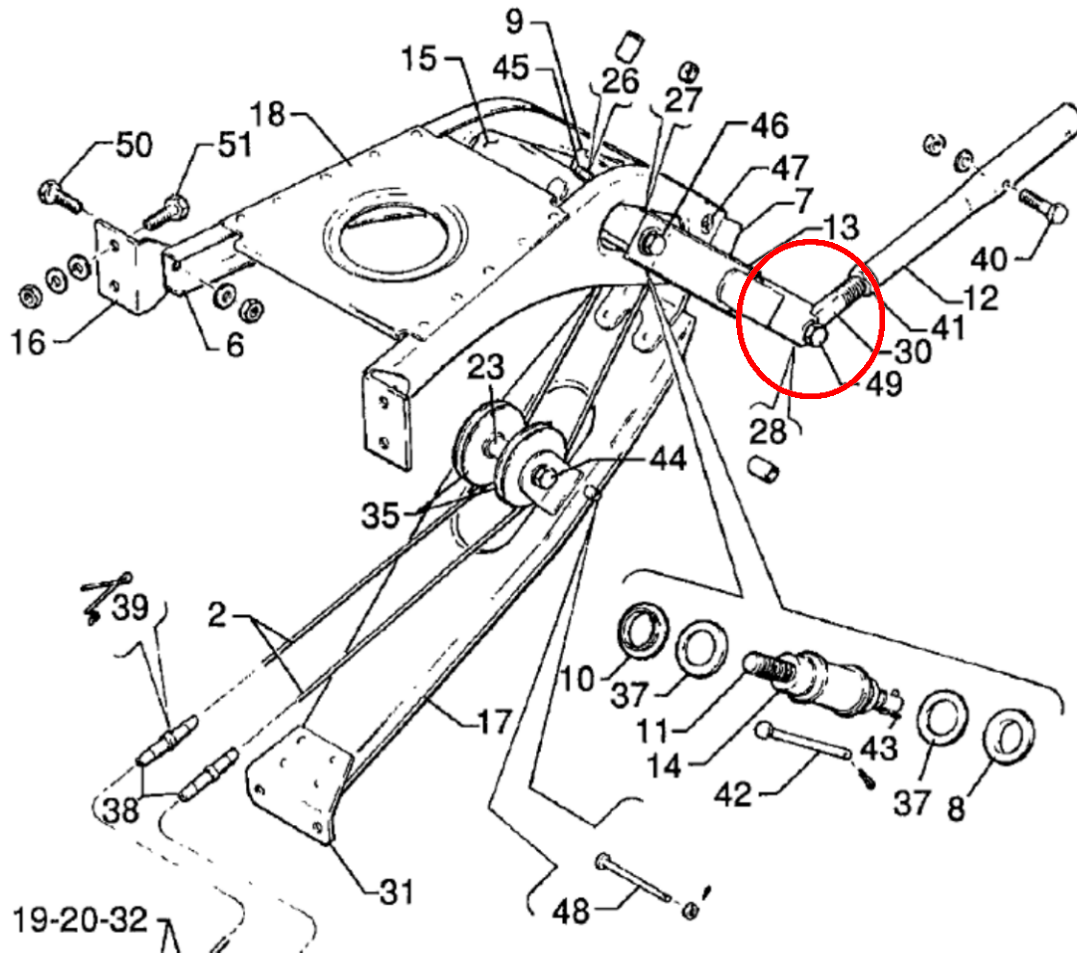
Figure 1. Illustrated Parts Catalog (Part Nos. 753-816)

A postaccident examination revealed that the bolt (item 49 in figure 1) which connects the stabilator trim rod assembly (item 12) to the stabilator link assembly (item 13) was missing. (Figure 2)

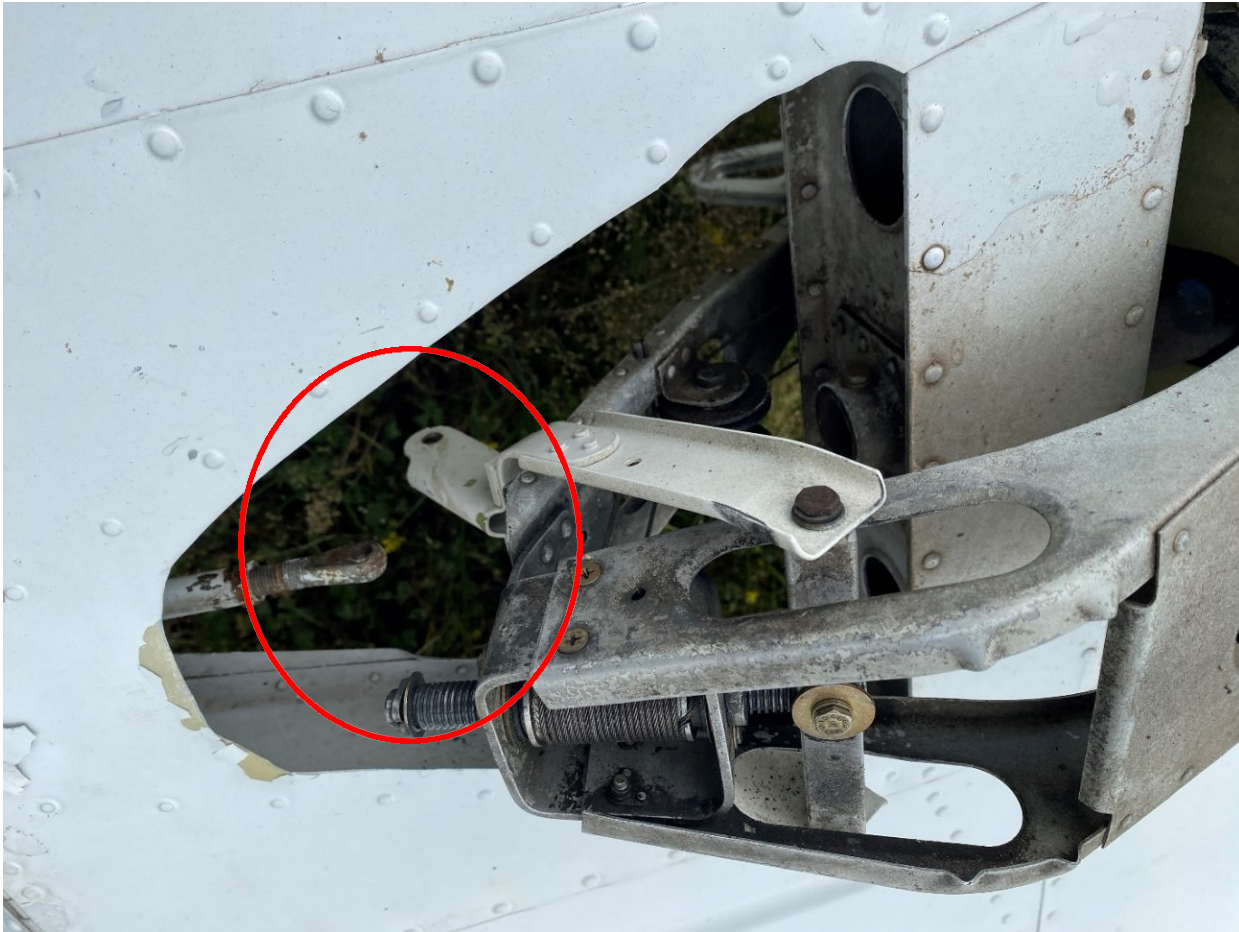
A postaccident examination revealed that the bolt that connects the stabilator trim rod assembly to the stabilator link assembly was missing and not located.

Since the bolt was not recovered, the reason for the separation could not be determined. Without being able to determine the reason for the separation, the flight school proactively inspected all same model airplanes in their fleet and replaced the bolt on each of them.

The stabilator trim rod assembly separated from the stabilator link assembly due to a missing connecting bolt, which resulted in the pilot's inability to maintain pitch control of the airplane.

Figure 2. Photo of the stabilator trim assembly (Photo courtesy of the FAA)

Following the accident, the flight school inspected all PA-34 airplanes in their fleet and replaced the affected bolt on each airplane.
