Aviation Investigation Final Report

Location:	Creswell, Oregon	Accident Number:	WPR23LA184
Date & Time:	May 9, 2023, 17:50 Local	Registration:	N468MM
Aircraft:	RANS S-21	Aircraft Damage:	Substantial
Defining Event:	Loss of engine power (total)	Injuries:	1 None
Flight Conducted Under:	Part 91: General aviation - Personal

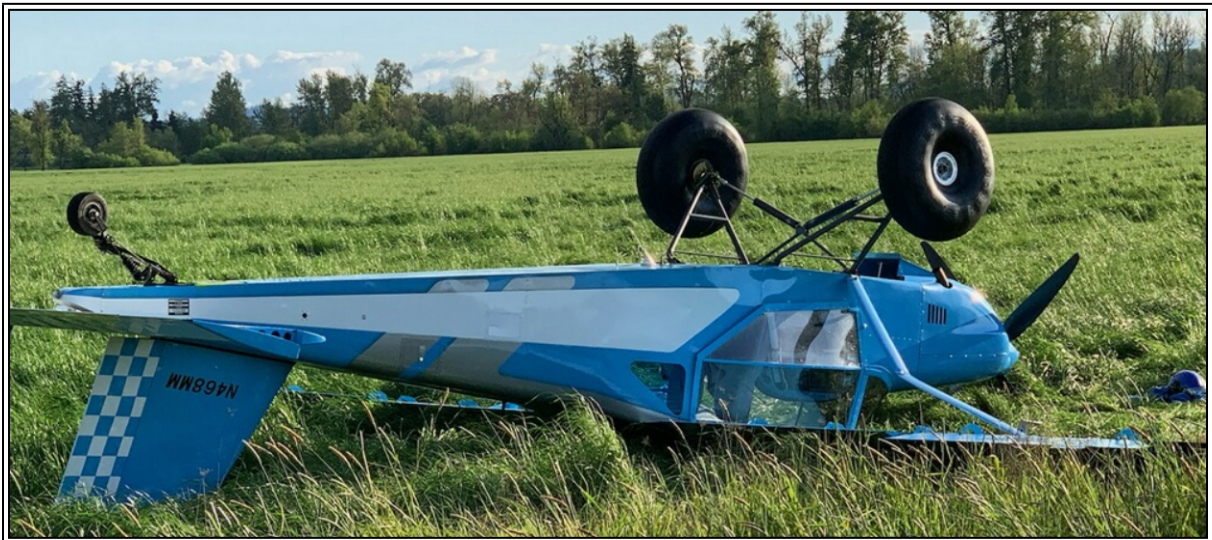
Figure 1: Wreckage

The pilot and his son had recently finished building the airplane. The accident flight was one of a series of test flights the pilot was performing after making cowling modifications. After a normal departure, the pilot flew to a test area and was in flight for about 20 minutes. While the pilot was maneuvering at about 700-900 feet above ground level (agl), the engine made “rough” sounds and vibrated. About 20 seconds later, the propeller seized, and the pilot made a forced landing in the field below. During landing roll out, the airplane flipped over and came to rest inverted, damaging the vertical stabilizer (see Figure 1 below).

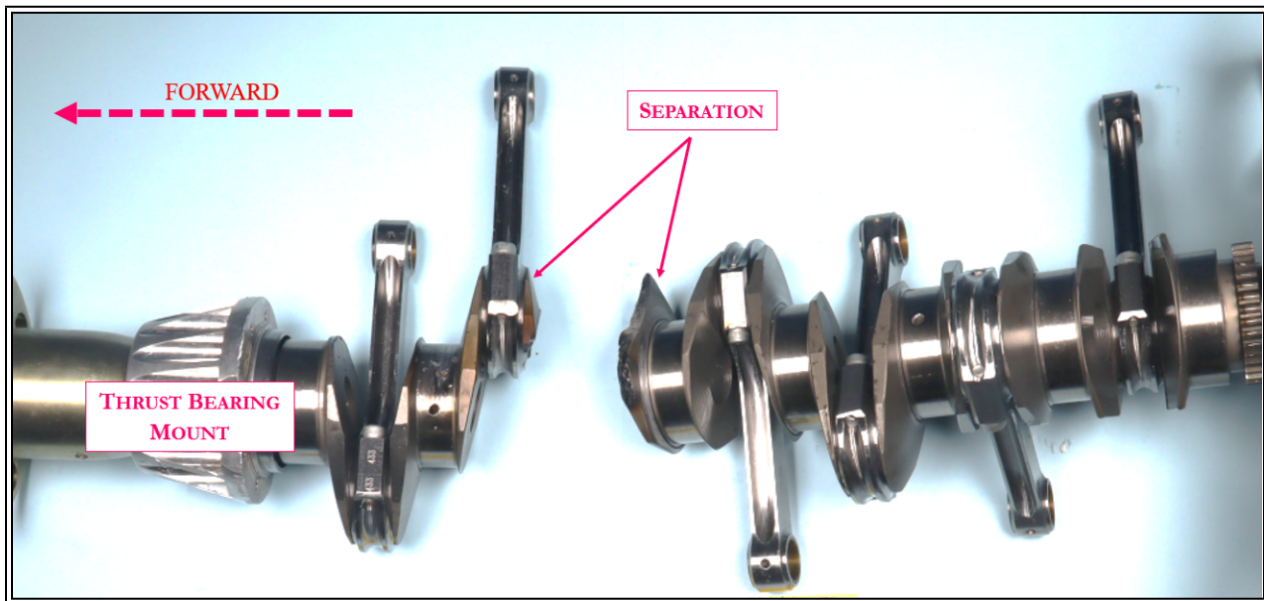
Figure 2: Crankshaft

Upon applying force to the propeller, the engine would not rotate through. Removal of the pistons revealed that the crankshaft was fractured at a web (crank cheek), just aft of the No. 2 connecting rod journal. The thrust bearing mount was able to move forward and aft.

Disassembly of the crankcase revealed that the six connecting rod journals still had their respective rods and caps attached; all were able to be easily rotated about their respective journals (see Figure 2 below).

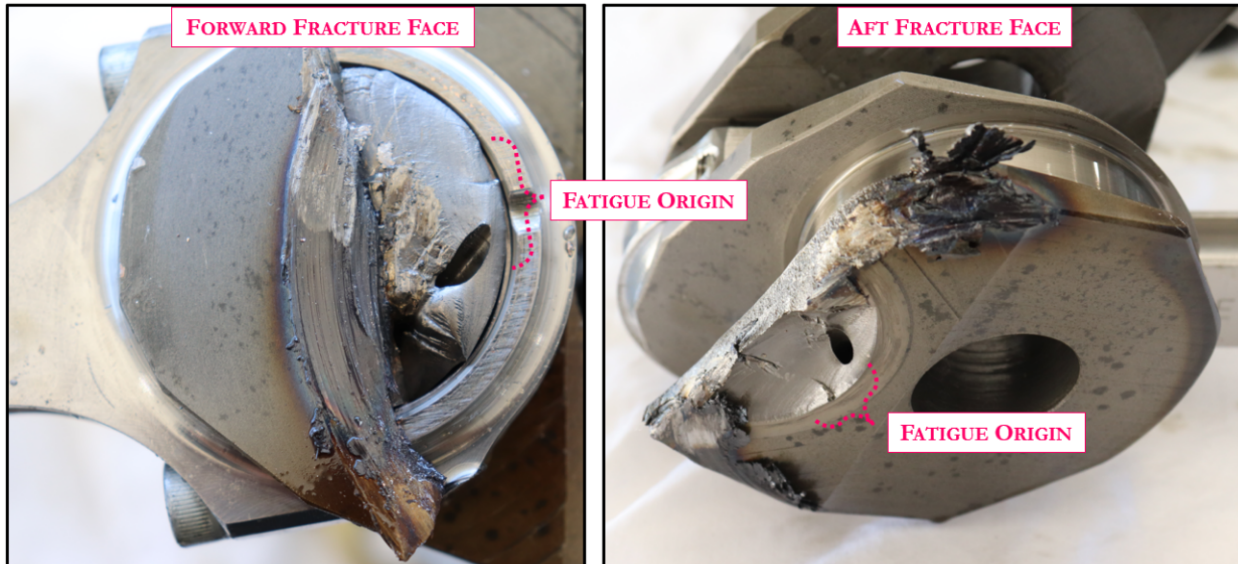
Figure 3: Mating Fracture Faces

A total loss of engine power caused by fatigue cracking and fracture of the crankshaft due to severe wear of the bearings.

The fracture extended through the crank cheek in the area between the No. 2 rod journal and the No. 3 main journal. The fracture surface was relatively shiny and reflective, with a portion of the cheek showing severe deformation damage and heat tinting on the forward face. The preliminary assessment of the fracture surfaces was consistent with a fatigue fracture at the aft radius of the No. 2 rod journal (see Figure 3 below).

The No. 2 rod journal's aft fracture face displayed crack arrest marks consistent with fatigue cracking, originating from multiple points at the surface of the aft radius. Circumferential scoring marks were present on the surface of the aft radius, intersecting the fatigue origin area, with the fatigue crack measuring about 1.6 inches. The crack propagated through 30% of the rod journal cross section. The remaining fracture extended axially through the crank cheek between the No. 2 rod journal and the No. 3 main journal. The major portion of the crank cheek fracture exhibited damage consistent with post-fracture mechanical damage. The mating fracture exhibited similar fracture features.
