# Aviation Investigation Preliminary Report

<b>Location:</b>	Winslow, AR	<b>Accident Number:</b>	CEN23FA190
<b>Date &amp; Time:</b>	May 17, 2023, 12:37 Local	<b>Registration:</b>	N522MJ
<b>Aircraft:</b>	Beech E-90	<b>Injuries:</b>	1 Fatal
<b>Flight Conducted Under:</b>	Part 91: General aviation - Personal

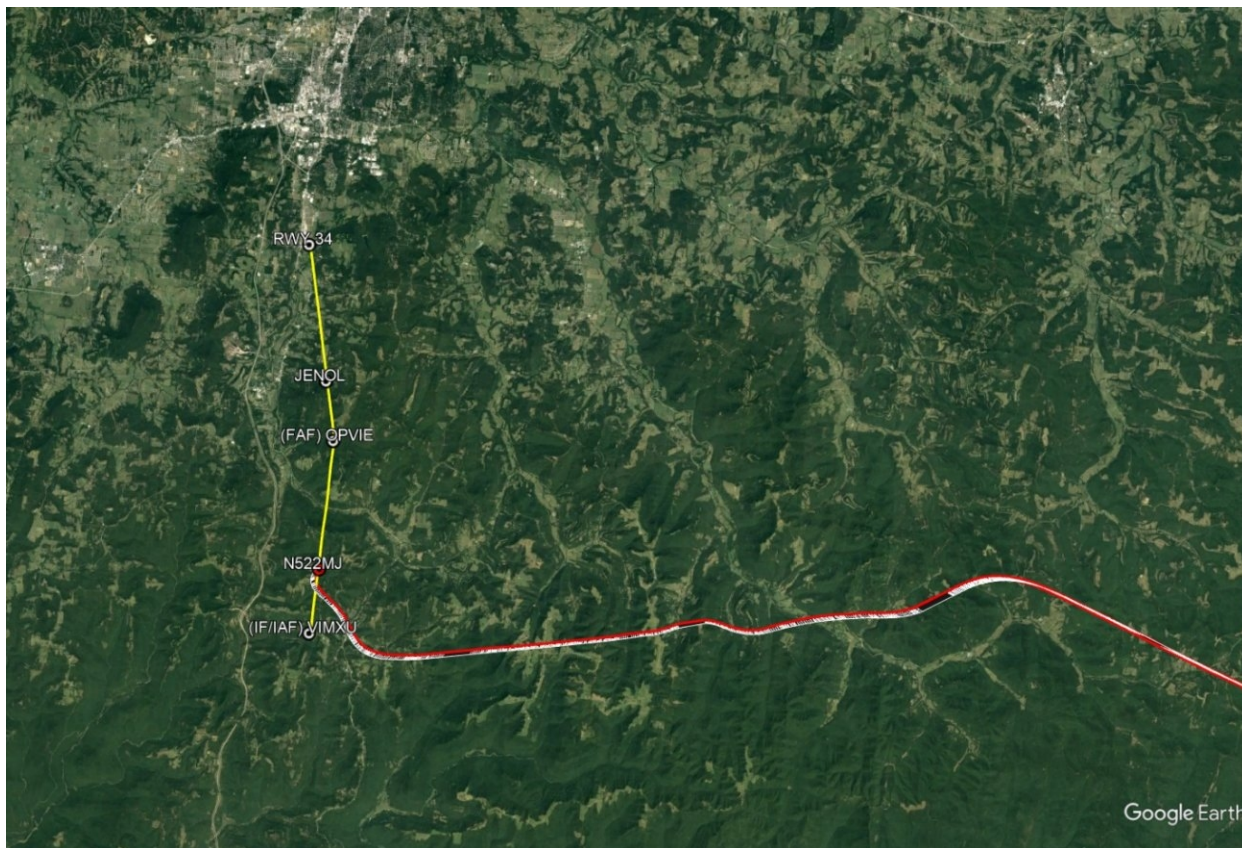
back up to 3,950 ft. When it had reached 3,950 ft it began a right turn, presumably to intercept the inbound approach course, but the airplane continued in the right turn and descended (see Figures 1 and 2). The final ADS-B data point, about 0.1 miles from the accident site, was at 1236:26 with a recorded altitude of 2,900 ft msl. The calculated descent rate between the final two data points was in excess of 15,000 ft/min.

Figure 1. The final portion of the accident flight shown in red with the FYV RNAV 34 approach fixes and approach segments depicted in yellow.

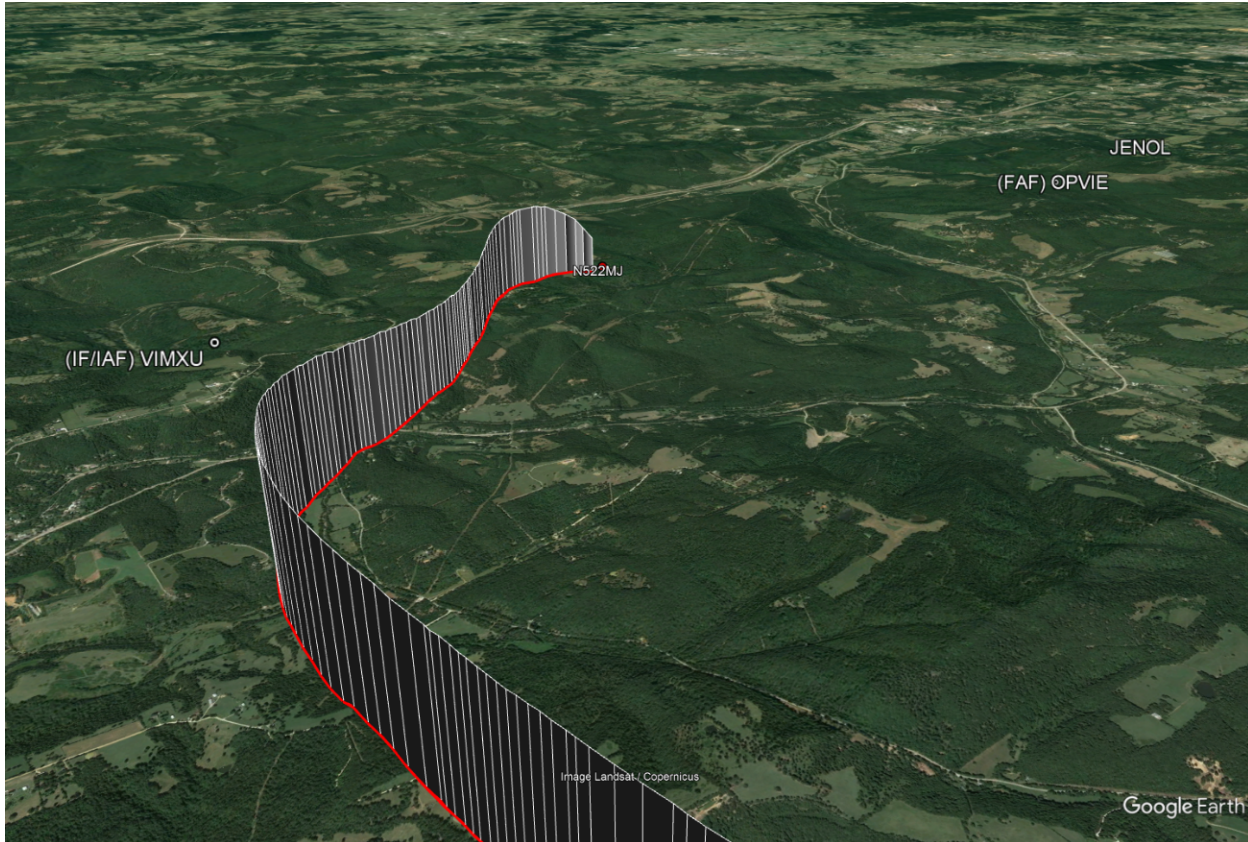
Figure 2. A 3-dimensional view of the final portion of the accident flight. The accident location and the approach fix (VIMXU) are depicted.
