# Aviation Investigation Final Report

<b>Location:</b>	Lake Worth, Florida	<b>Accident Number:</b>	ERA23FA247
<b>Date &amp; Time:</b>	May 26, 2023, 11:18 Local	<b>Registration:</b>	N3KV
<b>Aircraft:</b>	Cessna 172	<b>Aircraft Damage:</b>	Destroyed
<b>Defining Event:</b>	Flight control sys malf/fail	<b>Injuries:</b>	2 Fatal
<b>Flight Conducted Under:</b>	Part 91: General aviation - Instructional

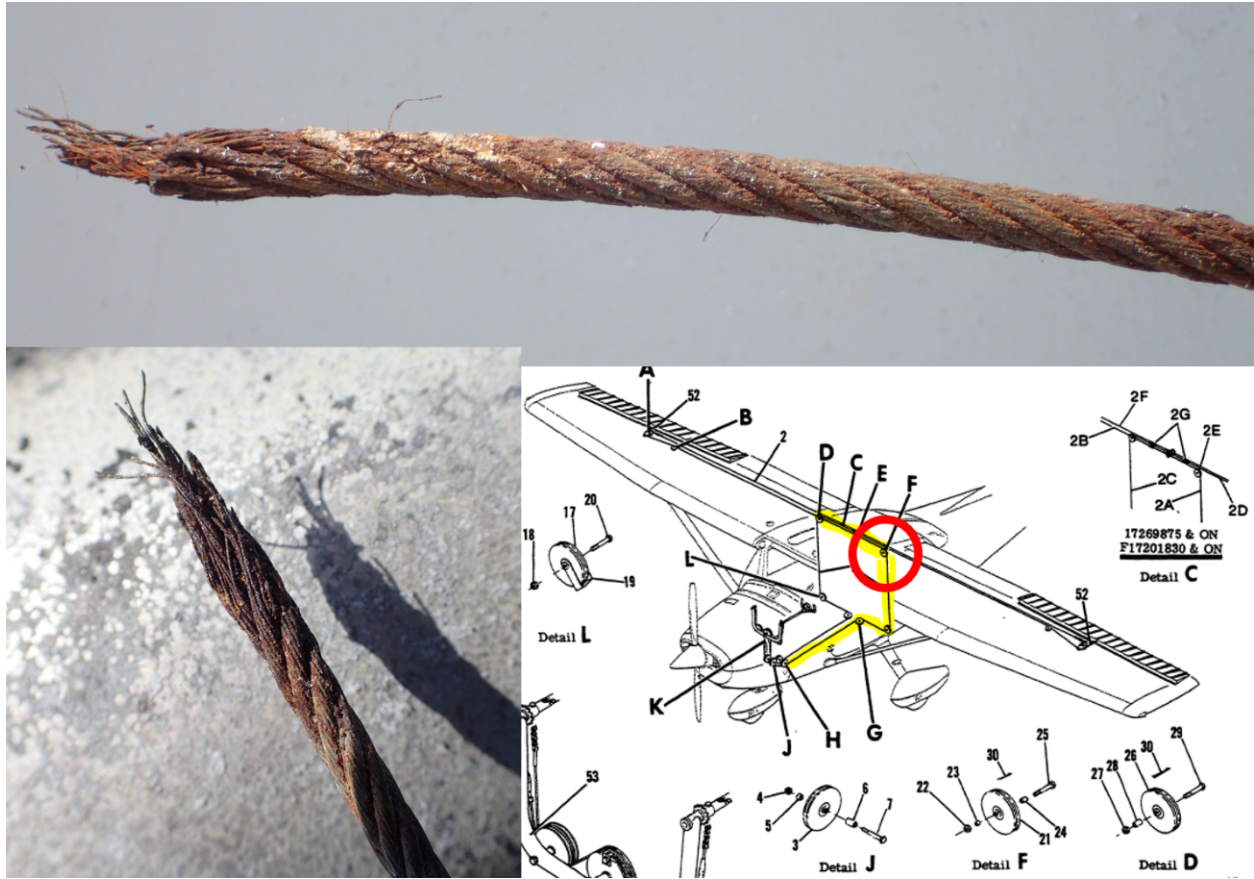
Examination of the wreckage revealed that there was a break in the aileron control cable system in the vicinity of the left upper door post right direct aileron cable pulley. A metallurgical examination of the break in the aileron control cable revealed that the mating fracture surfaces exhibited a woody appearance, shedding material, and pockmarks consistent with a corrosive attack. The angled fractured surfaces exhibited the same layered woody appearance, which indicated that those wires likely fractured in tension due to embrittlement and weakening from corrosive attack. If the cable was shedding material and becoming weaker, this process would have resulted in shedding material wire-by-wire and strand-by-strand over time. The remaining wires would have fractured from tensile overstress when there were no longer enough intact wires to carry the stress. It is likely that the overstress fracture occurred during the takeoff, which was consistent with the right roll as seen in the surveillance video.

Maintenance personnel’s failure to detect the corroded aileron cable during recent inspections, which resulted in the separation of the aileron control cable and a subsequent loss of airplane control during takeoff.

Aileron control continuity was not confirmed. A separation was noted in the aileron control system in the vicinity of the left upper door post right direct aileron cable pulley (see figure 1). The pulley was removed, examined, and exhibited corrosion. The pulley did not move freely. The right upper door post left direct aileron over pulley was removed and examined. The pulley did not rotate freely and corrosion was noted. Several other breaks noted in the aileron control system were consistent with tension overload failures.

Figure 1. Close up view of the separated aileron cable sections. The red circle indicates the approximate location of the broken portion of cable. The highlighted portion of aileron cable in the diagram indicates the section of cable sent to the NTSB Materials Laboratory.

Examination of the aileron control cables at the NTSB Materials Laboratory revealed that several wires exhibited uneven, localized thinning either at the separated ends or along the length of the wire. Pockmarks consistent with corrosive attack were observed on the surfaces of numerous wires. Some of the wire ends had necked down, with cup-cone fractures visible, while other wires had no thinning and angled fractures at the ends. The cable ends tapered to points and localized thinning of wires and shedding of material was noted, as well as pockmarks. The woody appearance of the cables, the shedding of material, and the pockmarks were consistent with a corrosive attack. Angled fracture surfaces were noted on some wires that also exhibited a woody appearance. Cup-cone fractures were noted on necked-down wires that had dimpled features consistent with ductile tensile overstress.
