Aviation Investigation Final Report

Location:	West Jordan, Utah	Accident Number:	WPR23LA203
Date & Time:	May 29, 2023, 11:52 Local	Registration:	N456Y
Aircraft:	Piper PA-28-181	Aircraft Damage:	Substantial
Defining Event:	Fuel starvation	Injuries:	2 None
Flight Conducted Under:	Part 91: General aviation - Instructional

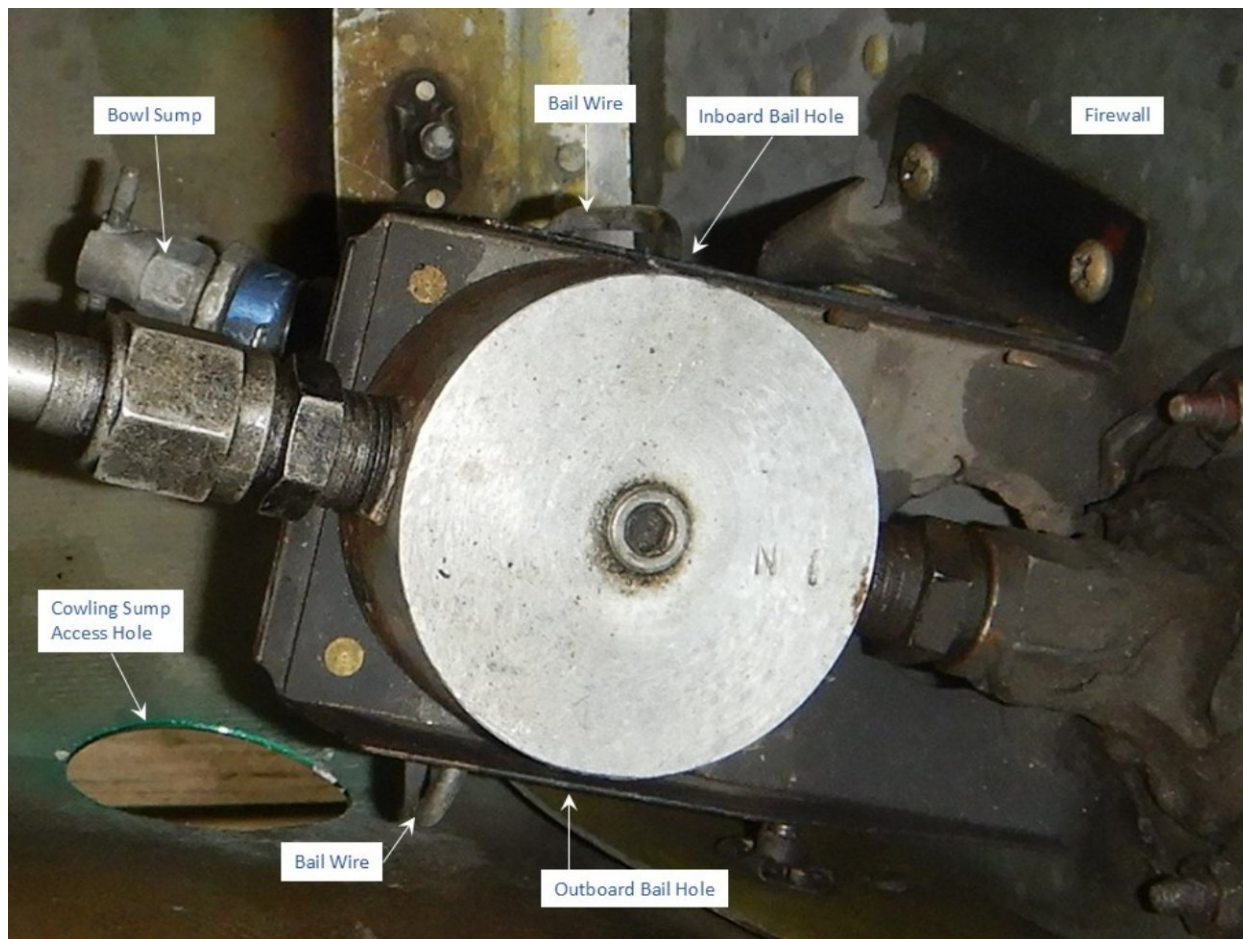
The postaccident examination revealed that the gascolator bowl bail wire attachment end was not engaged in the outboard attachment hole on the gascolator housing and was resting on the gascolator bracket forward of the hole. There was no observable impact damage to the gascolator or the surrounding area. The gascolator bowl was not sealed to the gascolator housing and was twisted inboard where the bowl's sump was pointing forward, instead of its normal position pointing outboard towards the cowling sump access hole. The interior surfaces of both upper and lower cowling were covered in a light residue of oil with the exception of the cowling and firewall area beneath the gascolator. The lower engine cowling was removed. The bail wire was not safety wired in place, and the strainer bowl retaining nut was safety wired to the gascolator sump fitting. The strainer bowl retaining nut was not properly positioned on the bottom of the bowl. The gascolator bowl was removed and the seal and screen were undamaged and clear of contamination. The gascolator bowl did not contain any fuel. The gascolator bail wire was not properly attached to the housing and the gascolator

bowl likely became unsealed, interrupting the fuel supply to the engine and causing the loss of engine power.

Loss of engine power due to fuel starvation as a result of the mechanic’s failure to properly secure the fuel system gascolator strainer bowl.

A postaccident examination of the wreckage revealed that the gascolator bowl bail wire attachment end was not engaged with the outboard attachment hole on the gascolator housing and was resting on the gascolator bracket forward of the hole, as shown in figure 1. There was no observable impact damage to the gascolator or the surrounding area. The gascolator bowl was not sealed to the gascolator housing and was twisted inboard where the

bowl's sump was pointing forward, instead of its normal position pointing outboard toward the cowling sump access hole. The interior surfaces of both upper and lower cowling were covered in a light residue of oil with the exception of the cowling and firewall area beneath the gascolator.

Figure 1-Gascolator as seen from above.

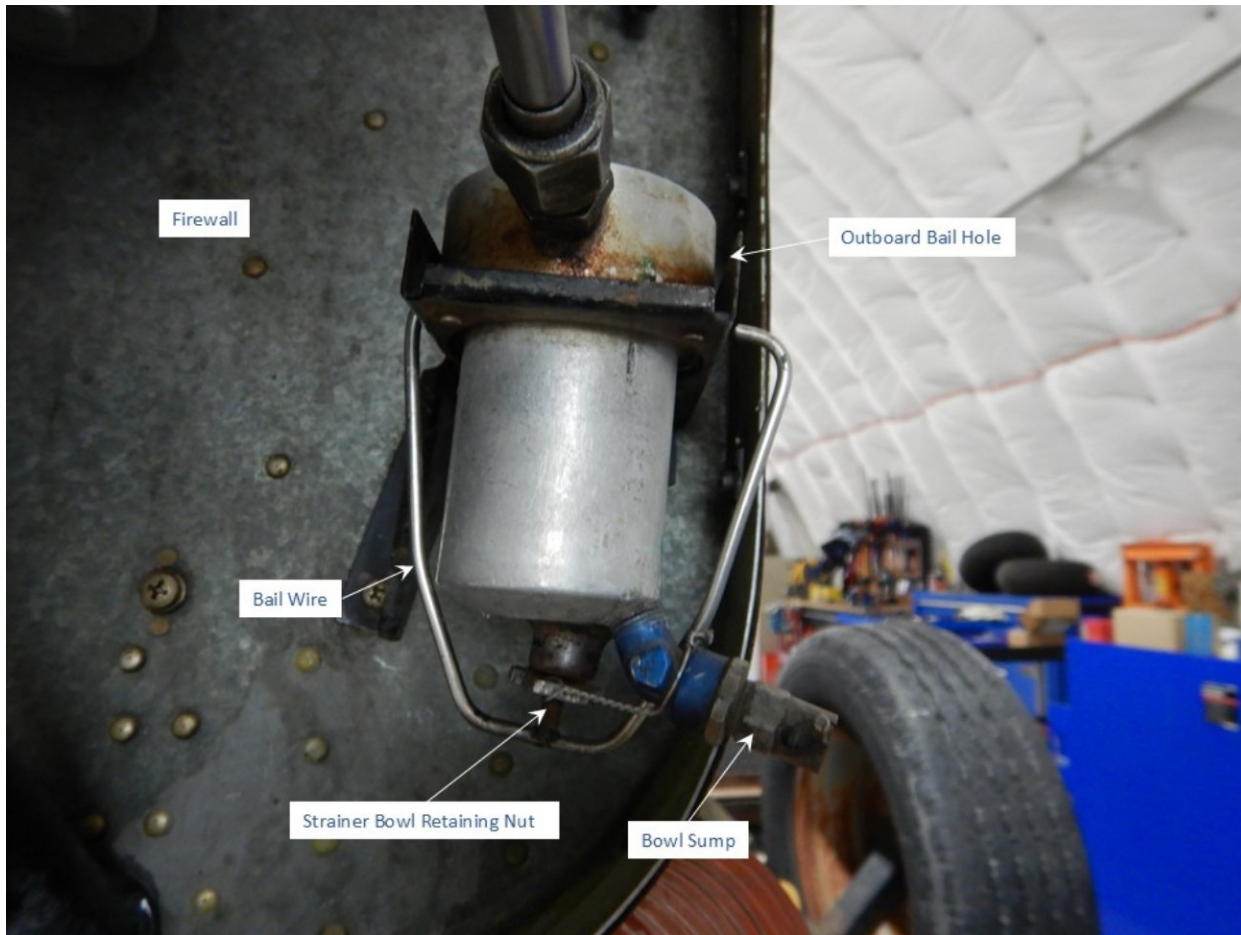
Figure 2-Gascolator forward side view, lower cowling removed.

The lower engine cowling was removed. The bail wire was not safety wired in place, and the strainer bowl retaining nut was safety wired to the gascolator sump fitting. The strainer bowl retaining nut was not properly positioned on the bottom of the bowl. The gascolator bowl was removed and the seal and screen were undamaged and clear of contamination. The gascolator bowl did not contain any fuel.

Both Piper Service Letter 1141, dated April 11, 2011, and the Piper Maintenance Manual provide instructions to maintain and install the gascolator. The instructions direct the installer to safety bail nut and bail wire with MS20995-C32 safety wire, as shown in figure 2. They direct the installer to use the “double twist” method, as described in the latest revision of FAA

Advisory Circular (AC) 43.13-1, Chapter 7 (Aircraft Hardware, Control Cables, and Turnbuckles), Section 7 (Safetying).

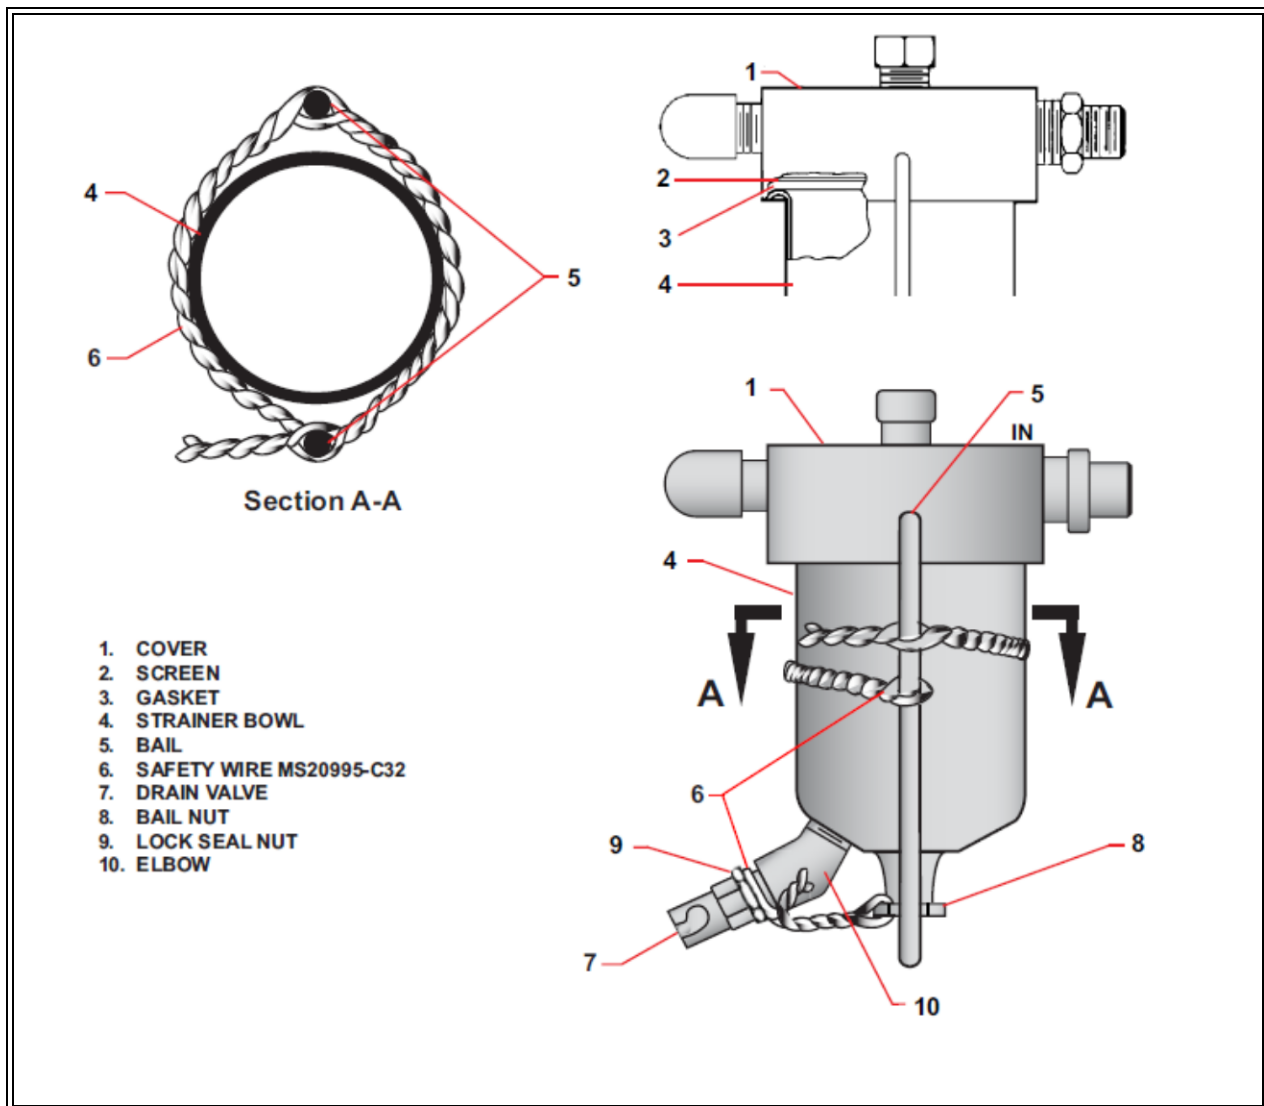
Figure 3-Excerpt from the Piper Maintenance Manual.
