Aviation Investigation Preliminary Report

Location: Montebello, VA Accident Number: ERA23FA256

Date & Time: June 4, 2023, 15:23 Local Registration: N611VG

Aircraft: Cessna 560 Injuries: 4 Fatal

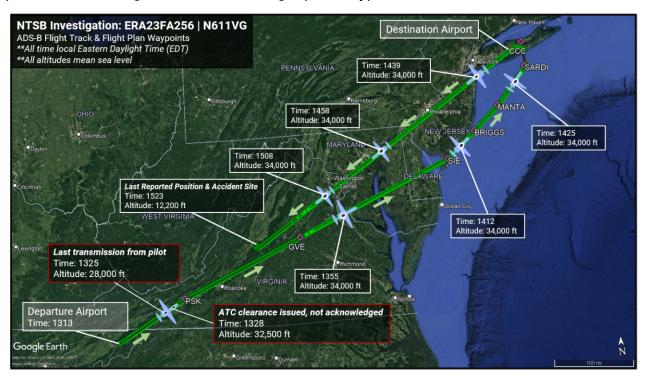
Review of preliminary Automatic Dependent Surveillance – Broadcast (ADS-B) data found that the airplane's flight track to the destination airport was consistent with the filed flight plan route. The airplane arrived overhead of ISP at 1432, maintaining 34,000 ft throughout the flight. The airplane subsequently continued flying southwest on a ground track of about 240°. The track showed little deviation or altitude change until 1522, where the airplane entered a rapidly descending right spiral descent into terrain.

NTSB Figure: Overview of the ADS-B flight track, flight plan waypoints, and select time/altitude labels.
