Aviation Investigation Final Report

Location:	Tacoma, Washington	Accident Number:	WPR23LA213
Date & Time:	May 30, 2023, 11:15 Local	Registration:	N9574X
Aircraft:	Cessna 210	Aircraft Damage:	Substantial
Defining Event:	Sys/Comp malf/fail (non-power)	Injuries:	2 None
Flight Conducted Under:	Part 91: General aviation - Instructional

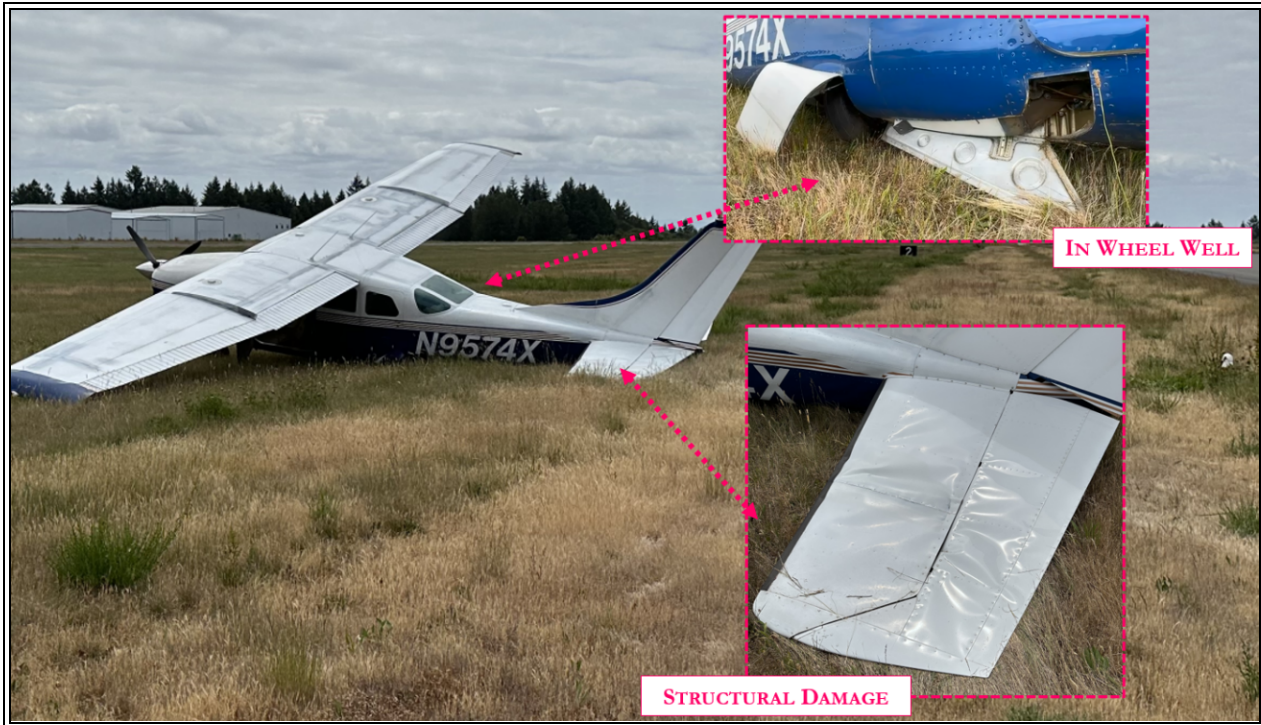
After about 1.5 hours of troubleshooting, the flight instructor decided to land with the gear partially extended. The airplane touched down on the centerline of the runway with the nose gear locked in place, which allowed for limited turning ability. The airplane came to rest in the grass off the left side of the runway. The left horizontal stabilizer was damaged during the accident sequence (see Figure 1).

Figure 1: Airplane damaged at the accident site.

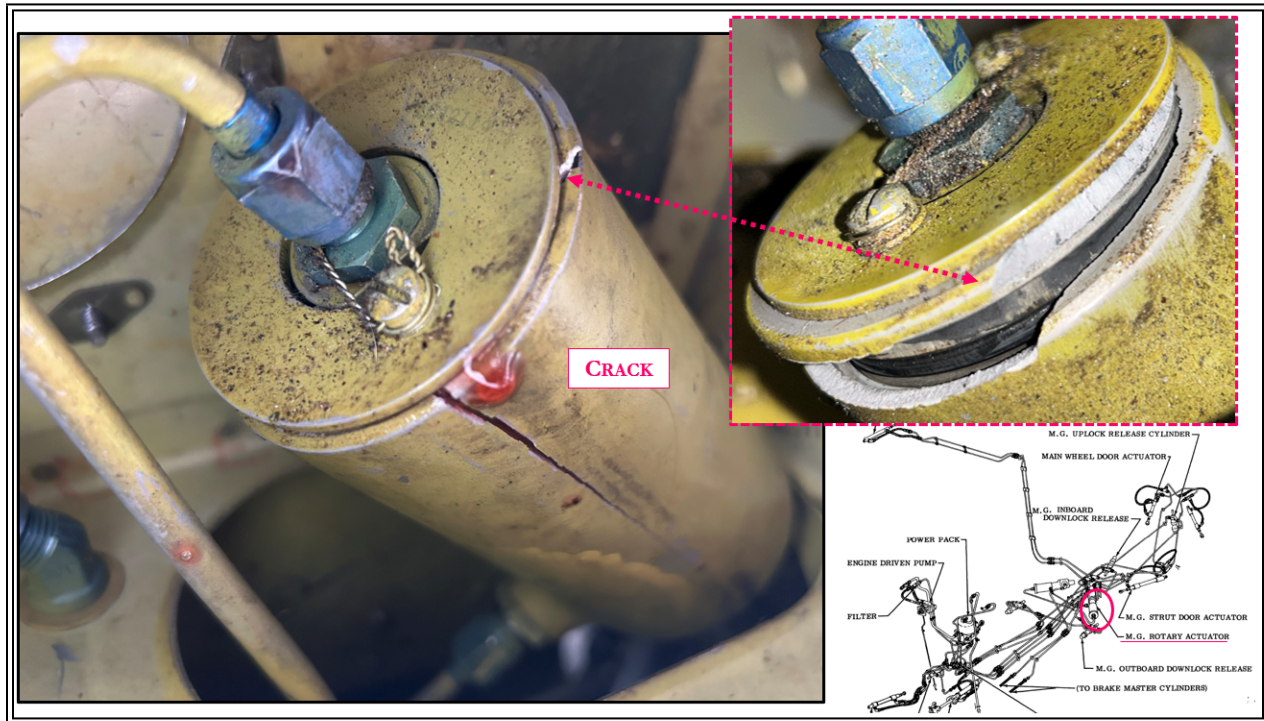
A postaccident examination of the landing gear was performed by a certified airframe and powerplant mechanic. He stated that the landing gear doors were locked in the open position. Removing the panels revealed that the left main gear rotary actuator was cracked and was leaking hydraulic fluid (see Figure 2).

Figure 2: Cracked actuator and location in the airplane.

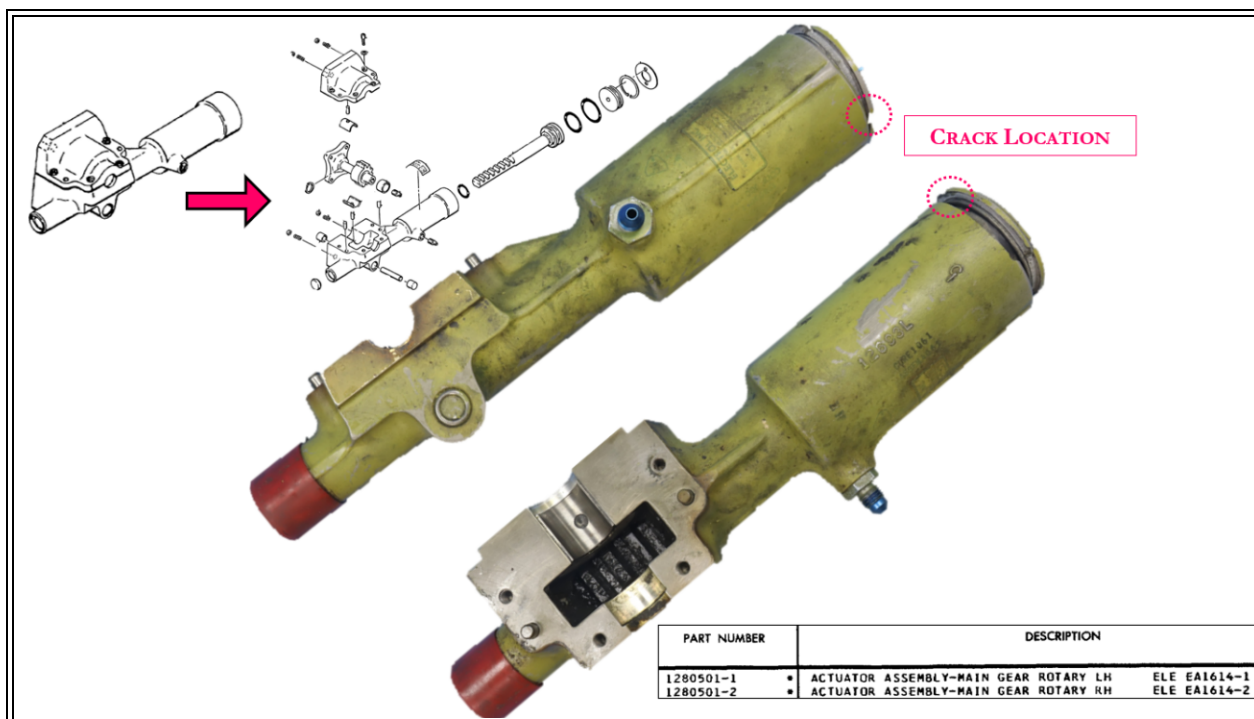
The Electrol Inc. actuator, part number (P/N) 1280501-1, was sent to the National Transportation Safety Board (NTSB) Materials Laboratory for examination. The examination revealed that there was a crack through the barrel, with circumferential and longitudinal sections. The crack initiated at the retaining ring groove, where corrosion pits were present, and propagated via fatigue circumferentially (see Figure 3). The longitudinal portion of the crack, which extended through more than half the actuator barrel's thickness, displayed signatures consistent with tensile overstress fracture. The actuator was composed of aluminum alloy, and its hardness and conductivity were consistent with the expected material properties.

Figure 3: Crack location on the actuator barrel.

Scanning electron microscopy (SEM) examination confirmed that the fatigue cracking had originated at corrosion pits along the ring groove. As demonstrated by striation features, the fatigue crack propagated circumferentially around the barrel until it reached a critical size, and then partially fractured longitudinally from overstress. Corrosion pits were present at the fatigue crack initiation points along the groove.

The material examination of the actuator using energy dispersive x-ray spectroscopy (EDS) found the retaining clip groove contained remnants of the cadmium plating from the clip, and confirmed the presence of aluminum oxide at the crack initiation sites. These findings were consistent with fatigue failure due to the presence of corrosion pits and the progressive propagation of cracks under cyclic stress, leading to the actuator's failure and the release of hydraulic fluid.
