# Aviation Investigation Final Report

| <b>Location:</b> | Sherrills Ford, North Carolina | <b>Accident Number:</b> | ERA23LA262 |
| <b>Date &amp; Time:</b> | May 31, 2023, 15:30 Local | <b>Registration:</b> | N2440S |
| <b>Aircraft:</b> | BURTON Searey | <b>Aircraft Damage:</b> | Substantial |

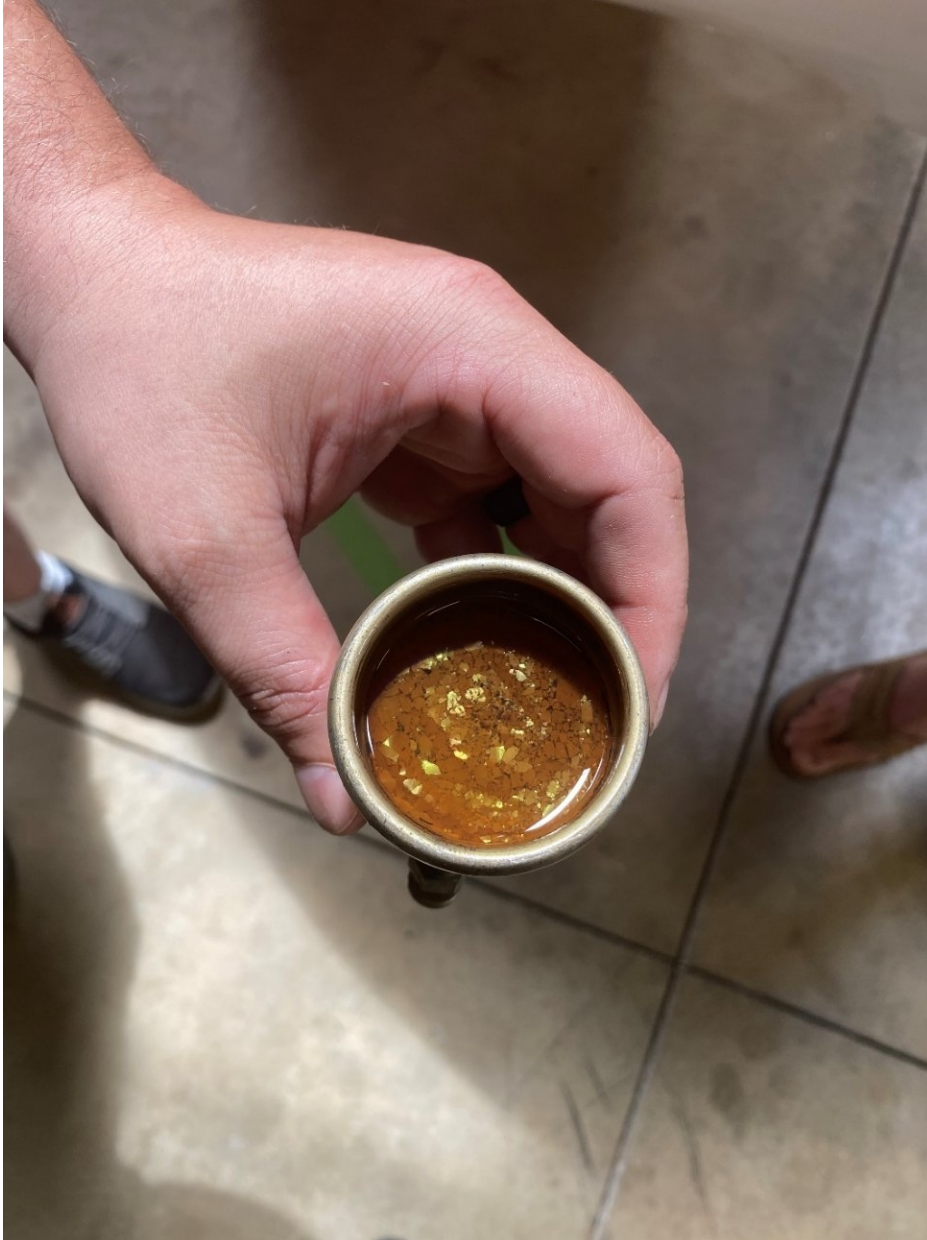
Immediately after the accident, the pilot started the engine several times, but it would "choke out" each time. Postaccident examination of the airplane revealed a gascolator occluded by rusty particles and containing water and trace amounts of fuel. The pilot reported that he was unaware of this gascolator in the fuel system, and that its occlusion could have led to both engine power loss events.

The pilot’s failure to configure the amphibious airplane’s landing gear before conducting a forced landing to a lake after a loss of engine power. Also causal was the occluded gascolator and the pilot’s lack of knowledge about the airplane’s fuel system, which resulted in his failure to locate and identify the condition of the gascolator following a previous loss of engine power event.

Following the accident, the airplane was inspected by an FAA aviation safety inspector and a representative of the engine manufacturer. A gascolator mounted in the root of the wing was removed and found occluded by rusted particles, water, and traces of fuel (see Figure 1). A "witness hole" below the gascolator provided access to the drain, but it was not placarded, and the pilot/owner stated that he had not known of it before the inspection.

Figure 1. – View of gascolator with rusted particles, water, and trace amounts of fuel as found (source FAA).
