# Aviation Investigation Final Report

<b>Location:</b>	Apache Junction, Arizona	<b>Accident Number:</b>	WPR23FA223
<b>Date &amp; Time:</b>	June 10, 2023, 07:51 Local	<b>Registration:</b>	N759F
<b>Aircraft:</b>	COMPAGNIE DAHER TB 30 EPSILON	<b>Aircraft Damage:</b>	Destroyed
<b>Defining Event:</b>	Low altitude operation/event	<b>Injuries:</b>	2 Fatal
<b>Flight Conducted Under:</b>	Part 91: General aviation - Personal

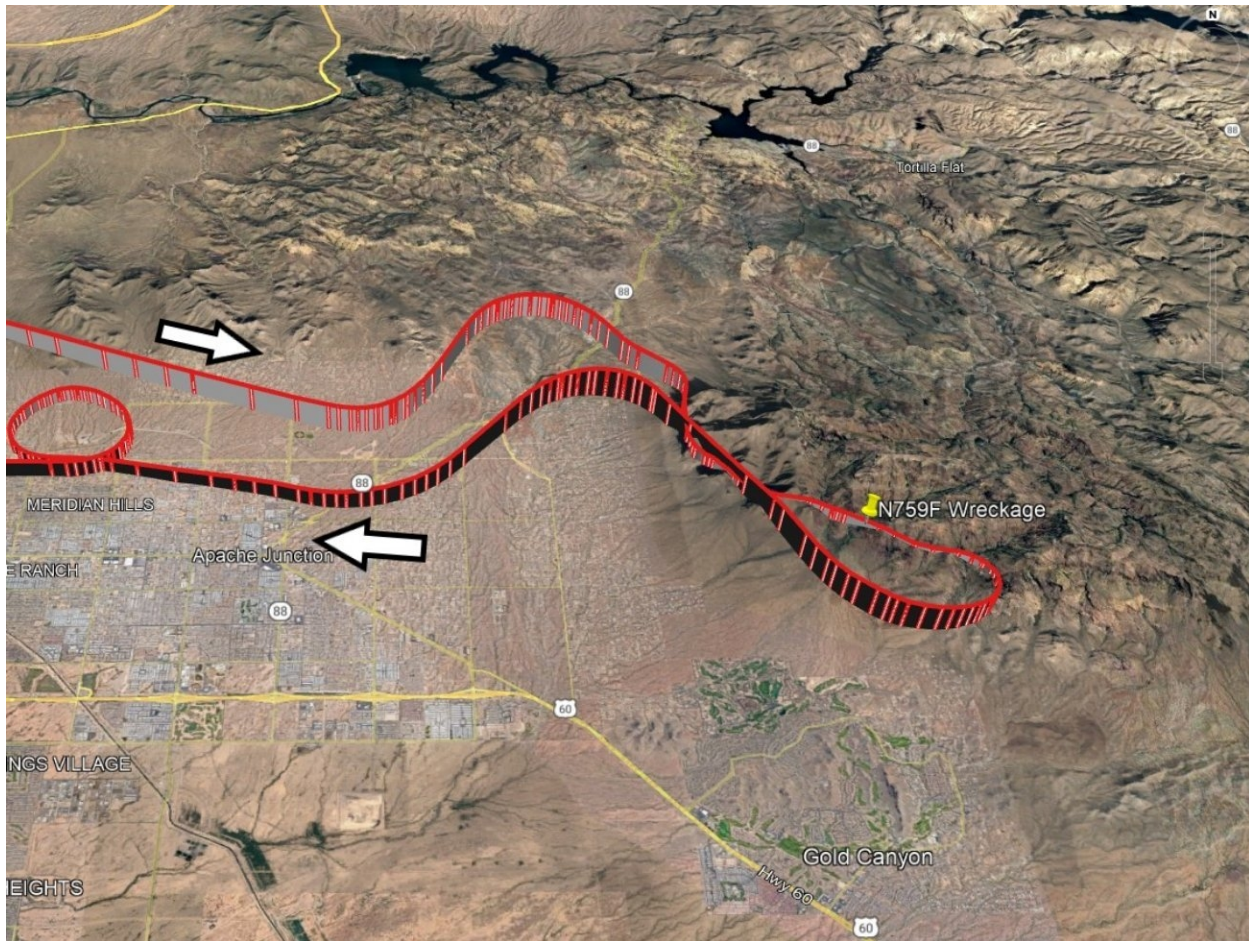
Figure 1 –Lead airplane's flight path (ADS-B Data)

Recorded ADS-B data was recovered for the lead and No. 3 airplanes. The data showed that the flight proceeded eastbound until about 0748, when the flight began maneuvering to the northeast. The flight then turned right to a southeasterly heading and descended towards the west side of the Superstition Mountains (figure 1). According to the lead and No. 3 pilots, the flights took spacing before descending toward the mountains and were in a “relaxed extended trail” formation about 500 ft above the ground as they flew around the mountains.

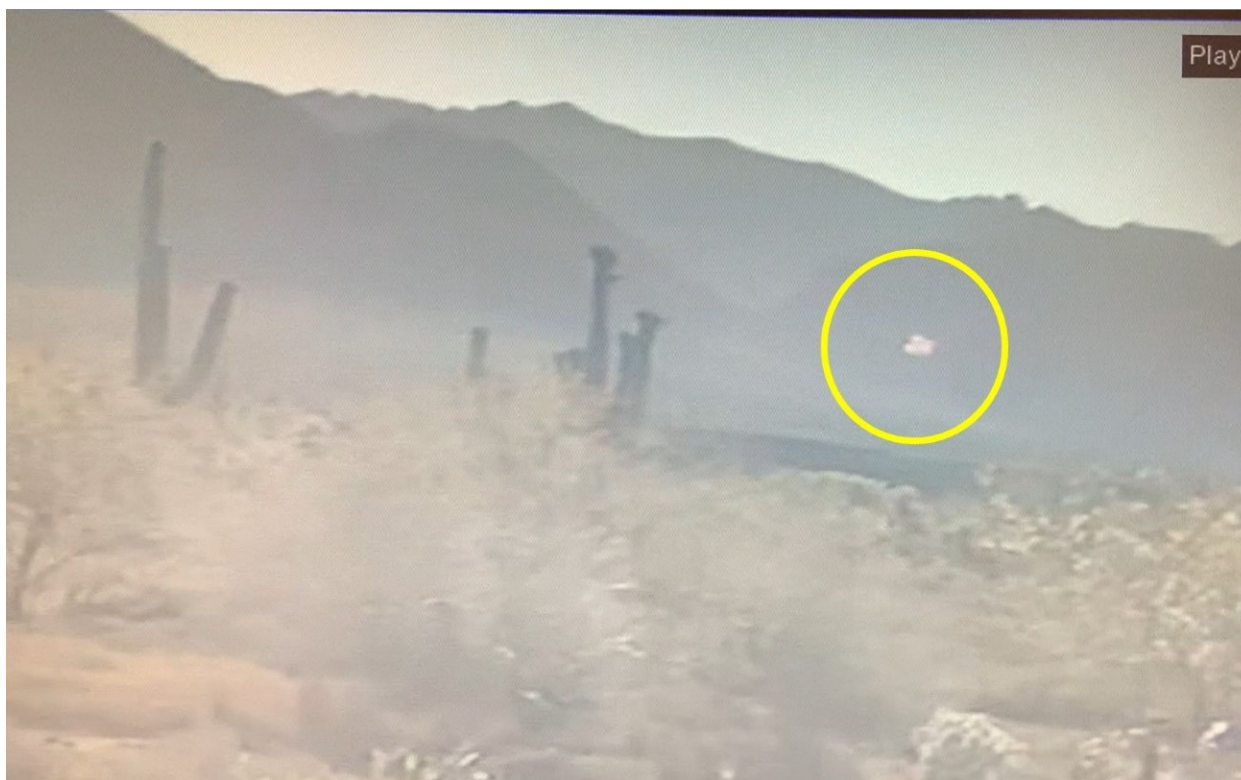
Figure 2 – Video screenshot of terrain and impact

pilot’s ability to avoid the terrain. The evidence is consistent with the shadowing effects resulting from the positioning of the sun creating depth perception difficulties for the pilot. The pilot likely failed to recognize the significance of rising terrain in front of the airplane until there was insufficient time to avoid it, resulting in controlled flight into terrain. Contributing to the accident was the decision by all three pilots to fly at a low altitude around the mountainous terrain.

Several witnesses observed the airplanes flying to the south along the west side of the mountains at a low altitude. They reported that the lead and No. 2 airplanes were close together, flying similar profiles, while the No. 3 airplane was further behind. One witness stated that the lead airplane crossed a ridgeline in over 90° of bank, and that the second airplane was less aggressive than the first, and the third airplane was higher and even less aggressive. No witnesses on the ground reported observing the accident. A home security camera, facing east, captured the moment the No. 2 airplane impacted terrain. The camera was located about 2.8 miles west of the accident site and showed an area of smoke appear at the accident site. No airplanes were identifiable in the video before the impact. The video showed that the west facing slopes of the mountains were shadowed and terrain features were not defined (figure 2).

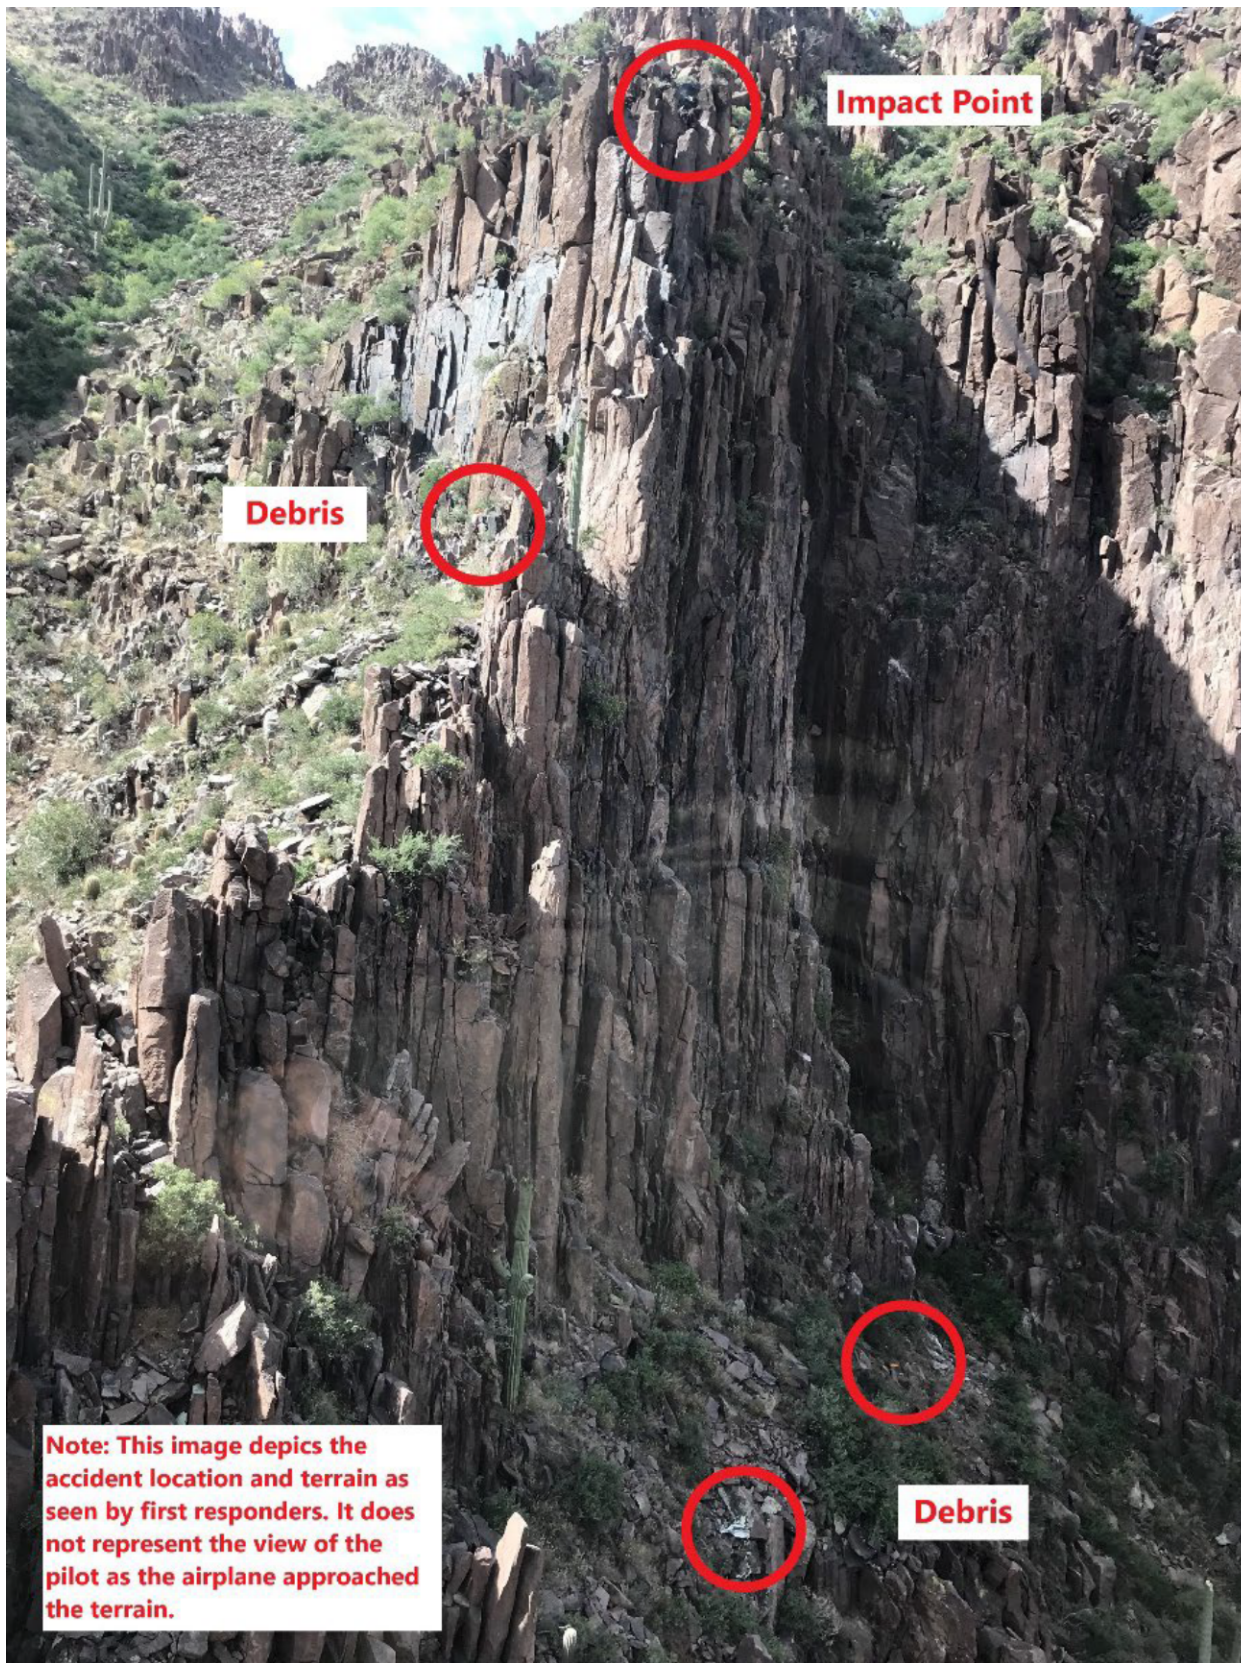
Figure 3 – Accident site and debris field

The accident site was not accessible by investigators due to rugged terrain. An aerial assessment of the accident site by a NTSB investigator the day of the accident revealed that the airplane impacted near-vertical terrain about 200-400 ft below a ridgeline on an easterly heading. The debris field extended about 200 ft downslope from the initial point of impact (figure 3).

The wreckage was highly fragmented. The identifiable components included portions of the cockpit, the tail section from the wing spar aft to the vertical stabilizer, flap fragments from both wings, and the left, right, and nose gear assemblies. The main landing gear appeared to be in the stowed position. The nose gear assembly was separated from the fuselage. Impact damage prevented determination of flight control continuity.
