Aviation Investigation Preliminary Report

Location:	McCall, ID	Accident Number:	WPR23FA225
Date & Time:	June 12, 2023, 10:29 Local	Registration:	N3138C
Aircraft:	Cessna R182	Injuries:	1 Fatal, 1 Serious
Flight Conducted Under:	Part 91: General aviation - Personal

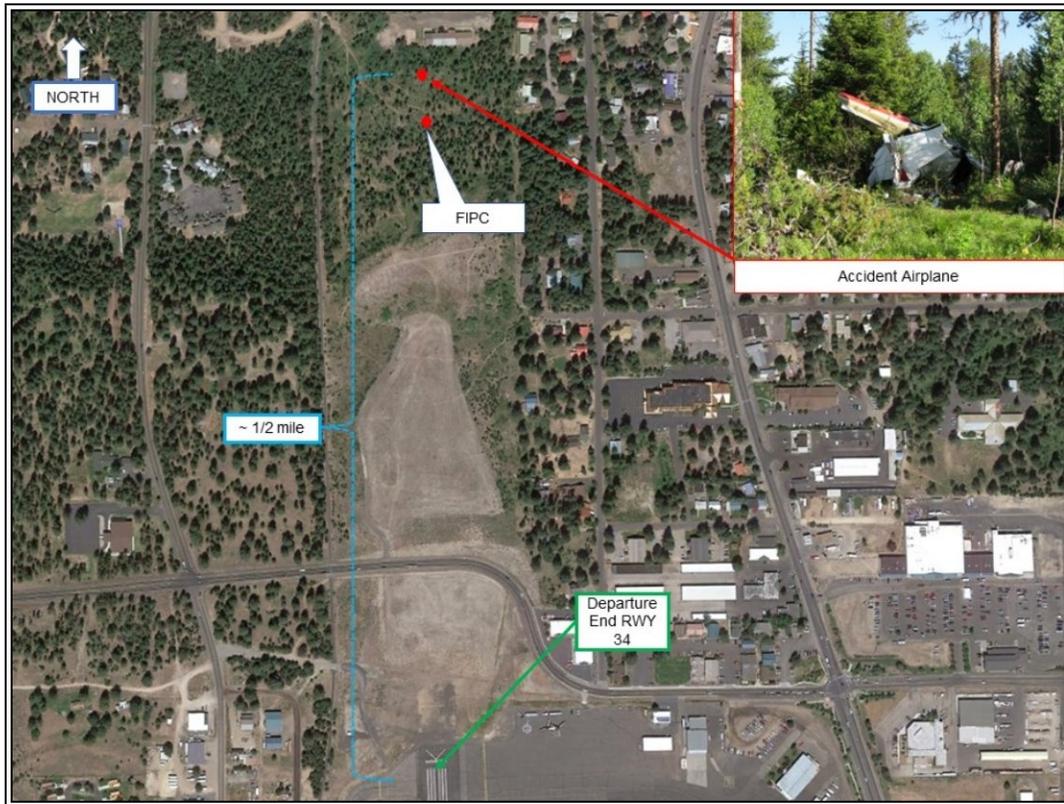
Examination of the accident site revealed that the airplane impacted trees about ½ mile north of the departure end of runway 34. The first identifiable point of contact (FIPC) was a 150 to 175 ft tall tree that had damaged limbs near its top. The debris path was oriented on a heading of about 335° magnetic and was about 225 ft in length from the FIPC to the main wreckage, as seen in figure 1. Portions of the left-wing, left-wing tip and left aileron, were observed

throughout the debris path. Several damaged trees were observed throughout the debris path. The fuselage came to rest on its right side against a tree, on a heading of about 020° magnetic at an elevation of 5,033 ft mean sea level.

Figure 1: Accident site diagram
