Aviation Investigation Preliminary Report

Location:	Watertown, WI	Accident Number:	CEN23FA239
Date & Time:	June 14, 2023, 09:03 Local	Registration:	N1025C
Aircraft:	Mooney M20R	Injuries:	2 Fatal
Flight Conducted Under:	Part 91: General aviation - Personal

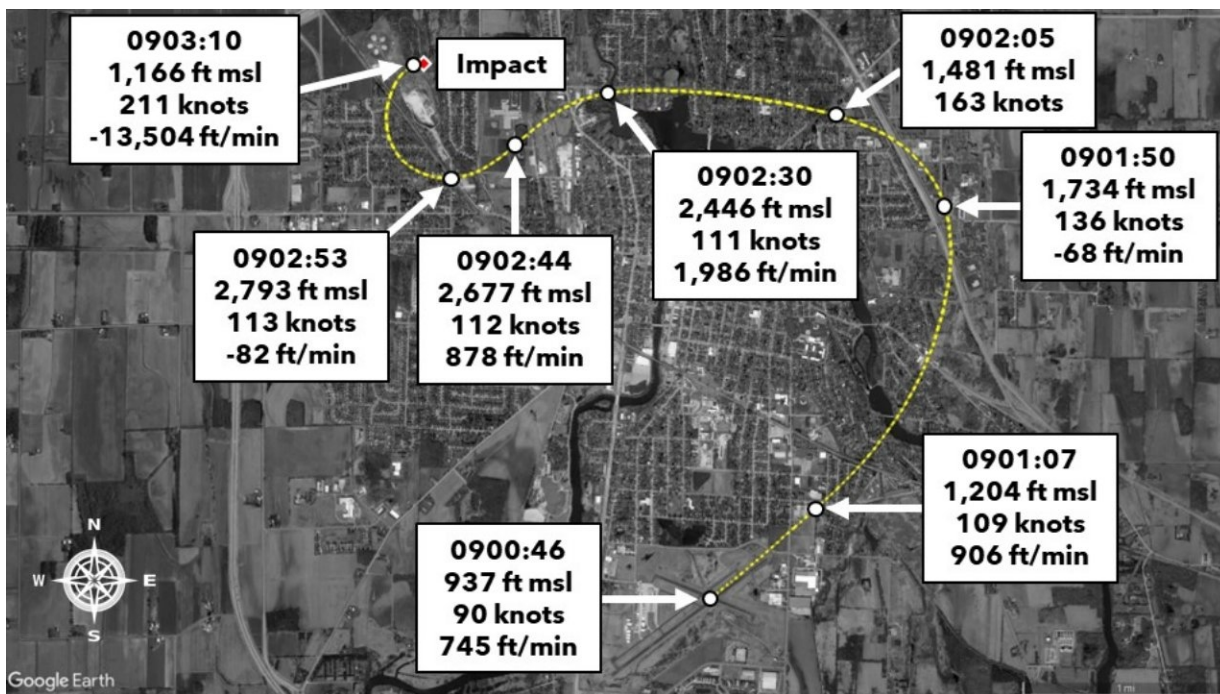
Figure 1 – Airplane Fight Track Data

According to automatic dependent surveillance-broadcast (ADS-B) data, at 0900:46, the airplane was on initial climb from runway 5 at RYV, as shown in Figure 1. An airport surveillance video camera at RYV captured the airplane climbing wings level into an overcast ceiling. The RYV weather station reported an overcast ceiling at 300 ft above ground level (agl). Based on several pilot reports, the reported cloud tops were about 3,000 ft mean sea level (msl).

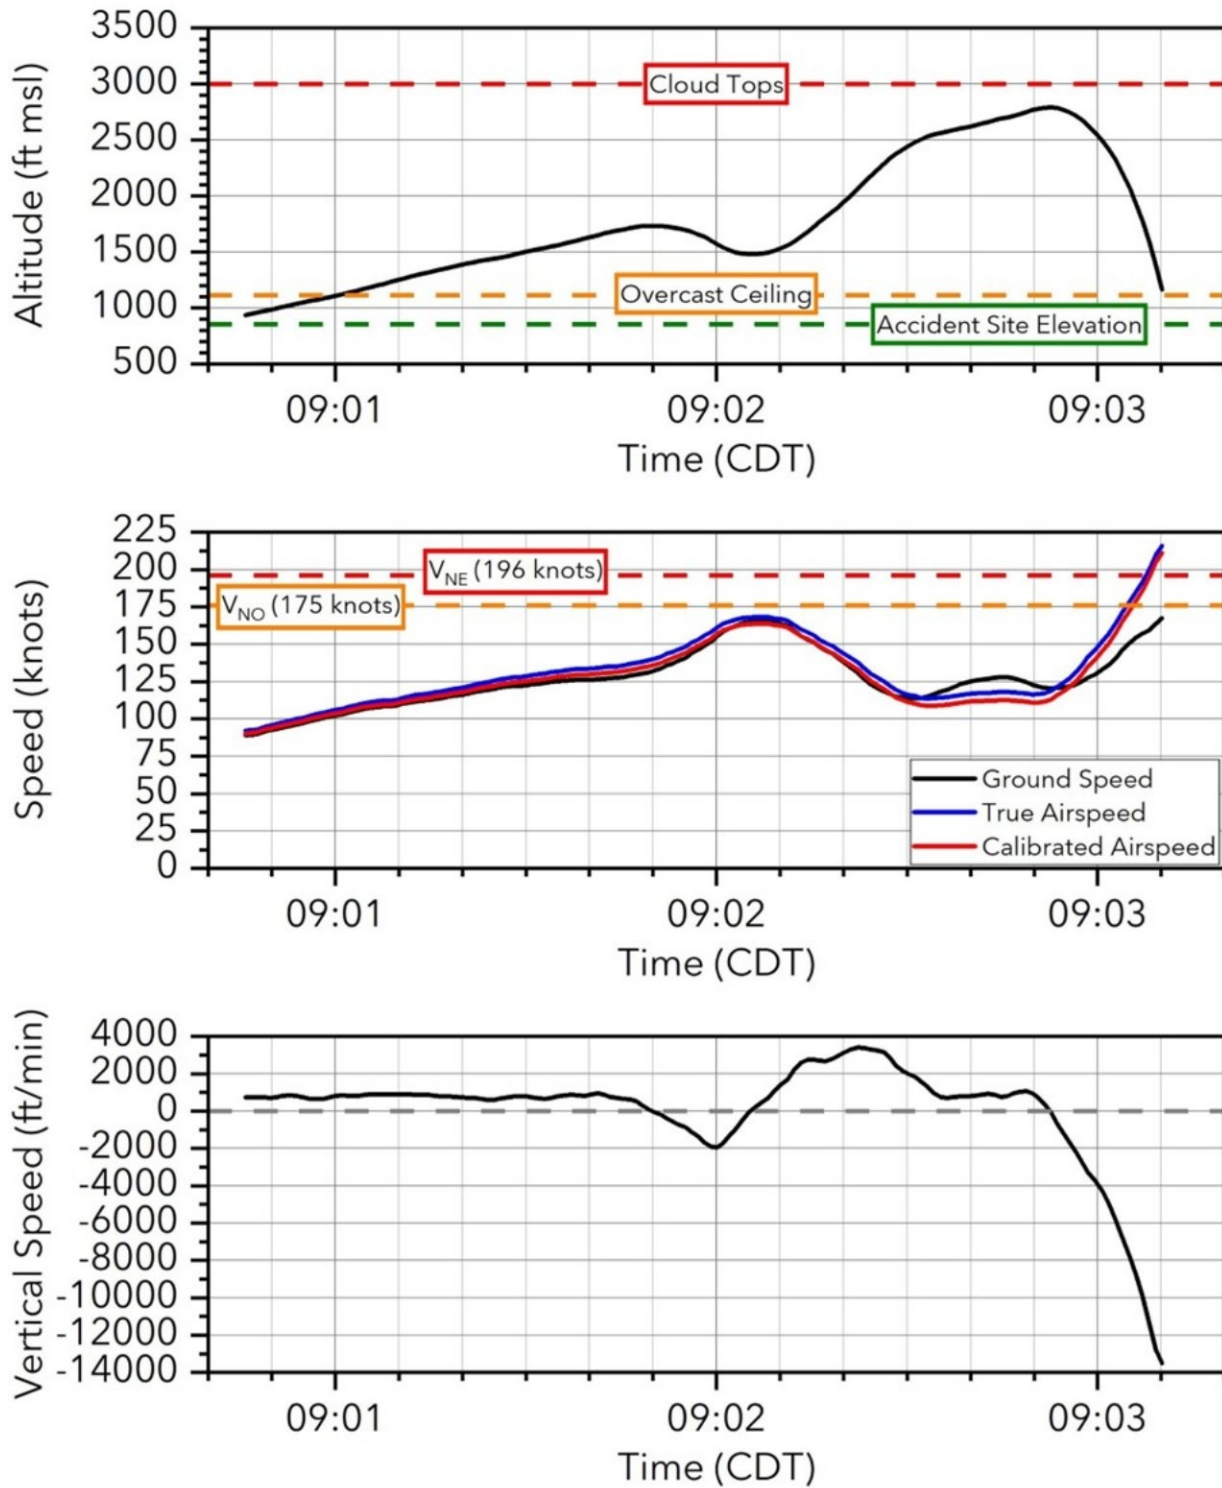
Figure 2 – Altitude, Speed, and Vertical Speed

At 0901:07, the airplane entered a climbing left turn toward west-northwest. At 0901:50, the airplane entered a descent from 1,734 ft msl while still in the left turn. At 0902:00, the airplane descended at 1,941 feet per minute (ft/min) with a 30° left-wing-down roll angle, as shown in Figure 2 and Figure 3. About 5 seconds later, at 0902:05, the airplane entered a climb from 1,481 ft msl while in a left turn toward west-northwest at 163 knots calibrated airspeed (KCAS).

At 0902:44, the airplane entered a climbing right turn toward north. At 0902:53, the airplane entered a descending right turn from a maximum altitude of 2,793 ft msl. About 15 seconds later, at 0903:08, the airplane's roll angle was about 80° right-wing-down as the airplane descended about 11,411 ft/min in a right turn toward northeast.

At 0903:10, the final recorded ADS-B data point, the airplane was flying at 211 KCAS as it descended 13,504 ft/min with a 56° right-wing-down roll angle. According to the Mooney M20R Pilot Operating Handbook, the airplane's never exceed airspeed (V_{NE}) was 196 KCAS. The final track point was at 1,166 ft msl and about 255 ft east-northeast of the initial impact with the ground.
