# Aviation Investigation Preliminary Report

<b>Location:</b>	Shaktoolik, AK	<b>Accident Number:</b>	ANC23FA042
<b>Date &amp; Time:</b>	June 16, 2023, 11:35 Local	<b>Registration:</b>	N91361
<b>Aircraft:</b>	Cessna 180	<b>Injuries:</b>	2 Fatal
<b>Flight Conducted Under:</b>	Part 135: Air taxi & commuter - Non-scheduled

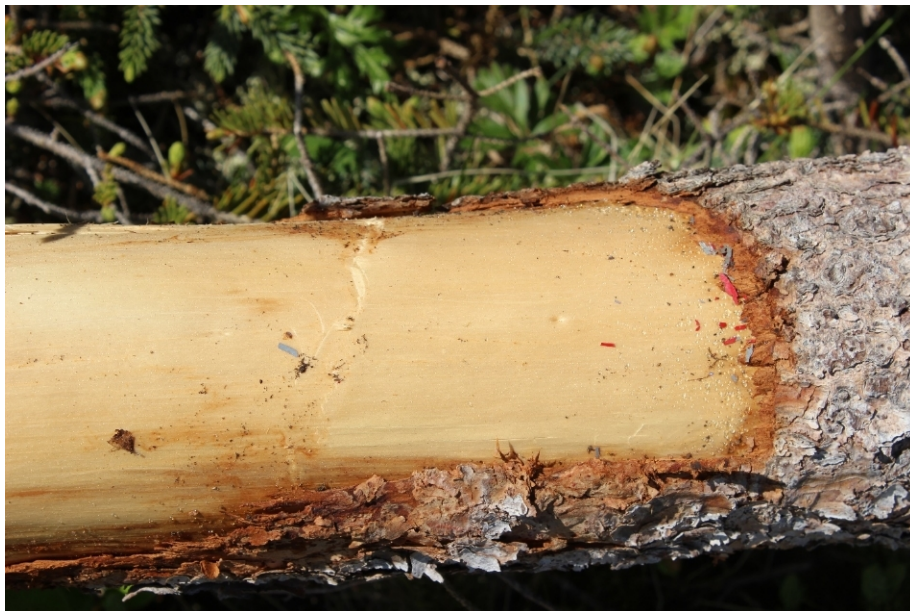
Examination of the airstrip revealed a small cluster of trees about 2/3 of the distance from the departure end on the runway’s left side, and downslope. One 12 ft tree, about 4 inches in diameter, was fractured about 4 ft from its base. The separated portion of the tree was found next to its trunk and displayed fragments of red paint that matched the accident airplane’s paint color.

Figure 1 View of the fractured tree with fragments of red paint.
