Aviation Investigation Preliminary Report

Location:	Shaktoolik, AK	Accident Number:	ANC23FA042
Date & Time:	June 16, 2023, 11:35 Local	Registration:	N91361
Aircraft:	Cessna 180	Injuries:	2 Fatal
Flight Conducted Under:	Part 135: Air taxi & commuter - Non-scheduled

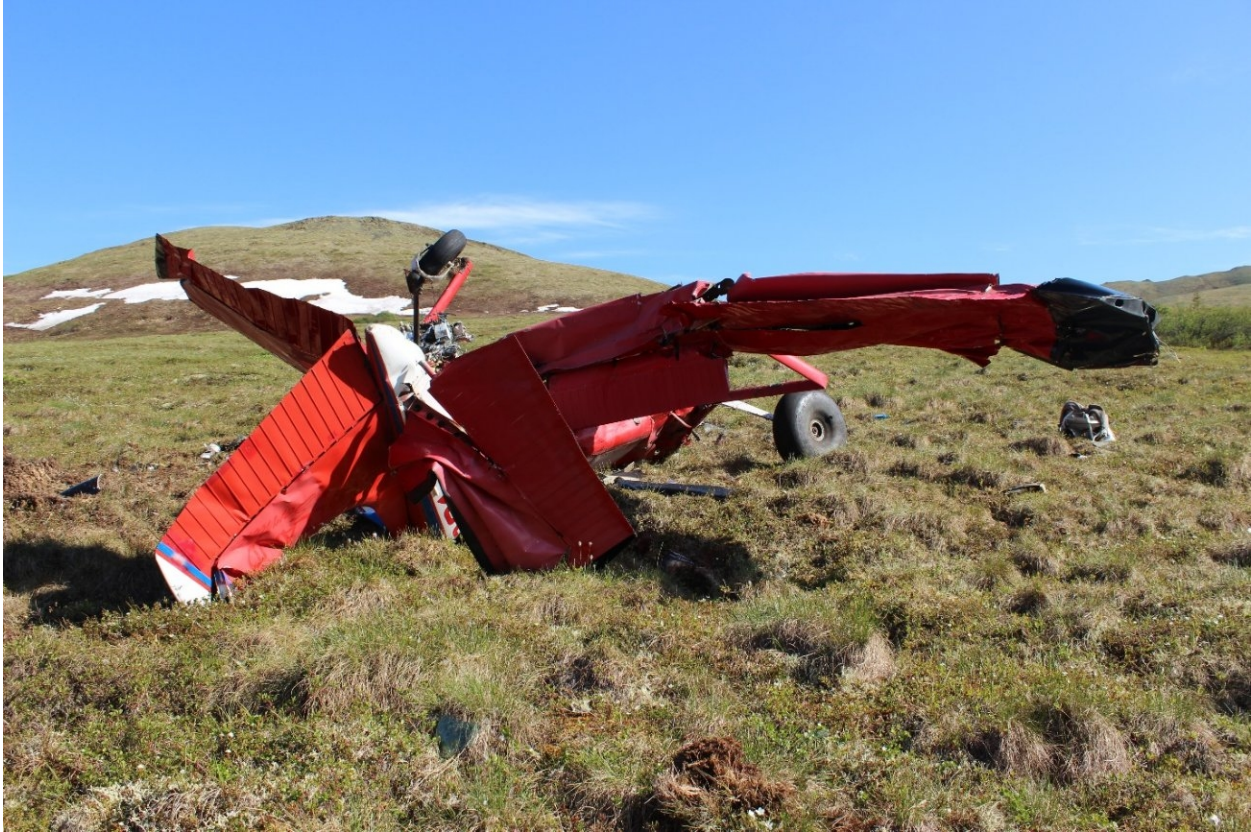
Examination of the wreckage revealed it impacted tundra in a steep nose-down wings level attitude about 1,200 ft. from the broken tree. The wings were displaced by impact, the right wing leading edge was uniformly crushed aft along its span. The upper and lower wing skins were crushed aft in compression. Flight control continuity was established through several breaks to the flight control surfaces. All breaks and separations were consistent with impact and overstress failure. The engine was separated from the airframe and came to rest inverted behind the left wing. The propeller hub was fractured, and the propeller blades were separated from the hub.

Figure 2 View of the airplane where it came to rest.

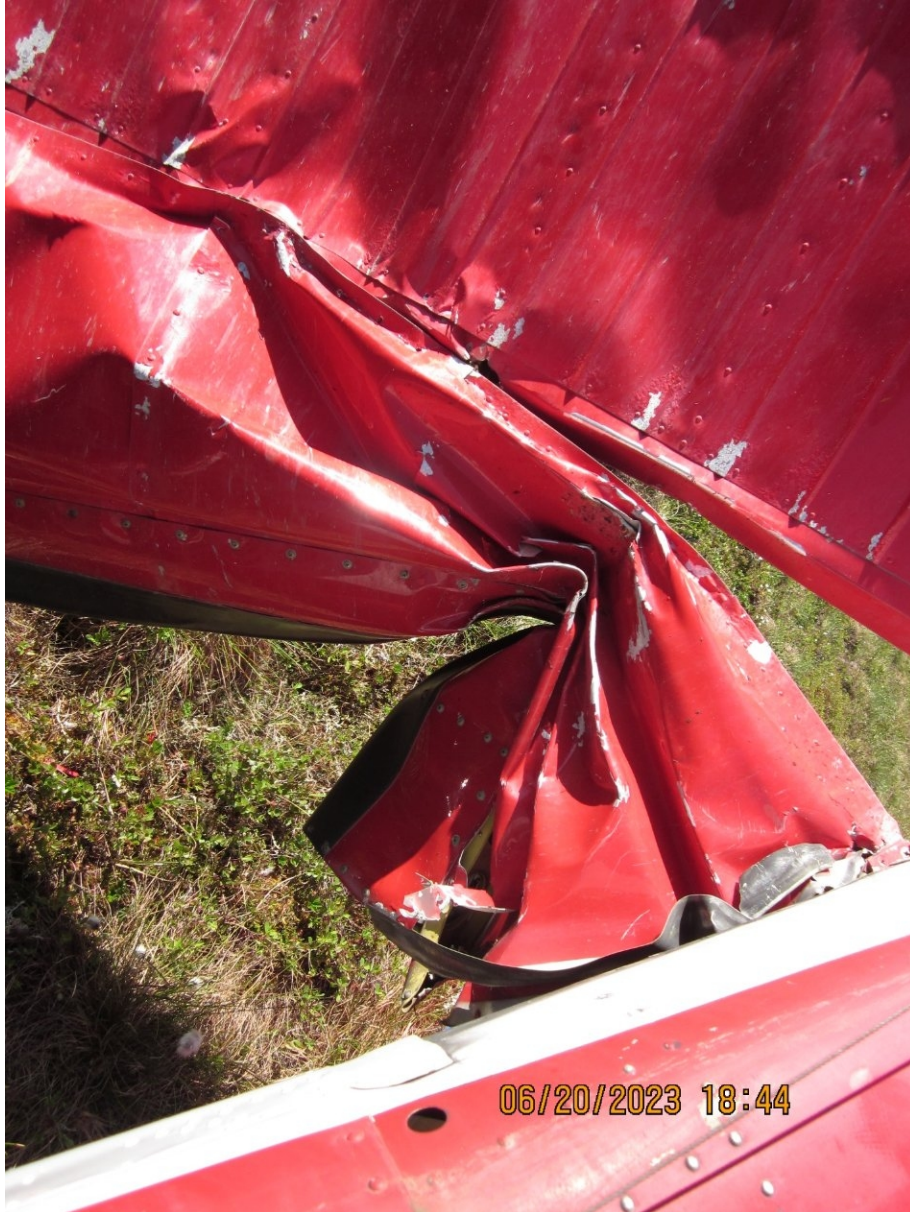
The left horizontal stabilizer displayed a concave dent perpendicular to the leading edge about 1 ft outboard of the stabilizer root. Tree sap and embedded tree fibers were observed in the leading edge of the horizontal stabilizer.

Figure 3 View of the aft crushing on the horizontal stabilizer.
