Aviation Investigation Final Report

Location:	Duluth, Minnesota	Accident Number:	CEN23FA248
Date & Time:	June 21, 2023, 07:19 Local	Registration:	N308ED
Aircraft:	Aeronca 7CCM	Aircraft Damage:	Substantial
Defining Event:	Aerodynamic stall/spin	Injuries:	2 Fatal
Flight Conducted Under:	Part 91: General aviation - Personal

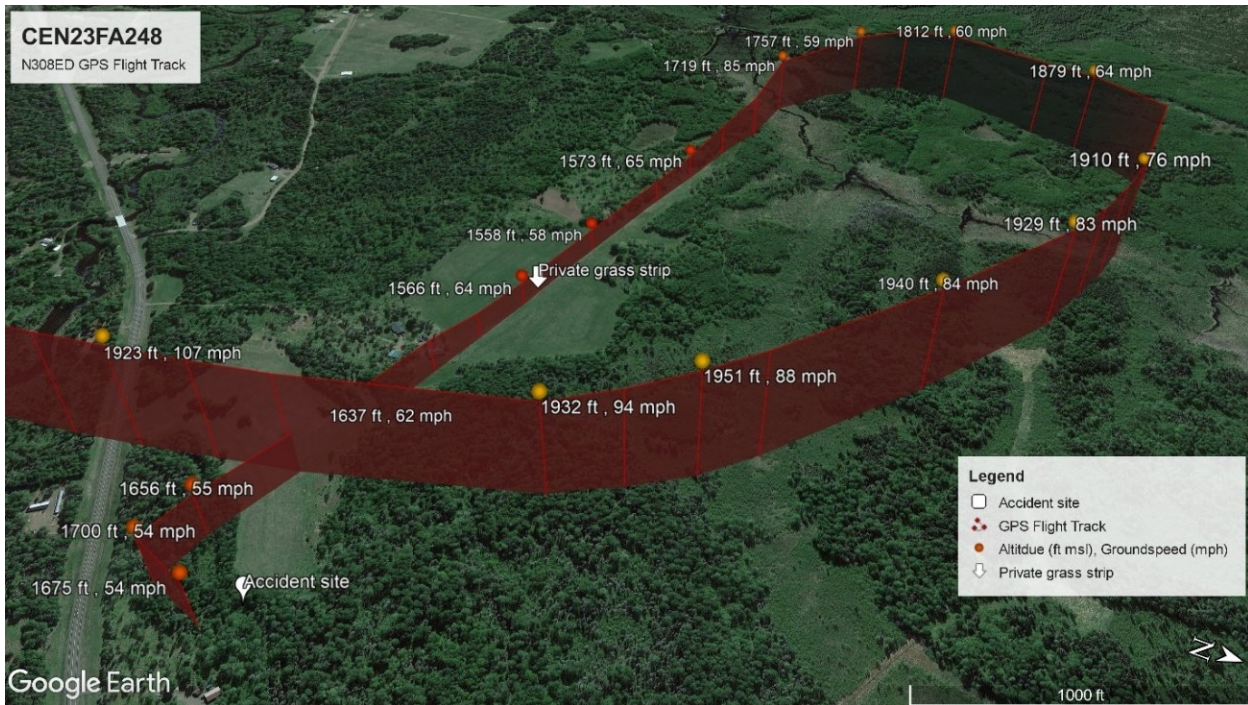
Data from the pilot's handheld GPS revealed that after departure, the airplane proceeded northeast about 18 nm to the pilot's private grass airstrip. The airplane approached from the south and entered a left downwind for the east runway. The airplane overflowed the runway about 100 ft agl and 58 mph groundspeed. Near the departure end of the runway the airplane climbed and accelerated to 64 mph, then gradually slowed to 54 mph and reached a peak of 240 ft agl. The airplane then made a descending left turn toward the accident site (Figure 1).

Figure 1. End of accident flight track overlaid on Google Earth.

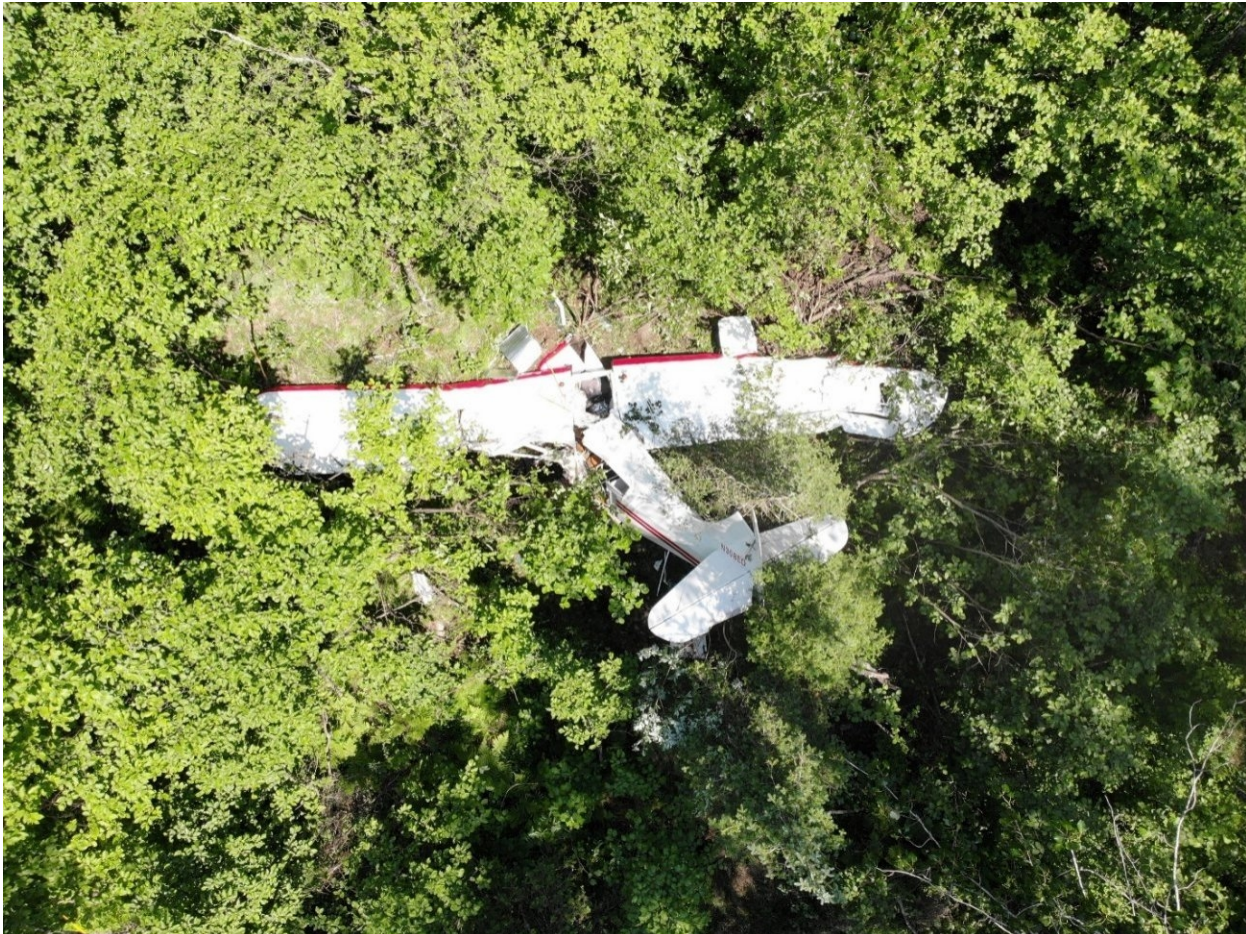
The wreckage was located in a densely wooded area about 1,500 ft east of the private grass strip. There was no noticeable damage to the surrounding trees or to the tree canopy (Figure 2). The airplane impacted in a right-wing-low and nose-down attitude. The right wing's leading edge exhibited accordion crush damage and the empennage was distorted to the right. The left wing was mostly straight with wrinkling and minimal leading edge damage.

Figure 2. Aerial view of accident site (Courtesy of Sheriff's Office).
