# Aviation Investigation Final Report

<b>Location:</b>	Scott City, Kansas	<b>Accident Number:</b>	CEN23LA264
<b>Date &amp; Time:</b>	June 24, 2023, 11:30 Local	<b>Registration:</b>	N9721Q
<b>Aircraft:</b>	Beech B19	<b>Aircraft Damage:</b>	Substantial
<b>Defining Event:</b>	Fuel starvation	<b>Injuries:</b>	1 None
<b>Flight Conducted Under:</b>	Part 91: General aviation - Personal

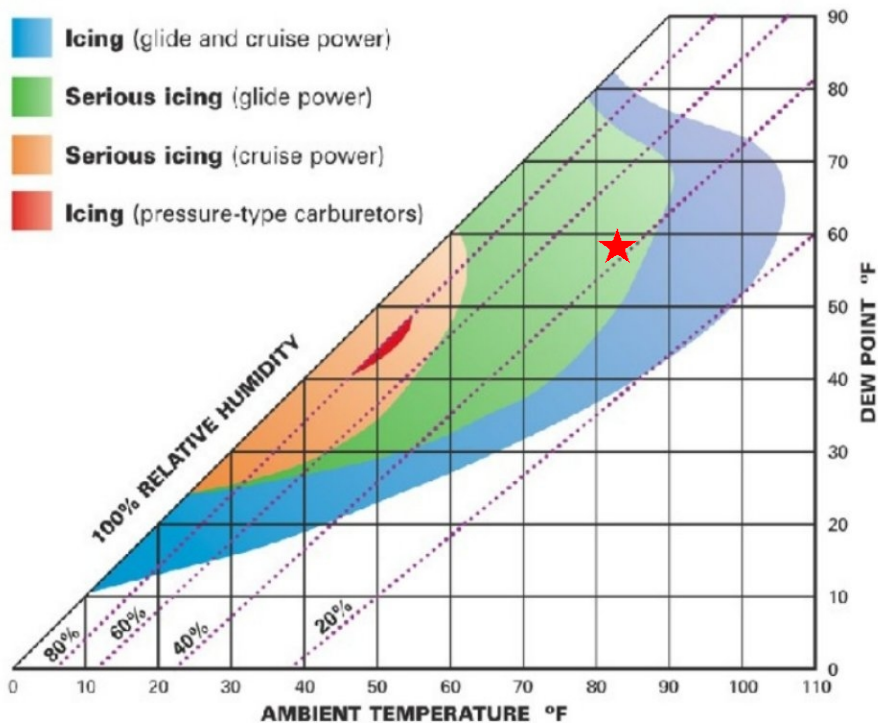
Figure 1: Carburetor Icing Probability Chart. Reference: Special Airworthiness Information Bulletin CE-09-35

When the temperature and dewpoint at the time of the accident were plotted on a carburetor icing probability chart, it was revealed that the airplane was operating in an environment conducive for serious carburetor icing at a glide power setting. The pilot stated that he checked the carburetor heat before departure. After the carburetor heat check, it is likely that ice began to form in the carburetor’s venturi during the extended ground operation before departure, which, in turn, limited the engine rpm at 2,200.

The reported weather conditions about 15 minutes before the accident included a temperature of 82°F and dewpoint of 59°F. When plotted on a carburetor icing probability chart, the airplane was operating in an environment conducive for serious carburetor icing at a glide power setting. (See Figure 1)
