Aviation Investigation Preliminary Report

Location:	Charlotte, NC	Accident Number:	DCA23FA339
Date & Time:	June 28, 2023, 08:58 Local	Registration:	N955AT
Aircraft:	Boeing 717-200	Injuries:	104 None
Flight Conducted Under:	Part 121: Air carrier - Scheduled

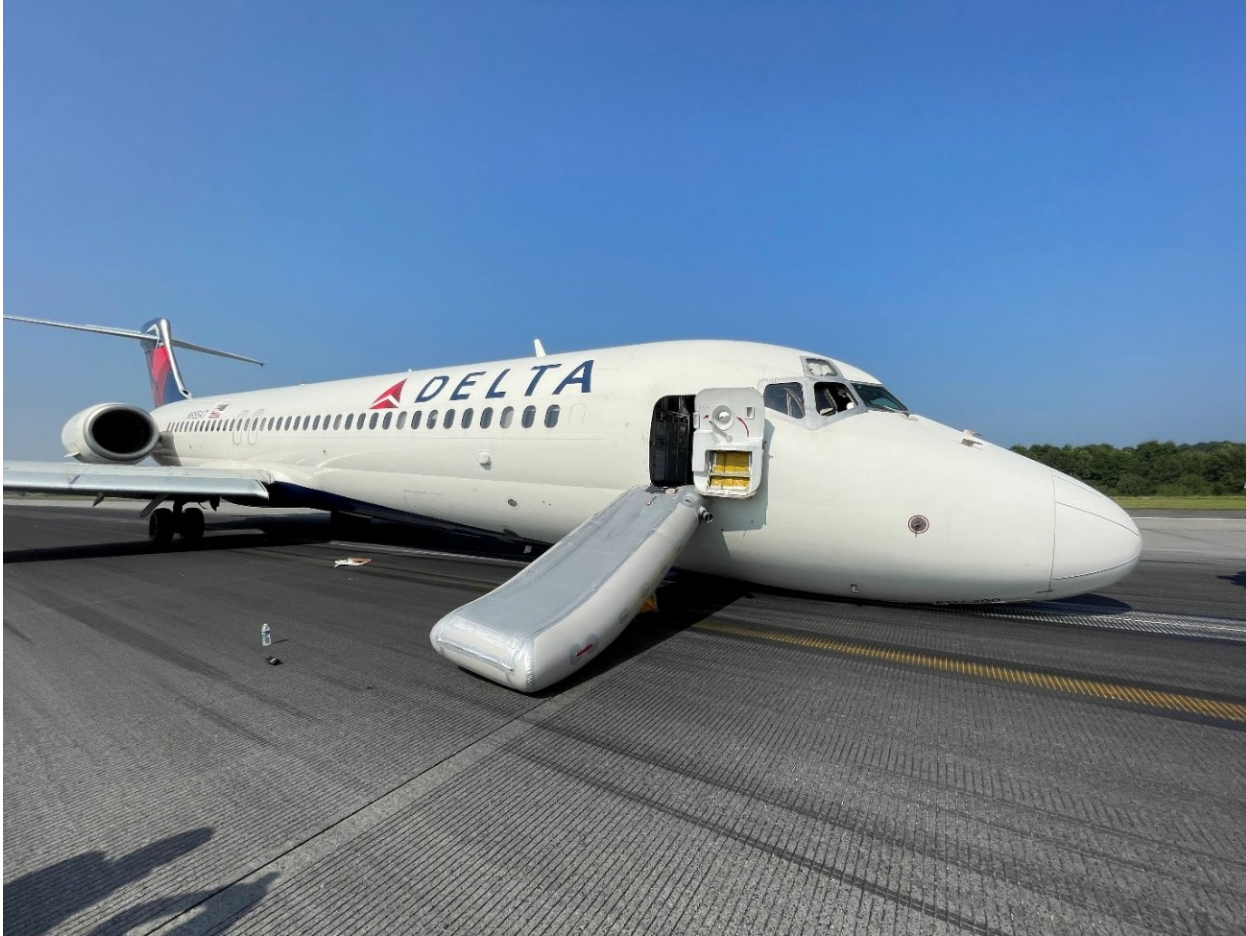
The airplane touched down about 1,400 ft from the runway's threshold and the nose was lowered onto the runway at about 80 knots. The airplane stopped just before taxiway W7 and CLT airport aircraft rescue and fire fighting (ARFF) sprayed the nose wheel area with water. The flight crew conducted the shutdown and evacuation checklists. After the fire chief verified that the area was safe, an evacuation was performed through the two forward entry doors with the passengers utilizing emergency slides.

Figure 1 – View of airplane in final resting position. Photo provided by FAA.

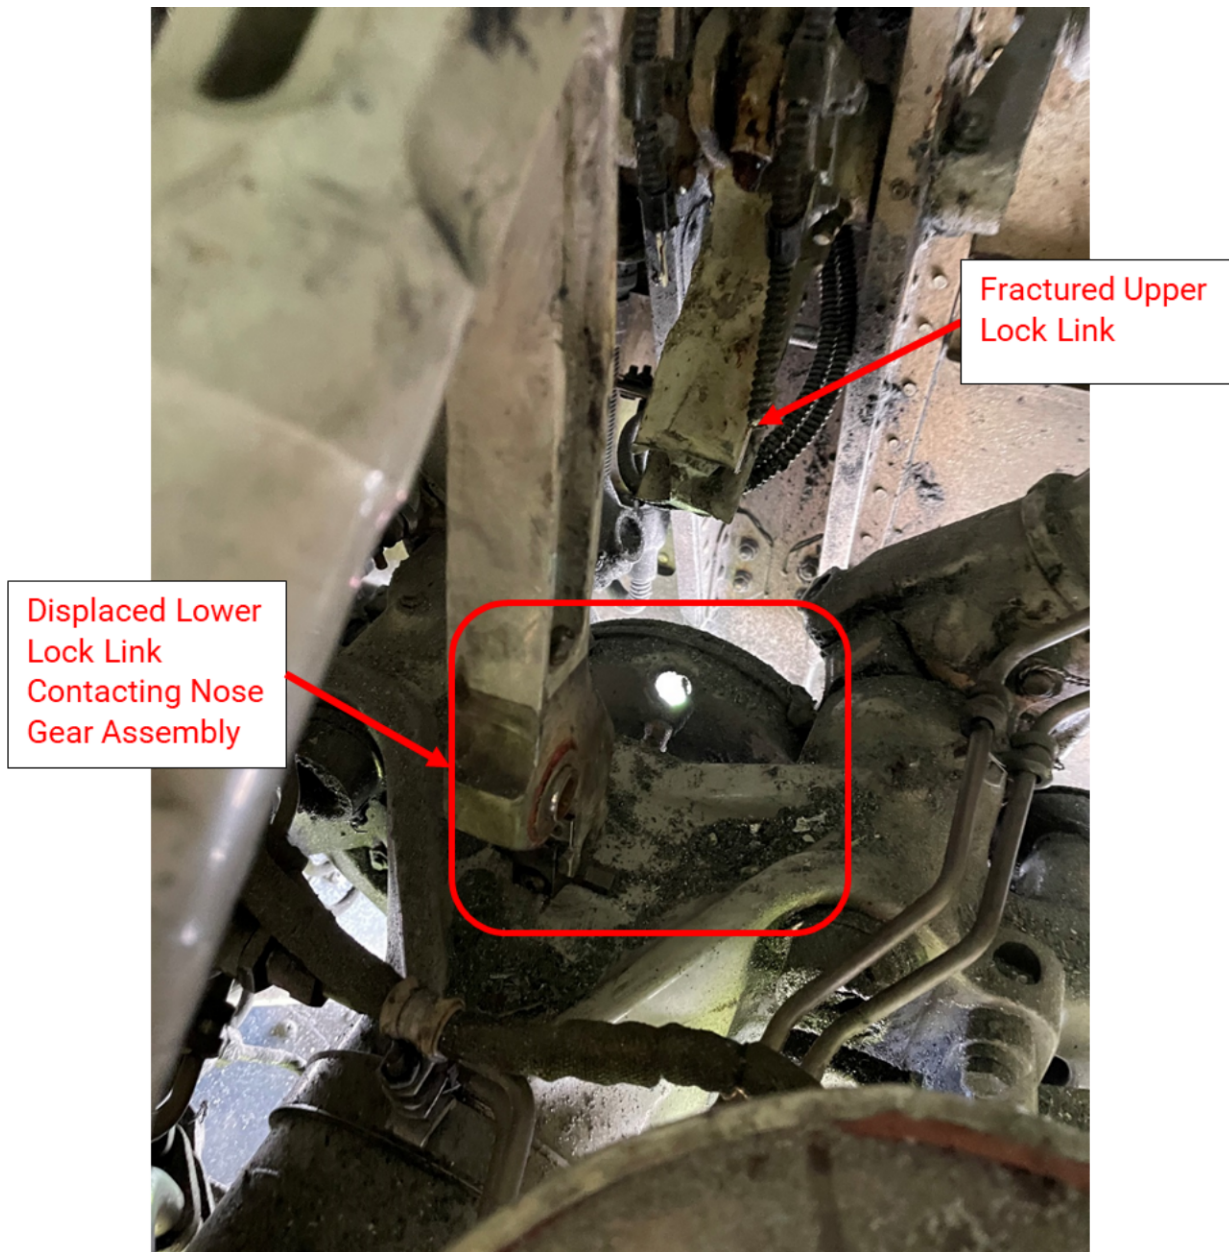
A postaccident examination of the nose landing gear system revealed a fractured upper lock link. Due to the fractured upper lock link, the lower lock link was free to swing down to a vertical position and made contact with the nose landing gear assembly and thereby restricted its movement.

Figure 2 - Displaced lower lock link contacting nose gear assembly in foreground. Note the forward section of the fractured upper lock link has previously been removed from the lower lock link during recovery. The aft section of the fractured upper lock link is in the background. View looking down and aft.
