Aviation Investigation Final Report

Location:	North Plains, Oregon	Accident Number:	WPR23LA255
Date & Time:	July 5, 2023, 11:30 Local	Registration:	N40233
Aircraft:	Avia Stroitel AC-5M	Aircraft Damage:	Substantial
Defining Event:	Loss of control in flight	Injuries:	1 Serious
Flight Conducted Under:	Part 91: General aviation - Personal

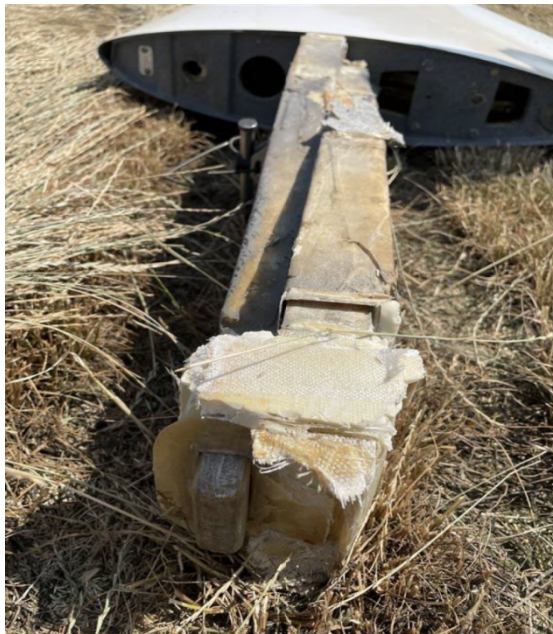
Photographic evidence revealed that the right wing's inboard spar was fracture separated. The left- and right-wing carry-through spar beams remained attached within the carry-through box and connected by the spar pin (see figure 1).

Figure 1. Accident site image of right-wing spar fracture separation.

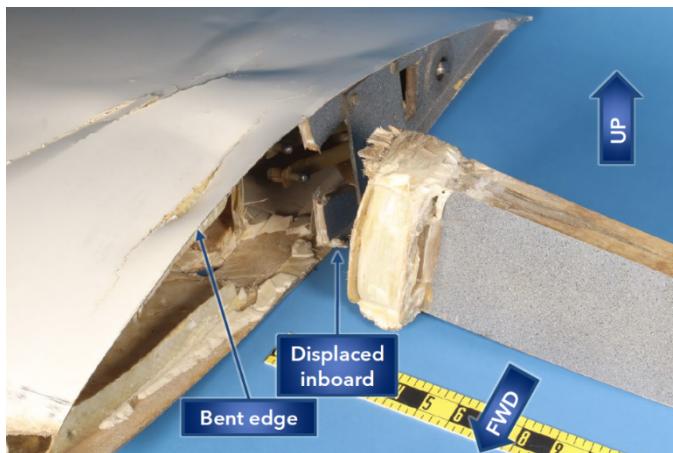
Postaccident examination of the right-wing spar separation revealed that the fracture occurred in the spar at the outboard side of the reinforced area of the closeout rib, as seen in figures 2 and 3. The spar caps were constructed of a fiber-reinforced composite material separated by a web constructed of wood laminate.

Figure 2. Inboard end of the right wing with separated carry-through beam.

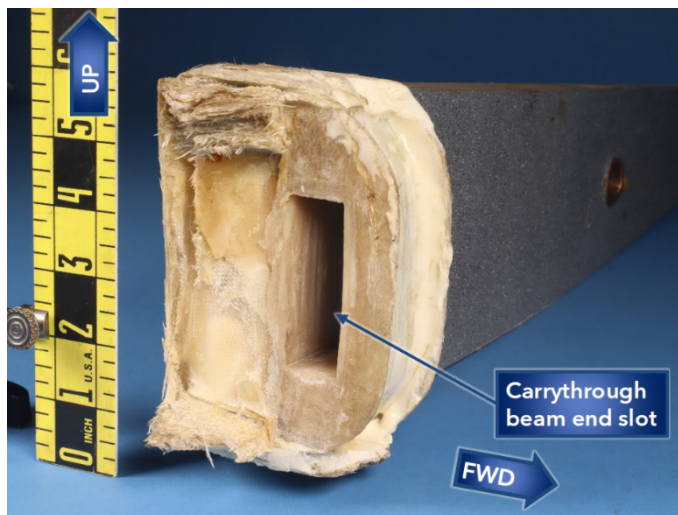
Figure 3. Inboard side of the right-wing spar fracture at the outboard end of the carry-through beam.

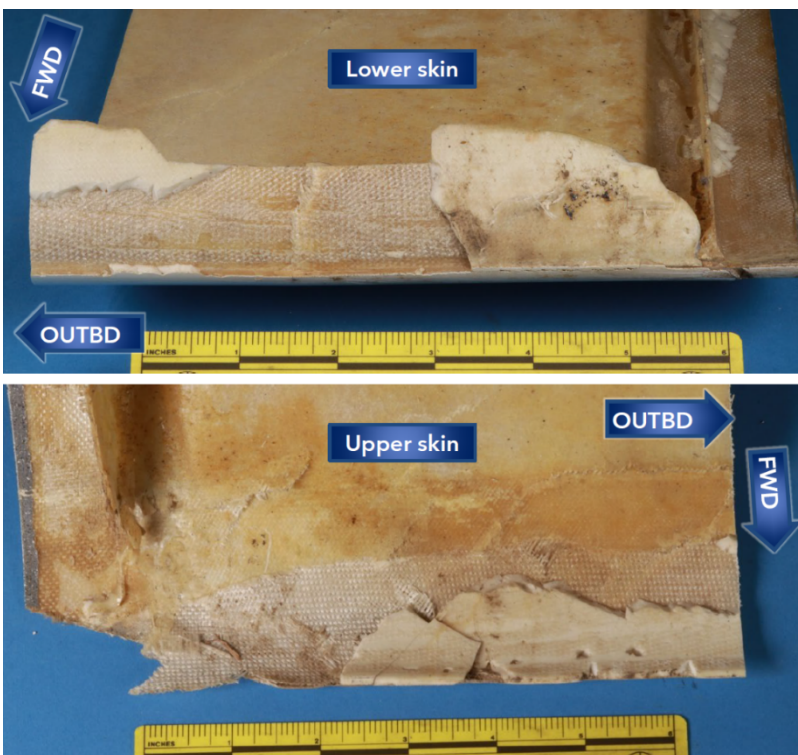
A materials lab examination revealed a cream-colored filler between the skin layers, and the fracture path varied between interfaces at either side of the filler. No evidence of preexisting or progressive fracture, such as arrest lines or rubbing damage from mating surfaces, was observed. (See figure 4.)

Figure 4. Sectioned right wing lower skin (upper image) and upper skin (lower image) after the upper skin was separated from the spar. The lower skin shows mating fracture surfaces at the inboard end of the leading-edge bond line.

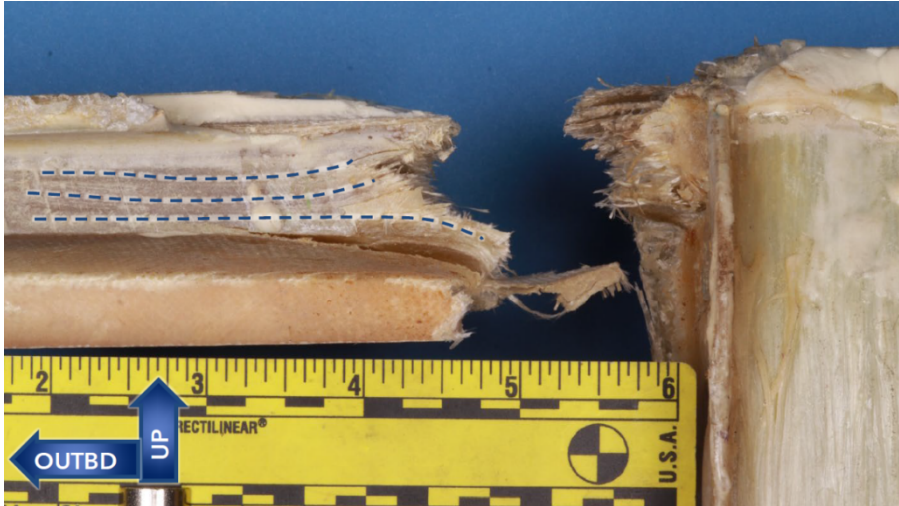
Mating sides of the fracture through the right-wing spar upper cap are shown in figures 5 and 6. Fiber reinforcement layers were visible at the forward side of the upper spar cap, and the longitudinal reinforcement layers appeared to deviate from the spanwise direction outboard of the fracture surface. Dashed lines in figure 5 trace several of the reinforcement layers visible on the forward face of the upper cap showing observed variations in fiber alignment.

Figure 5. Mating sides of the right-wing spar upper cap fracture after the outboard side was separated from the upper skin. Dashed lines indicate the orientation of reinforcement layers visible on the surface.

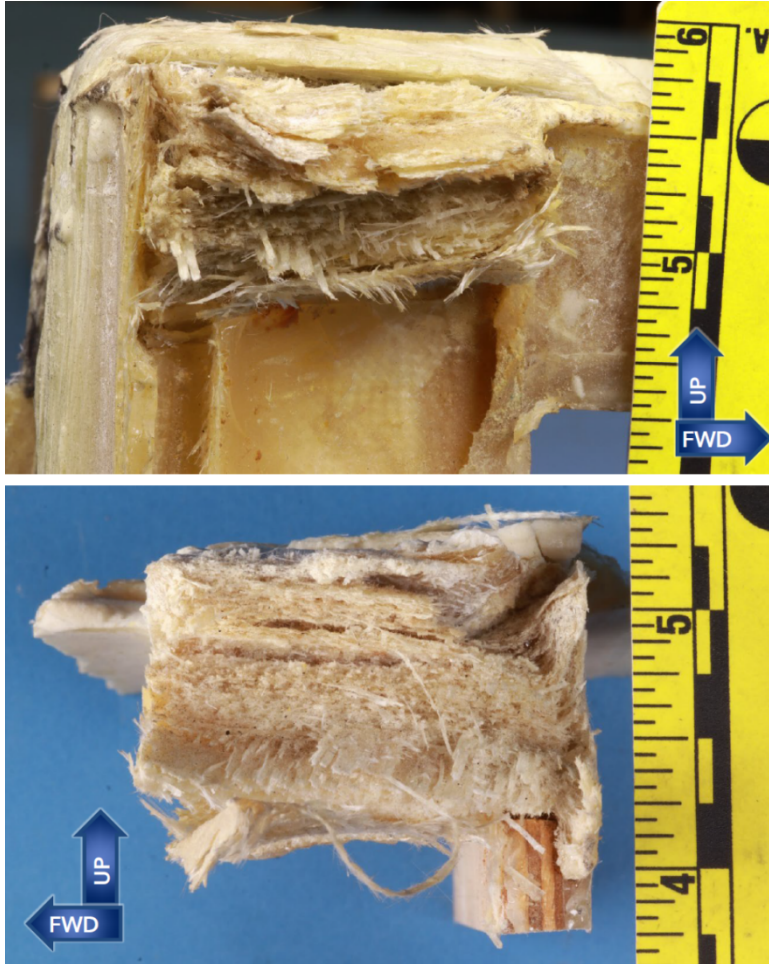
As viewed on the outboard side (figure 6), the fracture surface mostly had a rough fibrous appearance consistent with tensile overstress fracture. A small portion of the surface at the upper side of the fracture had a whiter flattened appearance consistent with compression failure. At the lower quarter of the fracture, the exposed longitudinal fibers were angled downward relative to the spanwise direction.

Figure 6. Inboard side (upper image) and outboard side (lower image) of the right-wing spar upper cap fracture.

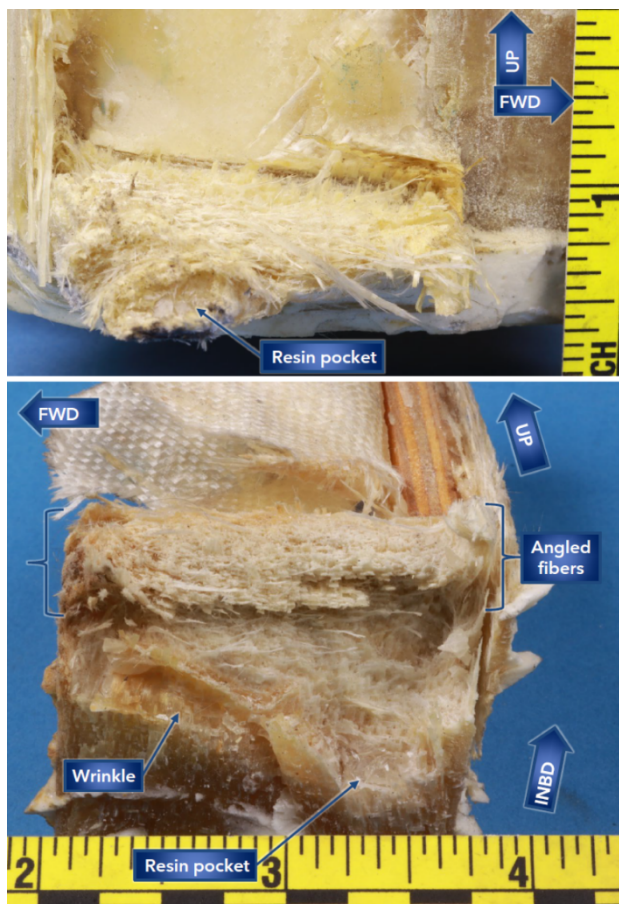
Mating sides of the right-wing spar fracture through the lower cap are shown in figure 7. The fracture surfaces had a rough fibrous appearance consistent with tensile overstress fracture. A relatively large pocket of fractured resin was observed at the lower aft side of the fracture, and that portion of the fracture was the furthest outboard. A wrinkle was observed in the fibers at the lower surface forward of the resin pocket. Additionally, brackets in figure 7 indicate fibers in the upper half of the fracture that were angled significantly downward relative to the spanwise direction.

Figure 7. Inboard side (upper image) and oblique view of the outboard side (lower image) of the right-wing main spar lower cap fracture.
