Aviation Investigation Final Report

Location:	Murrieta, California	Accident Number:	WPR23FA257
Date & Time:	July 8, 2023, 04:14 Local	Registration:	N819KR
Aircraft:	Cessna 550	Aircraft Damage:	Destroyed
Defining Event:	Altitude deviation	Injuries:	6 Fatal
Flight Conducted Under:	Part 91: General aviation - Personal

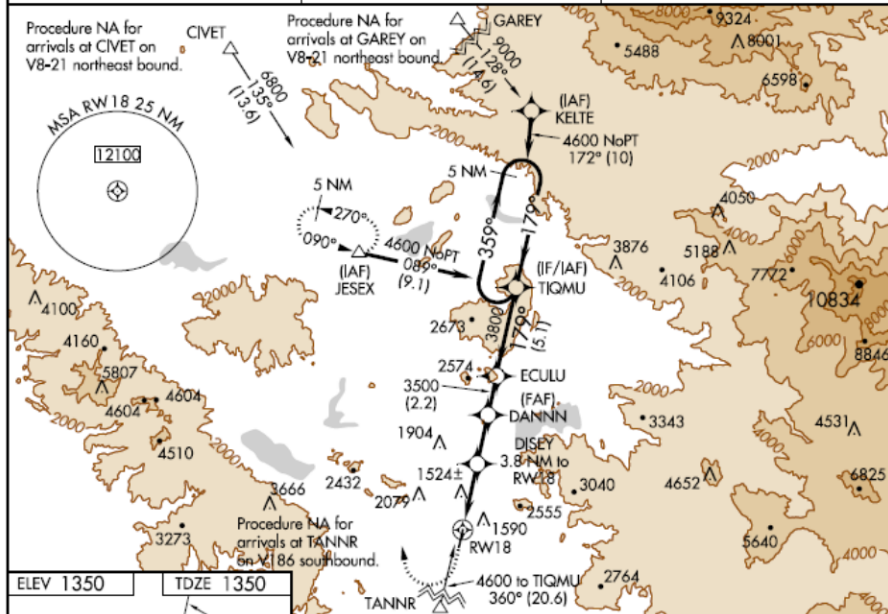
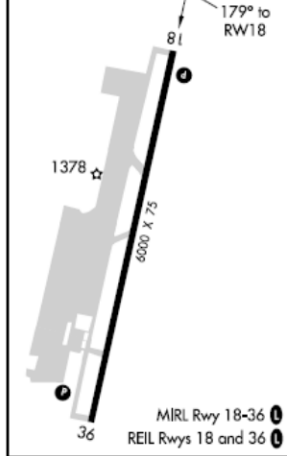
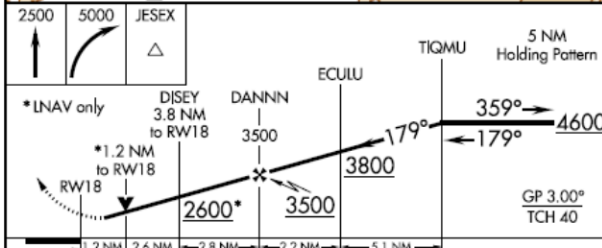
Figure 1. Runway 18 RNAV (GPS) instrument approach plate.

The airplane was cleared for the RNAV (GPS) Runway 18 instrument approach to the airport. The lowest visibility requirement on the approach was 7/8 of a mile. During the final approach, the pilot executed a missed approach and asked to try another instrument approach. During the second instrument approach, while on final approach, the pilot failed to fly a stabilized approach as the airplane's descent rate and airspeed were excessive. Subsequently, the airplane descended below the decision altitude of the approach without appropriate visual references and impacted terrain about 810 ft short of the runway threshold.

The RNAV (GPS) 18 was the instrument approach flown (see figure 1).
