Aviation Investigation Final Report

Location:	Santa Fe, New Mexico	Accident Number:	WPR23FA275
Date & Time:	July 18, 2023, 09:04 Local	Registration:	N5251C
Aircraft:	Cessna T310R	Aircraft Damage:	Substantial
Defining Event:	Loss of engine power (total)	Injuries:	1 Fatal
Flight Conducted Under:	Part 91: General aviation - Personal

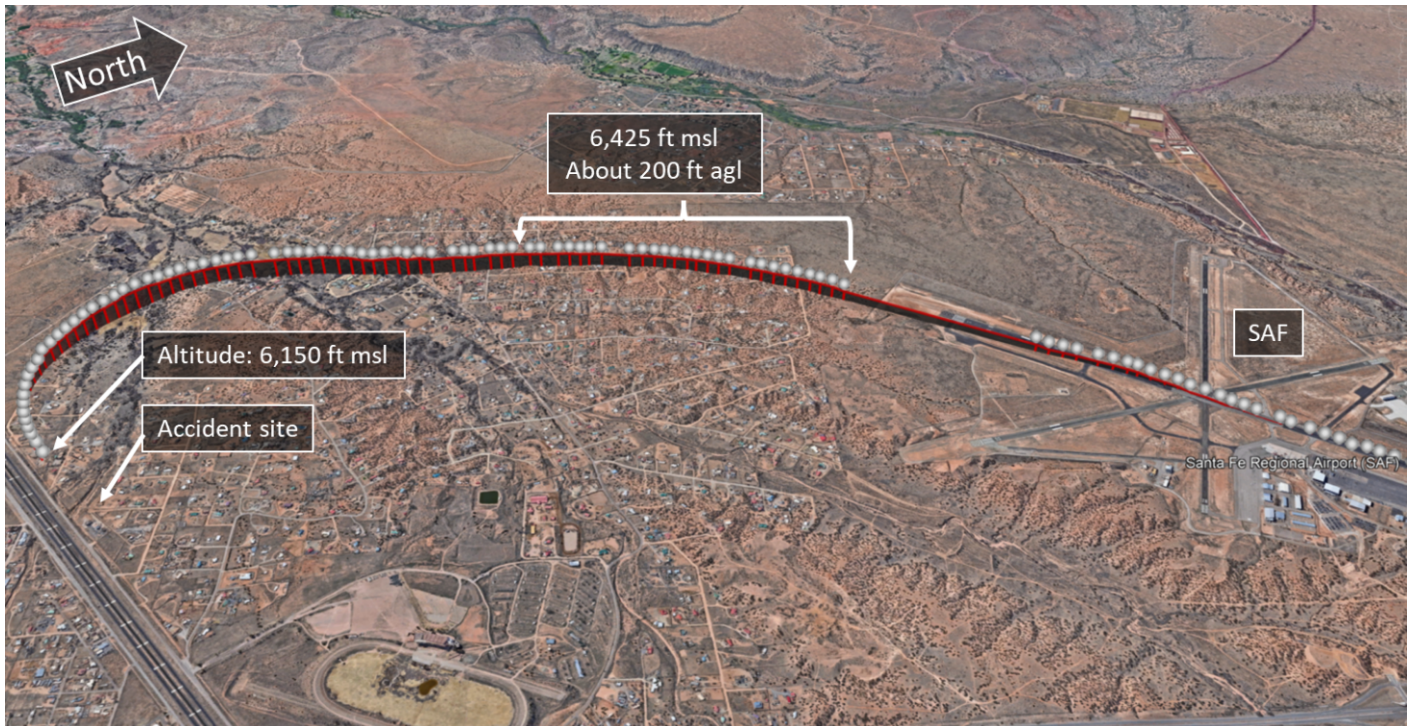
ADS-B data revealed that after takeoff, the airplane drifted from over the runway to the left but generally maintained the runway heading. Most of the flight was over a neighborhood. Upon departure, the airplane generally maintained the runway heading for about 1 mile and climbed to a maximum altitude of about 6,425 ft mean sea level (msl), or about 200 ft above ground level (agl). After about 1 mile, the airplane turned slightly to the left and continued south for about 1 mile. The airplane maintained 6,425 ft until 0902:37, when it began a slow descent and maintained about 101 to 102 knots ground speed. Around 0902:56, the airplane began a left turn while descending at a greater rate. (See figure 1.)

Figure 1. Google Earth image showing the accident airplane's flight path and altitude.

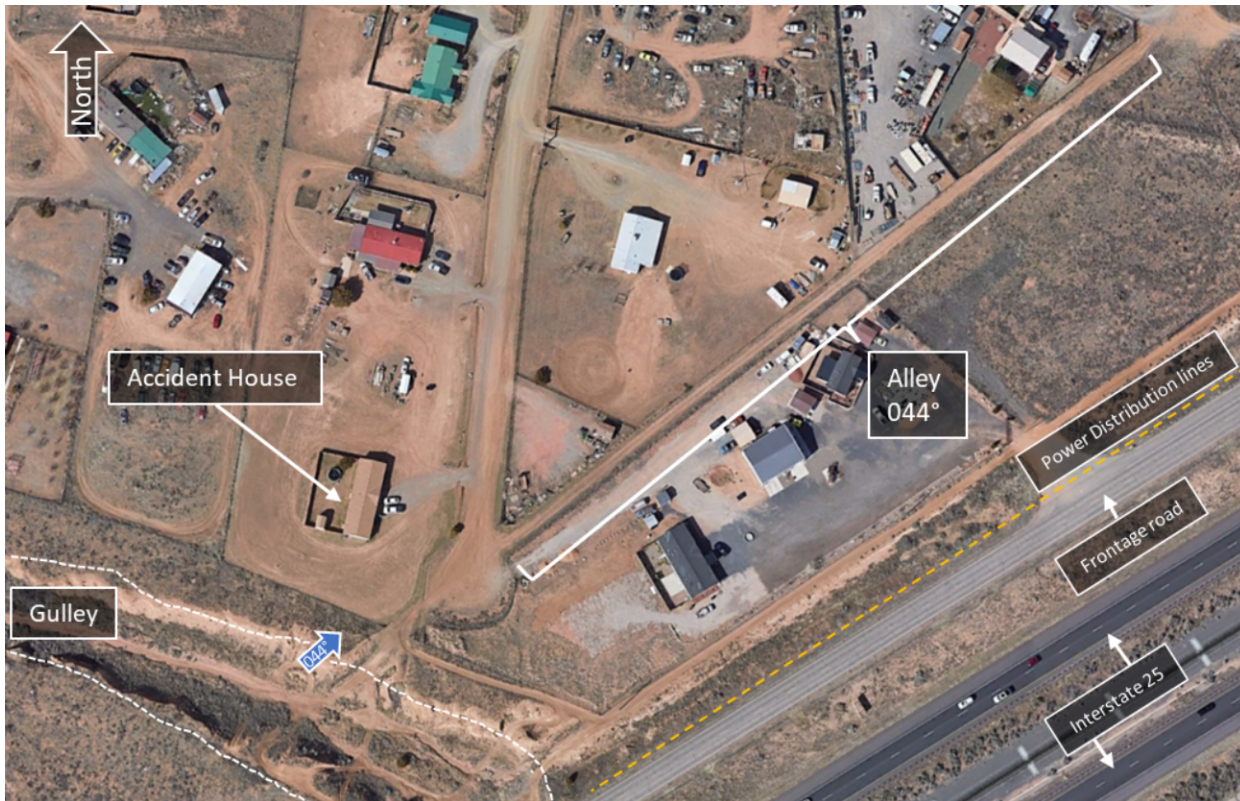
The last ADS-B data point, recorded at 0903:37, captured the airplane over a gully at an undetermined altitude, at 86 knots, on a track of 044°, and about 150 ft southwest of the accident site. The airplane was aligned with an alley that was oriented 044° magnetic, as shown in figure 2.

Figure 2. Google Earth image showing the estimated last ADS-B data point location of the airplane (blue arrow) on the recorded magnetic heading of 044°, and the alley in front of the airplane. A gully is outlined by dashed white lines, and power distribution lines are identified with a yellow dashed line.

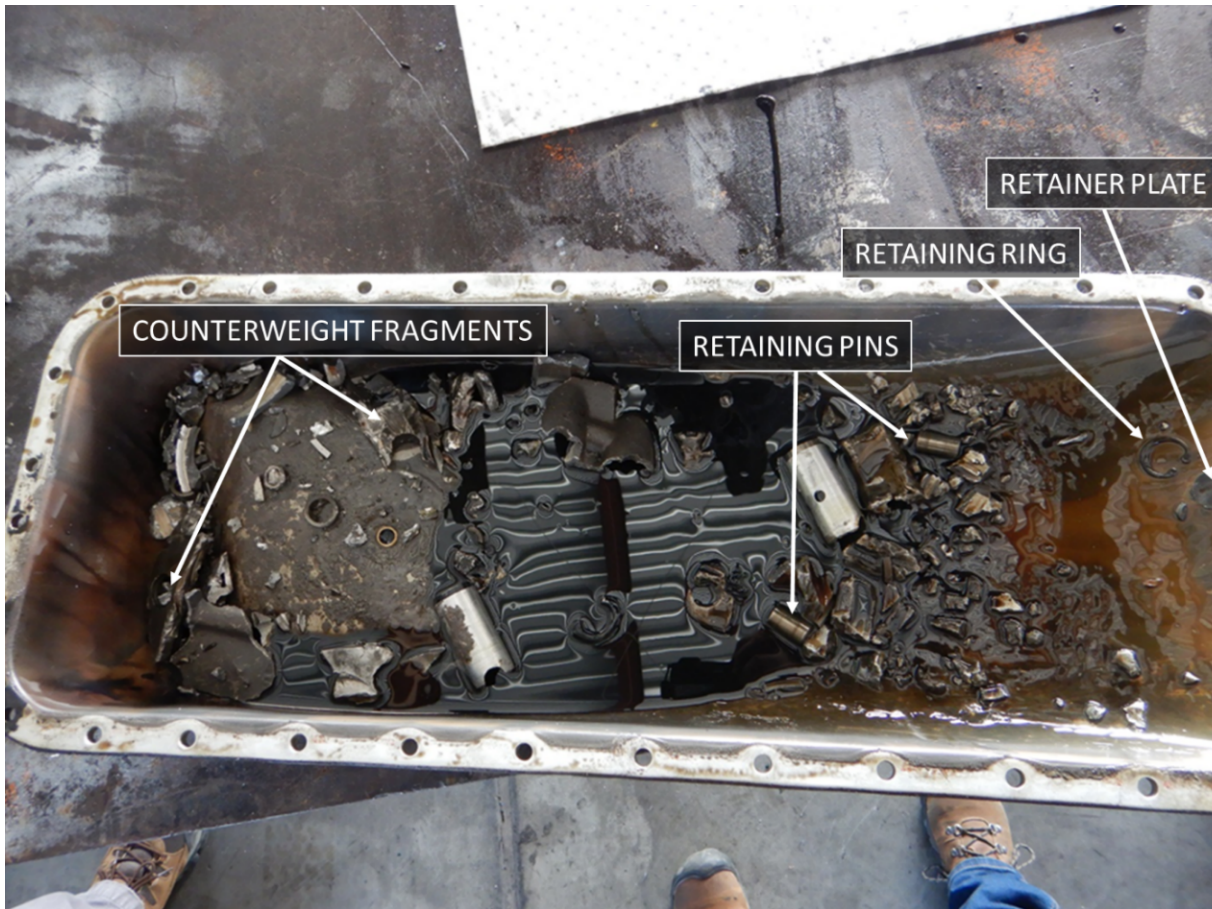
Examination of the left engine, model number TSIO-520-BB23B, serial number 287610-R, revealed a counterweight jammed next to cylinder No. 1. The oil sump was removed, and a significant amount of metal debris was observed in the sump. Among the debris were pieces of crankshaft counterweights, counterweight retaining rings, retainer plates, bushings, and a connecting rod cap, as shown in figure 3.

Figure 3. Photo of the oil sump with counterweight components identified.

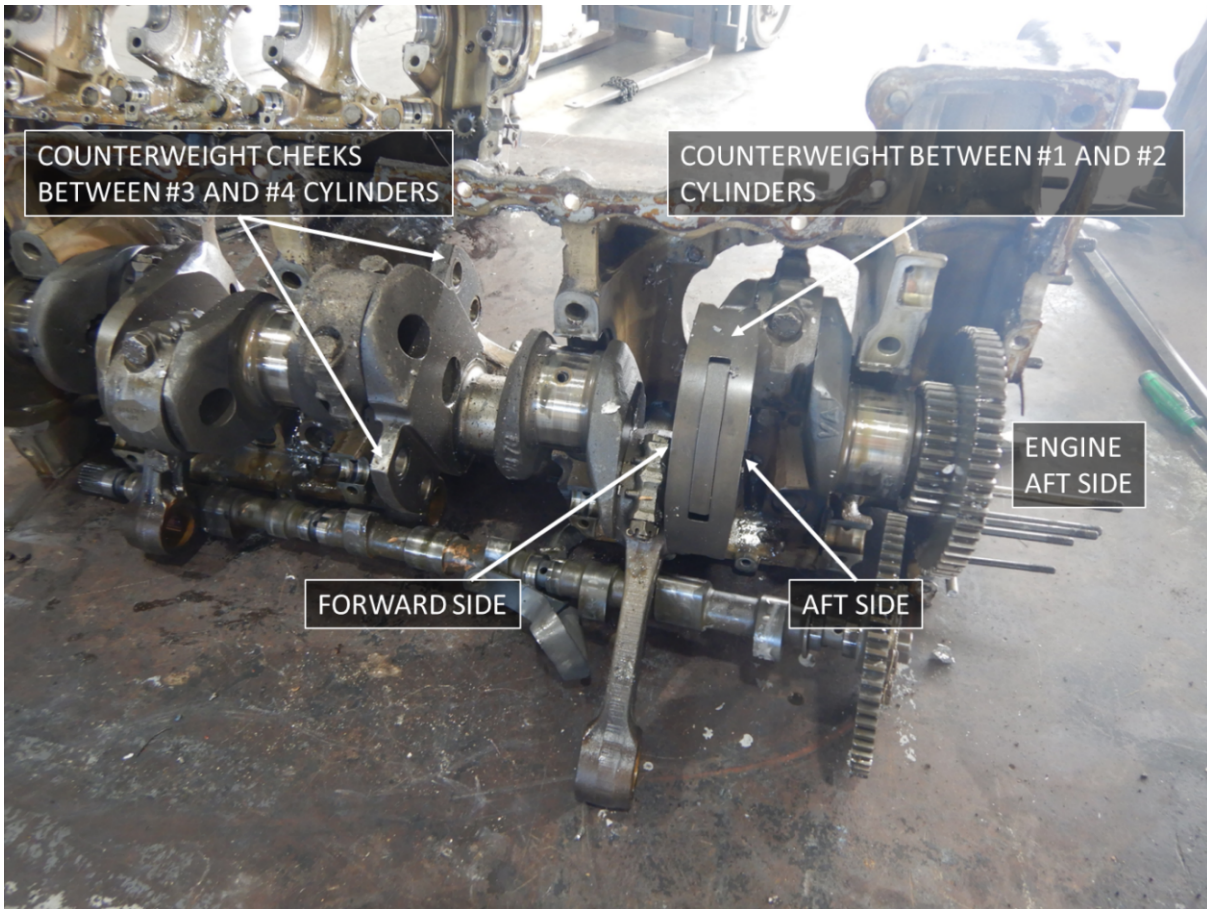
The cylinders and the crankcase bolts were removed and the crankcase was split open. The two counterweight assemblies located between cylinder Nos. 3 and 4 were found separated from the crankshaft attachment flanges or "cheeks." . One counterweight assembly, located between cylinder Nos. 1 and 2, remained attached; the other was partially separated from the crankshaft flange and was wedged against the crankcase between the crankshaft flange and valve lifters. (See figure 4.)

Figure 4. Left engine showing the counterweight cheeks, and the one attached counterweight.

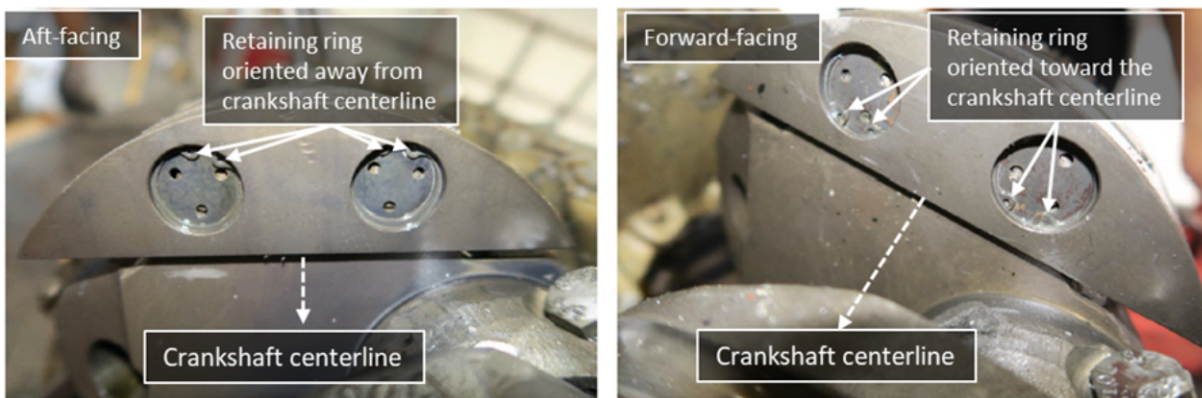
A total loss of left engine power as a result of improper installation of the aft-facing crankshaft counterweight retaining rings. Also causal was the pilot's failure to maintain adequate airspeed following the loss of left engine power, which resulted in the airplane's inability to climb and subsequent loss of control.

Visual examination of the counterweight that remained attached to the crankshaft flange showed that the retaining ring ears on the aft side were facing approximately 180° from the crankshaft centerline, while the retaining rings on the forward-facing side were oriented toward the crankshaft centerline. (See figure 5).

Figure 5. Left engine counterweight showing the retaining rings on the aft-facing side (left photo) and the retaining rings on the forward-facing side (right photo).

One of the aft retaining rings was found installed with the sharp edge outboard, while the other was incorrectly installed “flipped over,” with the sharp edge facing inboard.

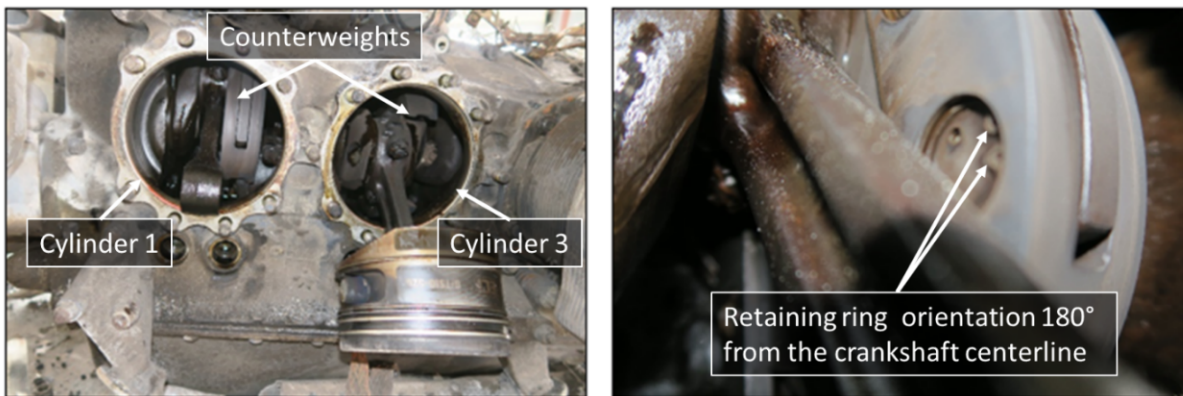
The right engine, model number TS10-520-BB24B, serial number 287609-R, was examined and the Nos. 1 and 3 cylinders were removed. Examination of the counterweights revealed that the aft facing retaining rings were oriented facing 180° from the crankshaft centerline, and the forward-facing retaining rings were oriented facing toward the crankshaft centerline, as shown in figure 6. Examination of the right engine revealed no mechanical malfunctions or failures that would have precluded normal operation.

Figure 6. The right engine, showing the removal of the Nos. 1 and No. 3 cylinders, and the aft-facing retaining ring of one counterweight.

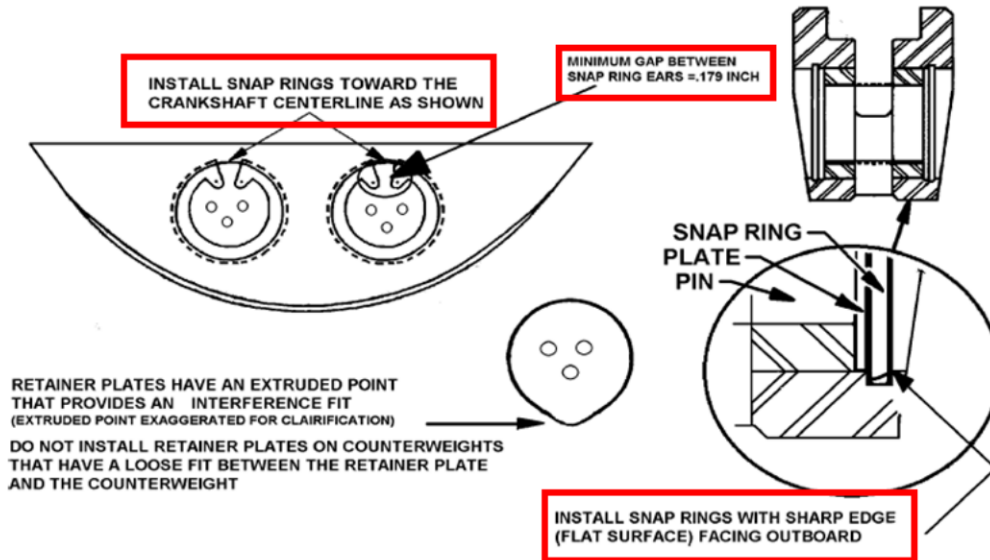
MSB 99-3C stated in part, *"INSTALL SNAP RINGS TOWARD THE CRANKSHAFT CENTERLINE AS SHOWN."* and *"INSTALL SNAP RINGS WITH SHARP EDGE (FLAT SURFACE) FACING OUTBOARD."* and *"MINIMUM GAP BETWEEN SNAP RING EARS = 0.179 INCH."* (See figure 7.)

Figure 7. Excerpt from MSB 99-3C.
