Aviation Investigation Preliminary Report

Location:	Wainwright, AK	Accident Number:	ANC23FA056
Date & Time:	July 20, 2023, 11:05 Local	Registration:	N311MH
Aircraft:	Bell 206-L4	Injuries:	4 Fatal
Flight Conducted Under:	Part 135: Air taxi & commuter - Non-scheduled

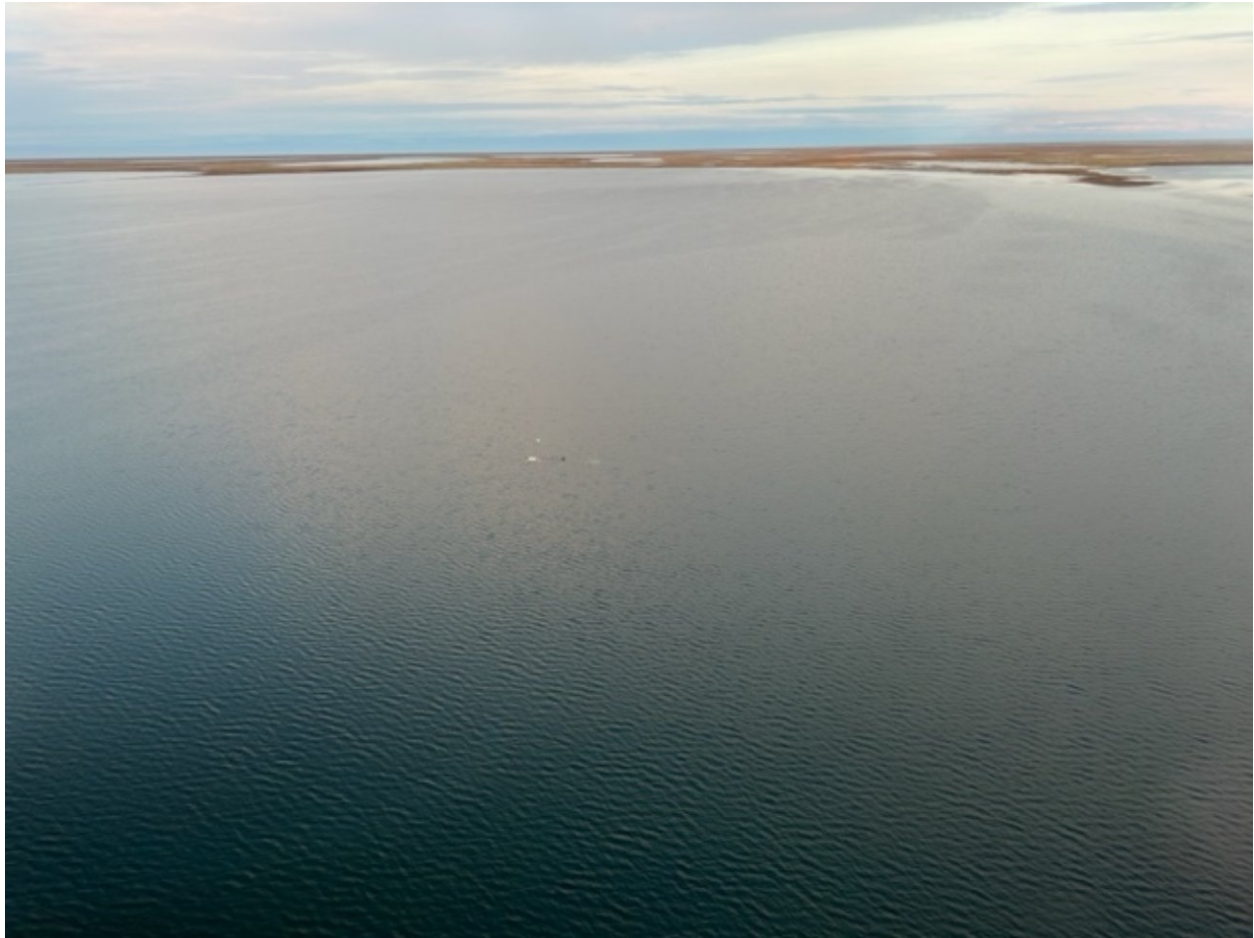
Figure 1 Aerial view Lake Ttinik with wreckage noted in circle (North Slope Borough Search and Rescue photo).
